Department of the Interior Aviation Lessons Learned

No. DOI 09-05

Subject: Aircraft Accident Lessons Learned

Area of Concern: Aviat Husky A-1B wing covers and fuel vents

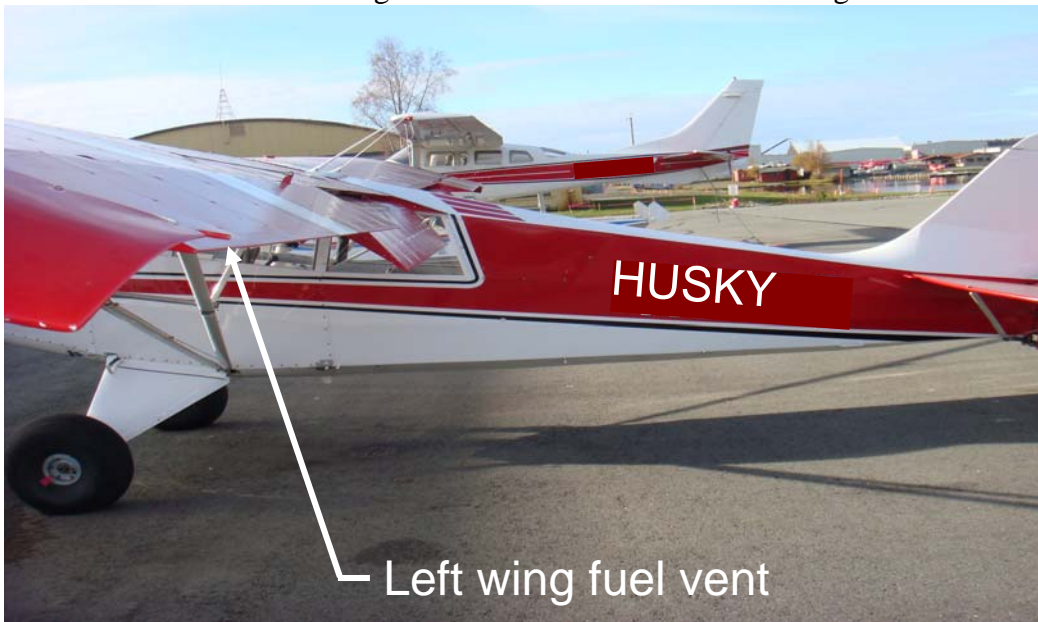
Photo A

Discussion: Improper use and removal of the Husky wing cover can result in damage to the fuel vents. Even moderate bending of these fuel vents can result in flight control restriction.

Husky fuel vents are located parallel to the outside edge of the ailerons toward the wingtip and extend past the training edge of the wing by 1-2 inches. On page 1, photo A shows the location of the fuel vent on the left wing. Photos B and C are close-up photos of the fuel vent on the right wing.

After removing the Husky wing cover, or even after a strong wind event, check to ensure that the fuel vents have not been bent. If they have been bent, they could interfere with the ailerons and prohibit the movement of control surfaces. Even a slight bend narrows an already small gap between the vent and the aileron.

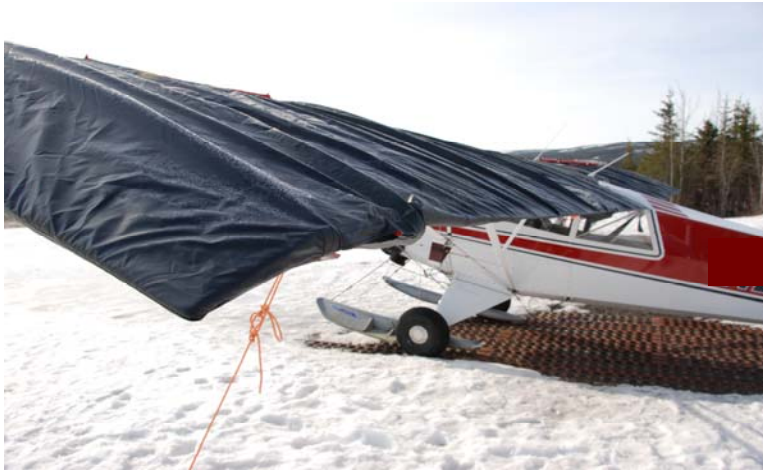
Husky wing covers are form-fit to slip over the wing tip and are secured with straps under the wing. The covers are usually made of medium weight nylon. Older wing covers only have small holes for the fuel vents, whereas newer wing covers have a velcro reinforced slit which allows the fuel vents to extend through the cover.

Wing cover installed on Husky
