**US Army Corps
of Engineers®**

**Assessment of Health Care Infrastructure and Services
Lyndon Baines Johnson Tropical Medical Center
Pago Pago, American Samoa
22-24 April 2019**

Executive Summary
Assessment of Health Care Infrastructure and Services
Lyndon Baines Johnson Tropical Medical Center
Pago Pago, American Samoa

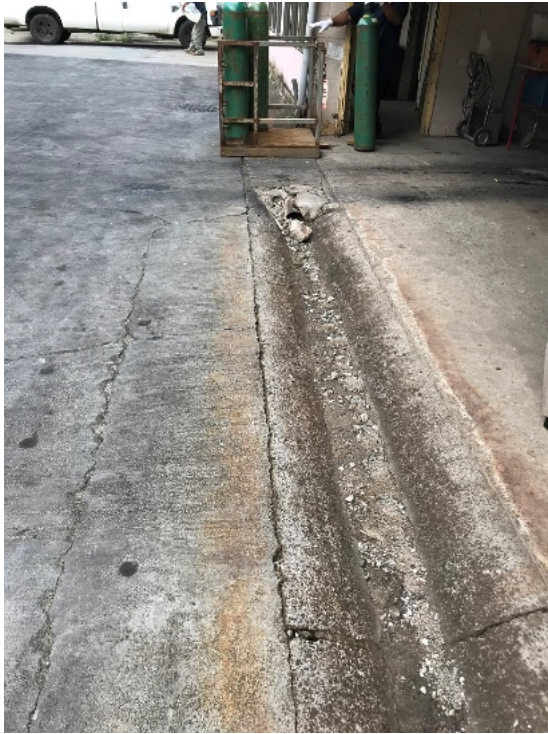
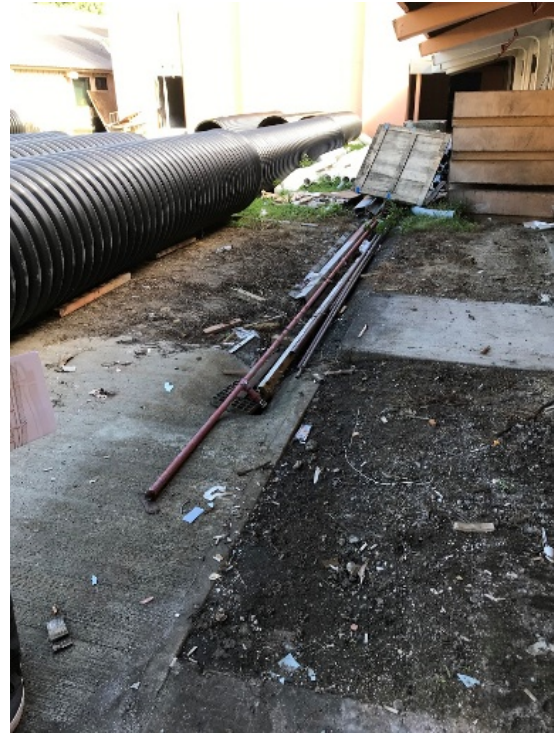
Drainage Canals: Drainage canals over site are in GOOD condition, however some have build-up (dirt, debris, etc.) and/or blocked by deteriorating concrete culverts or parking/roadway material. While, other drainage canals have construction materials stacked in/over potentially blocking drainage flow. **MINOR Repair: This is general maintenance which can be cleaned and maintained or repaired. Construction material should be consolidated and strategically stacked, stored and placed to allow natural site drainage and prevent safety risks to patients. Site needs a dedicated contractor lay down area. These areas are typically fenced and secured. Conex shipping containers are ideal storage along with elevating materials off ground to prevent corrosion or contamination.**

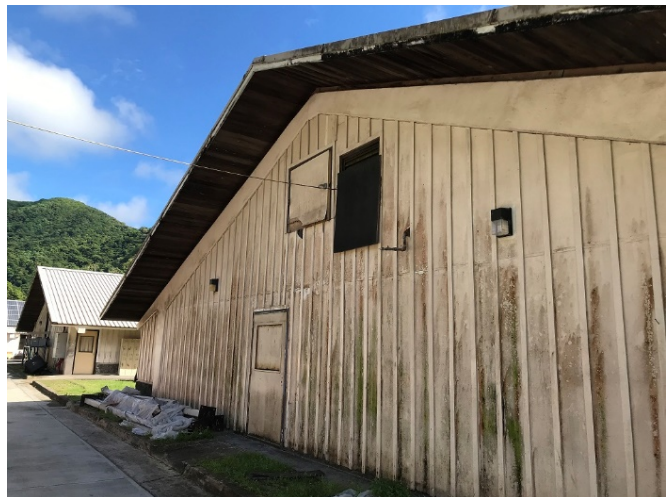
This mold may be caused from the moist conditions/environment, low quality paint, from an inferior, damaged or missing vapor barrier or simply the exterior materials used. Another influence, could be negative pressure rooms located at/near the exterior wall drawing the moisture into the building. Buildings in general should be positively pressured. The Dialysis building, although a relatively newer renovation in 2017 is showing significant signs of mold at the exterior walls and under the canopy. Original drawings were very limited in regards to validation of the construction/components of the exterior wall. Without destructive investigation, it is impossible to confirm the cause, extent of the mold, or quality of evidence of an exterior envelope vapor barrier. **MAJOR REPAIR: Recommend a destructive investigation at severe areas by removing sections of the exterior finish to check extent of damage and envelope composition for repairs. The entire exterior of the facility should be sprayed with chemicals and power washed, then sealed, caulked and painted with a high quality mold resistant paint. Implement a mold prevention/ maintenance plan to clean the exterior regularly. Consider using materials less susceptible to mold than wood such as concrete, CMU, brick, stone, etc.**

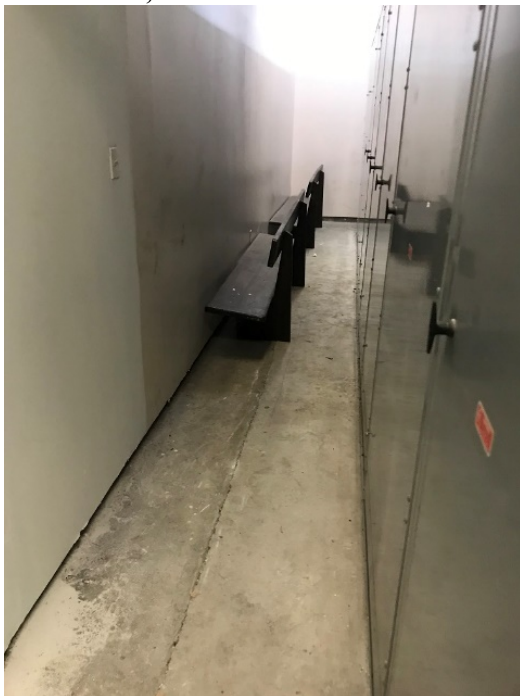
Storage in Electrical Rooms: Main electrical rooms have items such as wood benches, boxes, medical equipment and other items being stored. **MINOR Repair: Recommend removing all items not associated with the Electrical room. Storage in Electrical rooms is prohibited per NFPA 101, CMS and The Joint Commission (TJC).**

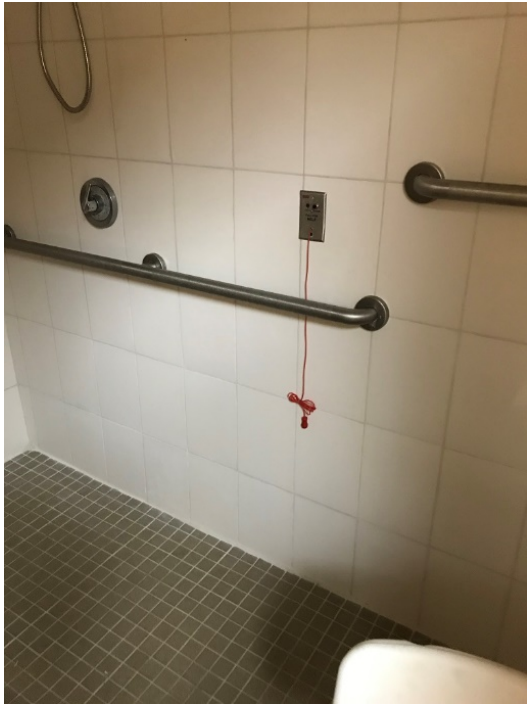
Nurse call: Pull switch/ chord is tied up and does not extend to the floor so it can be reached by a patient. **MINOR Repair: Recommend extending pull chord straight down and cutting so that the end of the chord is at a minimum of 1 inch off finish floor. See NFPA 99 Section 7.3.3.1.2.6. A pull chord shall be permitted to enable access by a patient lying on the floor.**

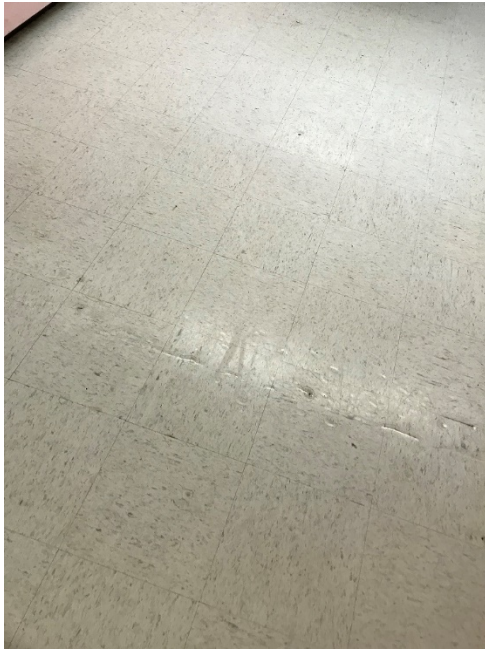
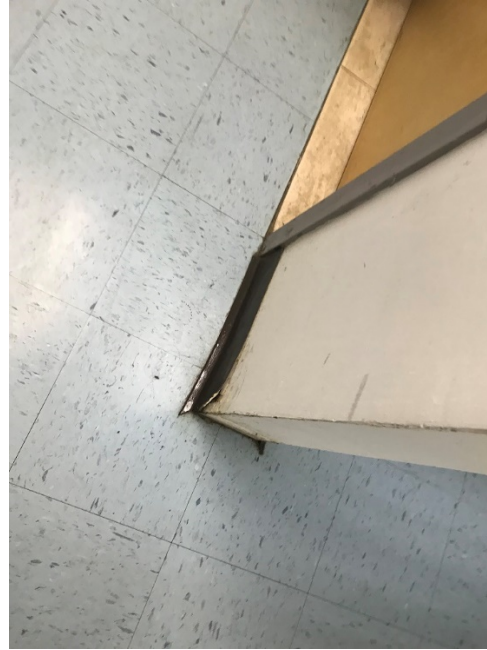
Painted Surfaces: Interior surfaces are in POOR condition. Walls and door frames are worn significantly providing no protective properties. As they are damaged, peeling or have mold growth. There are a number of other areas throughout the facility that have been patched which are not finished. Drywall mud has not been sanded, walls primed and not painted. Selection of interior construction and finishes must consider the need for aseptic environments. Use smooth, nonporous, seamless materials to minimize contamination and reduce housekeeping requirements. Smooth, seamless wall and floor coverings facilitate cleaning. Cabinetry should be designed and installed without gaps behind or underneath base units. At a minimum, these areas shall be designed for ease of housekeeping, with elimination of materials or surfaces that could harbor contamination and to minimize maintenance. Painted surfaces should be durable, cleanable and maintained on a continuous basis to include annual maintenance plans.

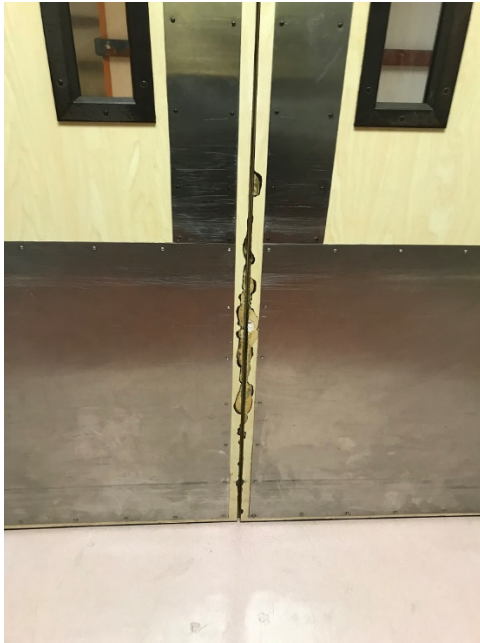
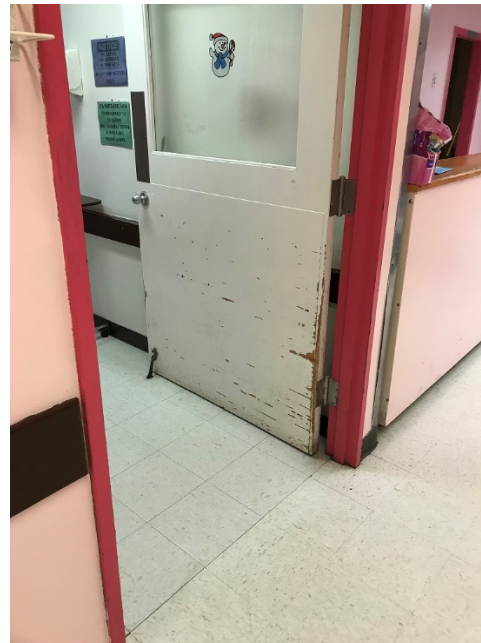
Interior Doors: Interior doors are typically laminated, wood or metal with hollow metal frames. The majority of the frames are in FAIR to POOR condition. Numerous doors throughout the facility are damaged, chipped and/or delaminating. **MAJOR to SIGNIFICANT Repair: Recommend all interior doors throughout the facility be replaced. Frames in most of the openings could possibly be reused saving cost and impact/interruption to patient care. However, replace frames as necessary. Highly recommend the use of FRP doors with a continuous hinge due to the weight. These doors cost much more than typical solid core wood doors but are impact resistant and will probably hold up better to climate (humidity) and maintenance is very minimal as these doors will never need to be painted. They do come in a nice wood grain finish.**

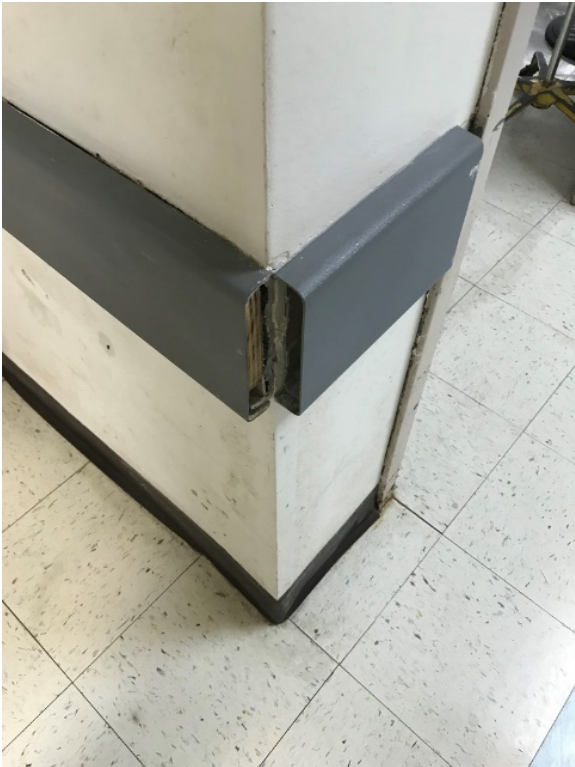
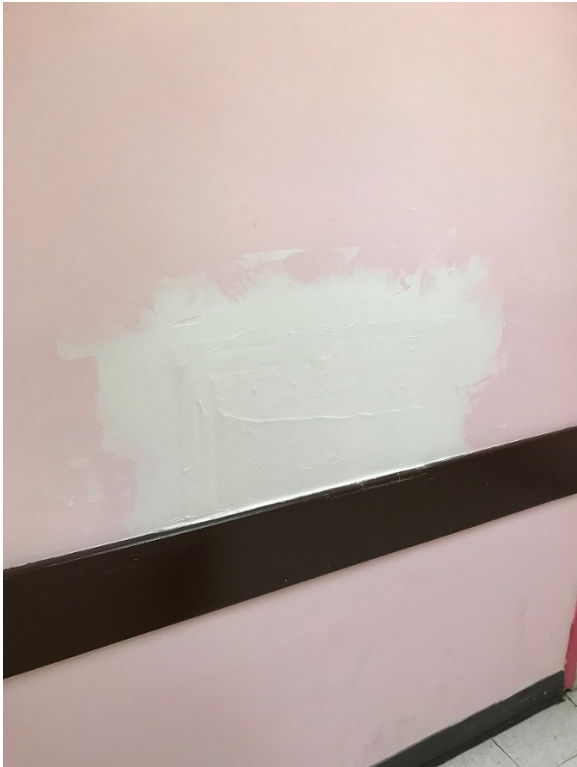
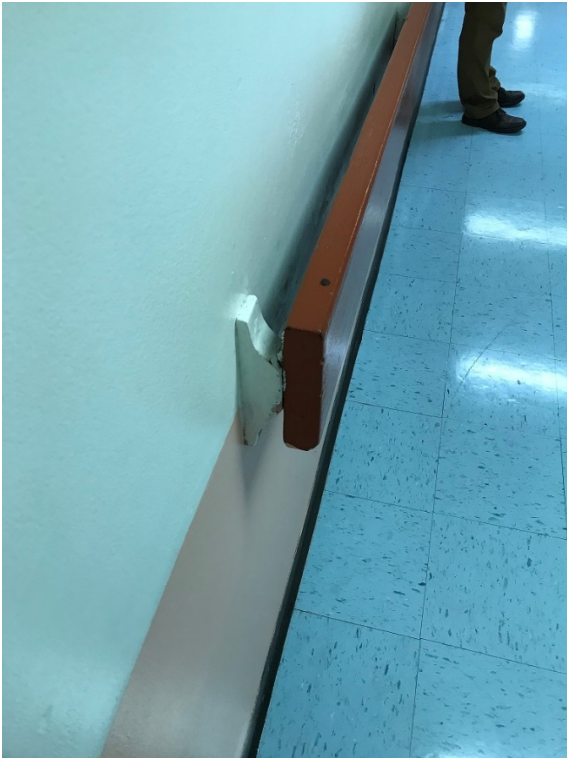
Handrails: Handrails are in FAIR condition, which are required at both sides of the corridors to assist patients in healthcare facilities per FGI, ABA, DoD and DVA criteria. Some patient care areas only have handrails on one side, crash rail in place of handrails, while other areas don't have handrail at all or the handrails are old (wood), damaged and not continuous. Damaged handrails provide open areas for dust and other contaminations to harbor or collect. Handrail serve many purposes from assisting mobility, protection for the walls to aesthetics. Handrails shall be continuous, durable and cleanable. **MAJOR Repair: Recommend installing acrovyn handrails throughout facility. In high traffic areas wall protection can be installed below the handrails along with crashrails near the base, to protect the walls from rolling equipment damage. Corner guards should also be installed throughout the facility.**

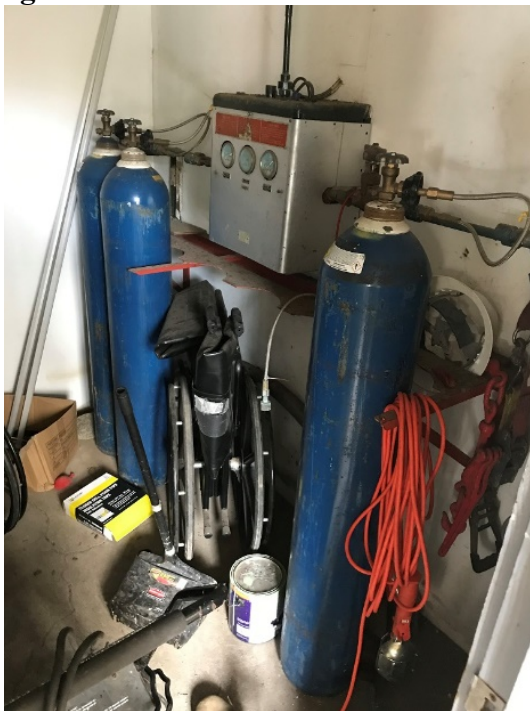
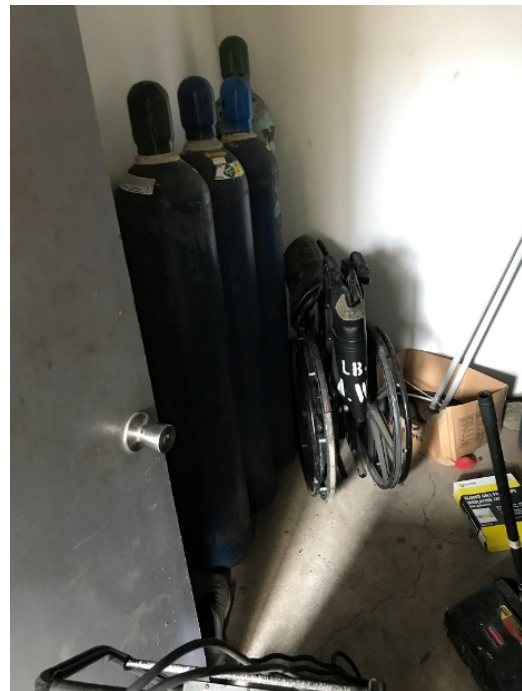
Nitrous (N2O) med gas room #1: Located at Mechanical/CUP area, N2O manifold cylinder tanks and empty tanks stored in room do not have any type of restraints. These are prone to falling over which could result in serious injury (safety) or hazardous event (Life Safety). Also, gas storage rooms have a lot of other supplies (paint, etc.), junk, empty boxes, equipment and items stored. The only items that are allowed in these rooms are the items for which the rooms are design, function and purpose. Everything else must be removed and the rooms cleaned. This is a violation of NFPA 99, CMS and/or TJC. N2O storage room door was wide open and not secured. **MINOR Repair: Recommend installing proper racks with double restraints (top & bottom) or individual tank strap brackets (top & bottom) to hold tanks in the vertical position and to prevent them from falling over. The bottom strap is essentially for seismic events to prevent the tank from shifting outward. Also recommend removing all items that do not belong or serve this rooms function. Comply with by providing a locked access door per NFPA 99, Section 11.6.5.5 which states that nitrous oxide cylinders shall be secured against unauthorized access.**

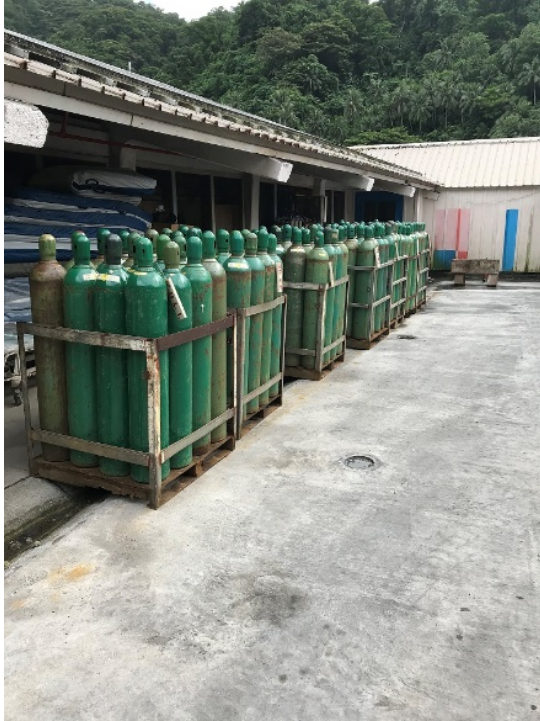
Med Gas Tanks storage: Med gas rooms do not have precautionary signage per NFPA 99, Section 11.3. Empty and full cylinders are stored within the same enclosure shall be segregated. Empty cylinder shall be marked to avoid confusion or delay if full cylinder is needed in a rapid manner. The majority of the full tanks are stored outside in bulk racks in close proximity to the building, which can be considered a hazardous situation, until they are needed for manifold install. Storage shall be planned so that they can be used in the order in which they are received from the supplier. **MINOR Repair: Recommend complying with NFPA Section 11.3 and**

Section 11.6.5 on segregation of tanks and labeling (empty and full tanks). The full containers had no identification indicating when they were delivered or order received. See NFPA Section 11.6.5.1. Recommend having a designed storage area outside away from the building that is secured for full cylinder tanks. Inventory and use as received. Also, full tanks may also need to be located within each med gas room, secured ready to be installed.

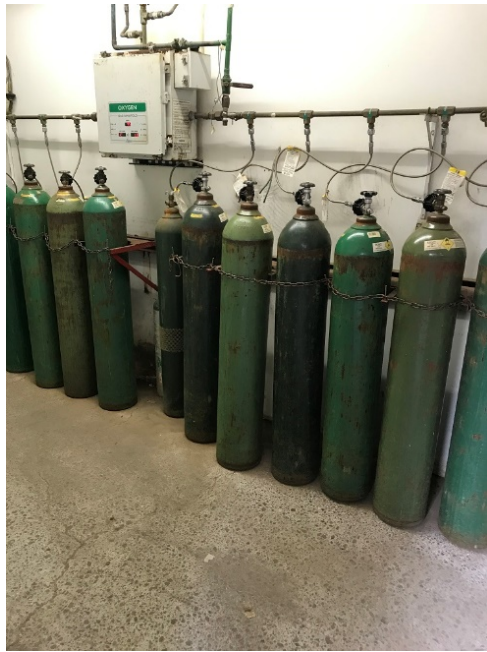
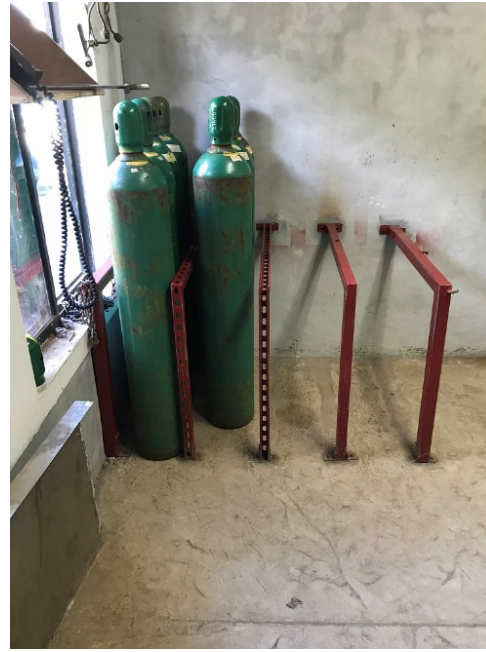
Oxygen (02) Med Gas Room: There are two rooms at Mechanical/CUP area, which the full tanks connected to the manifold have top restraint (chain) but not bottom. **MINOR Repair: Highly recommend a two strap approach as the top restraint is not always sufficient to secure the tanks. The bottom strap is essentially for seismic events to prevent the tank from shifting outward. Empty tanks have a rack system but no chains for restraint. Recommend installing chains (top & bottom) for each row and between each tank.**

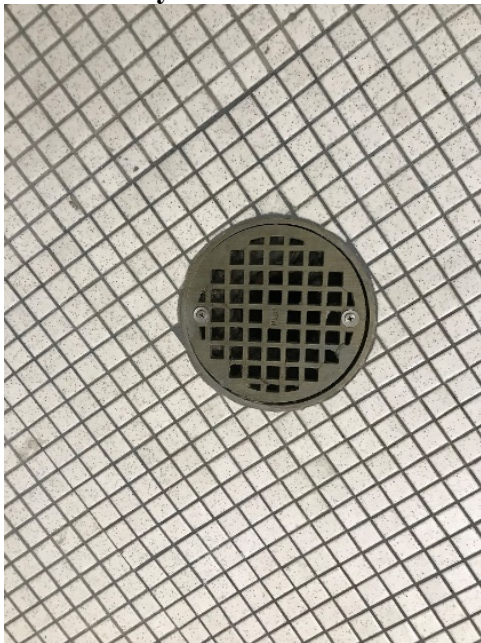
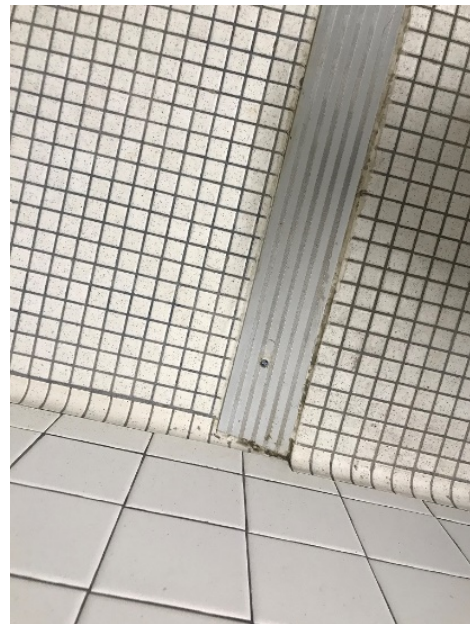
BH Tamperproof Fasteners – Patient Rooms: The furniture in BH patient bedrooms shall be minimized, heavily weighted or fixed to the floor, be non-breakable and contain no compartments for hiding. Mounting and fastening of equipment to avoid ligature risks or detachment from the wall. In-Patient room bed and wall units both have exposed hex head bolts or nuts. There are also Philip head screws used to fasten drain cap, shower tile floor transition cover and door stop. These fastening devices used are not anti-ligature and not compliant with BH standards. All fasteners should be tamper resistant or tamper proof type. **MINOR Repair: Recommend changing fasteners to meet BH standards. Minor item that can be done immediately with minimal cost.**

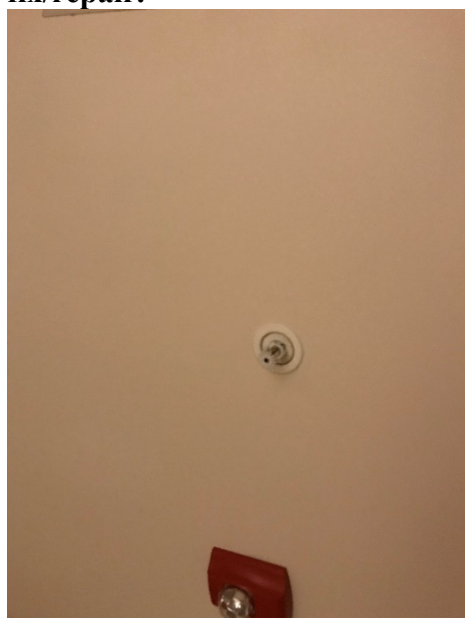
BH Sprinkler Heads - Seclusion Room: Sprinkler head is a standard (quick response) type which projects below the ceiling. Every effort shall be made to eliminate ligature points, sharp edges, and the potential to make weapons out of objects or materials. This is considered a ligature point which a patient can try to harm themselves or can break the filament causing the sprinkler to activate. **MINOR Repair: Recommend changing to a tamper resistant or tamper proof sprinkler head similar to in-patient private rooms. May need LS ILSM and Risk assessment in place depending on how long Fire Protection System will be down to fix/repair.**

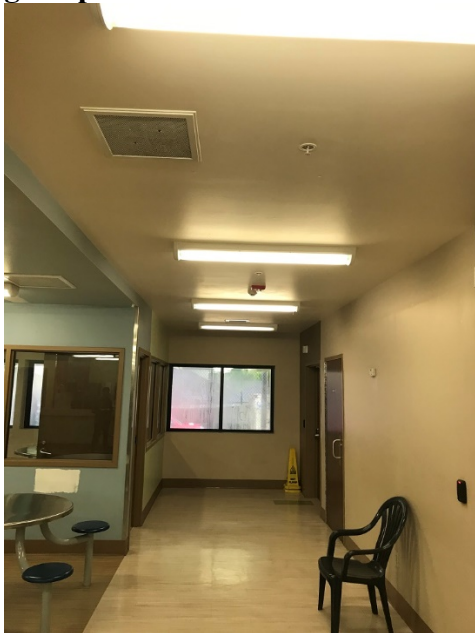
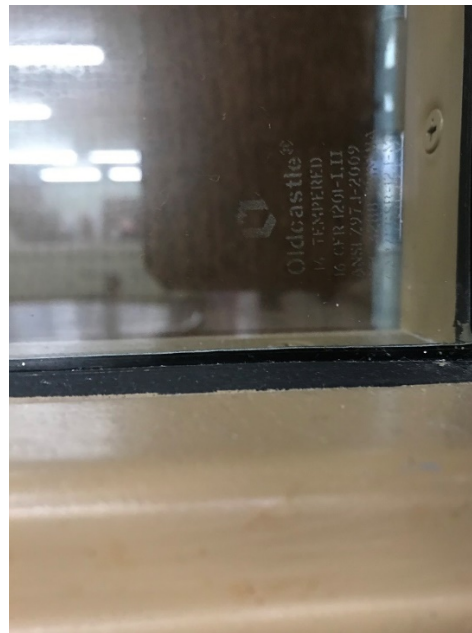
BH Windows and Glazing: Large glass windows at day room are currently tempered glass. When tempered glass breaks it shatters into very small shared pieces. Laminated glazing should be used in all patient accessible areas inclusive of interior window surfaces, and on the interior face of exterior windows in all inpatient BH Units. The thickness of the glazing will depend on the size of the opening. Typically, 7/16 inch is used in most applications. Laminated glazing is the preferred alternative to glass-clad polycarbonate glazing because it is more durable, not easily scratched and is less expensive. **MAJOR Repair: Recommend providing laminated glass per BH Standards.**

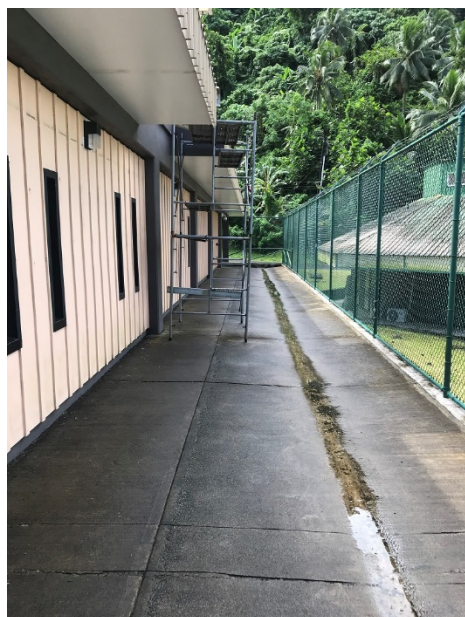
BH Outdoor Patient Area - Scaffolding: There is a scaffold set up in the outdoor secured patient area for maintenance access to the elevated attic doors. This equipment is open to patients and not secured. Careful consideration of the location and design of this outdoor space to reduce the risk of elopement, climbing, jumping, impalement and equipment placement are essential to operations and protection of patients. **MINOR Repair: It was noted that patients have tried to climb and/or escape on this equipment. Recommend removing this equipment entirely from outdoor patient area. If maintenance is necessary, the area can be blocked off and a ladder can be used for access. Otherwise, recommend creating a project to install a permanent ladder that as a security cage that is lockable and cannot be climbed from the exterior.**

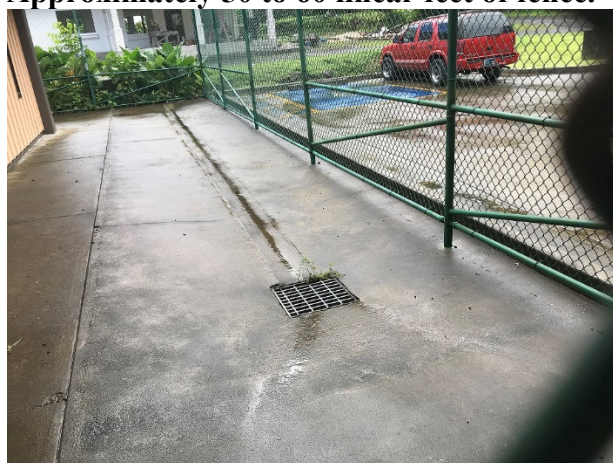
BH Exterior Security Fence: The exterior security fence at the front of the building has an excessive gap at the bottom, approximately 12 to 14 inches, between the bottom horizontal railing and concrete. A patient has escaped thru this area previously. **MINOR Repair: Recommend providing a closure panel at the bottom to prevent elopements. Approximately 50 to 60 linear feet of fence.**

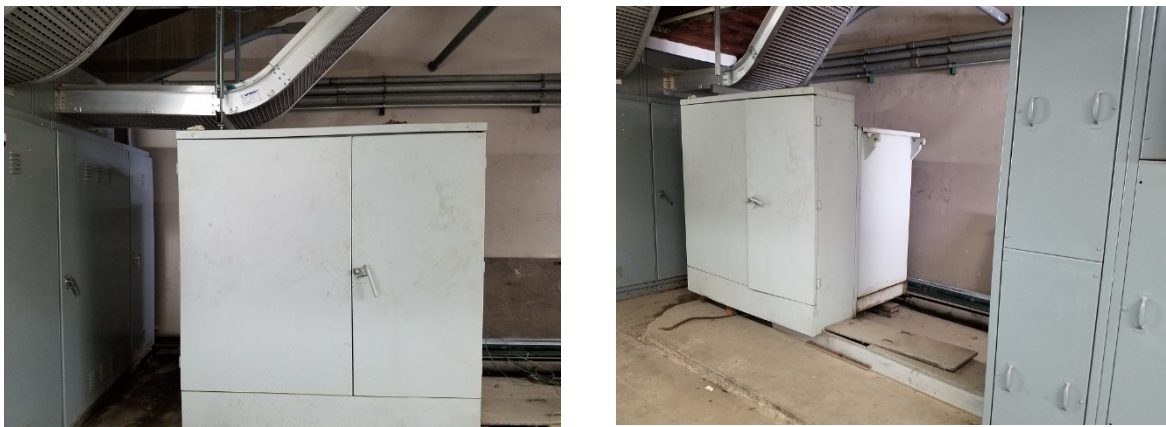
Old Main Transformer and Old Service Transfer Board, with New Generator Switchboard Behind

The Old System was essentially a single 750kVA transformer that fed a transfer switch, which was also backed up by a 900kW diesel generator. The transfer switch fed over to a main switchboard in the old main electrical room that served the entire hospital. A second service transformer, rated 300kVA, was added later to power chillers. The main transformer, the service-rated transfer switch, and the generator still reside in the generator room, but are now accompanied by the new generator switchboard provided by the new project (see pictures below). The transformer limits access to the new generator switchboard, and one of the busways exiting the new switchboard is routed very close to the transformer.

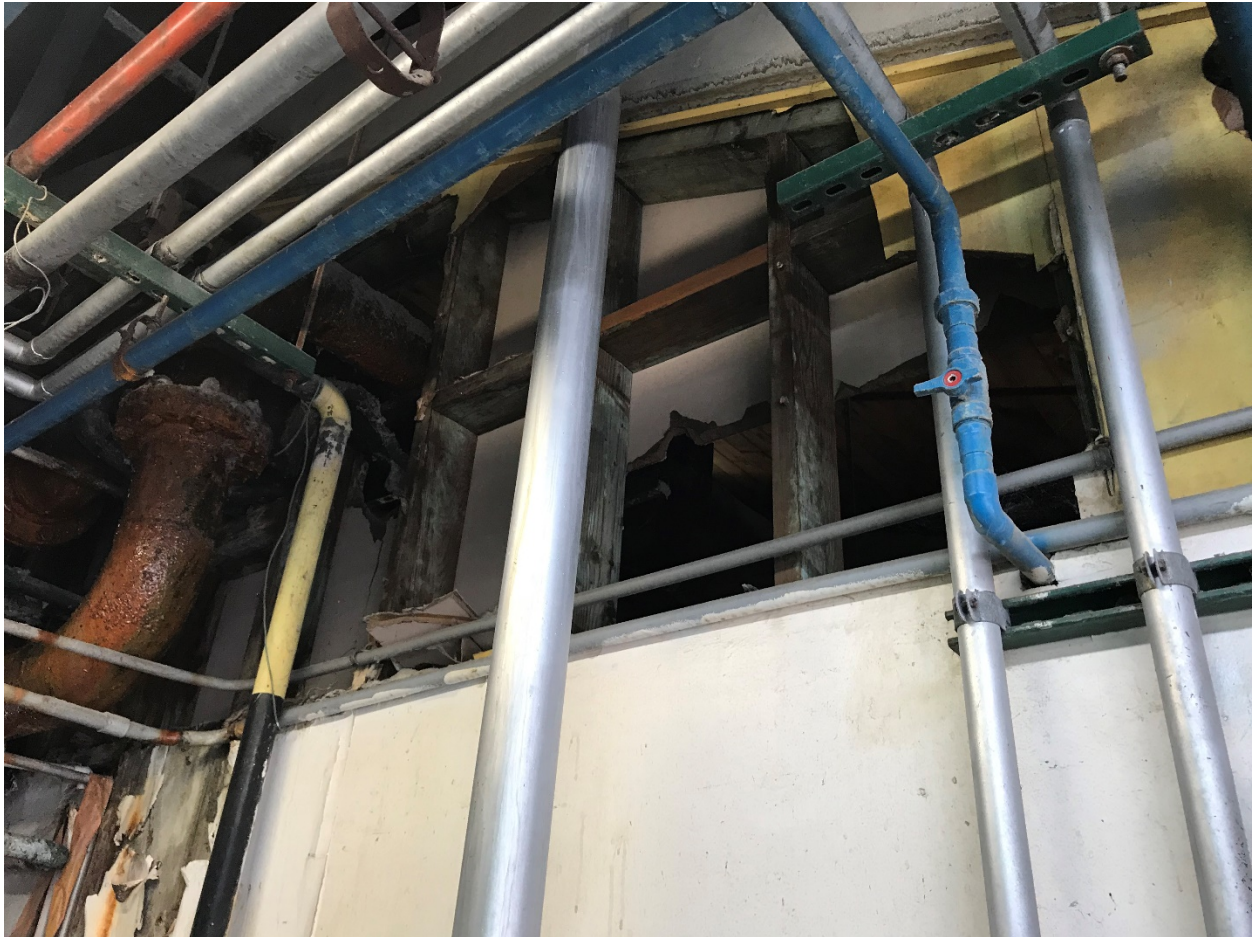
Lack of Firewall Separation in Central Utility Plant

There was no complete firewall separation of the central utility plant area and the adjacent laundry facility and other inpatient care areas. This lack of protection will result in catastrophic damage and loss of life in the event of fire in that area.

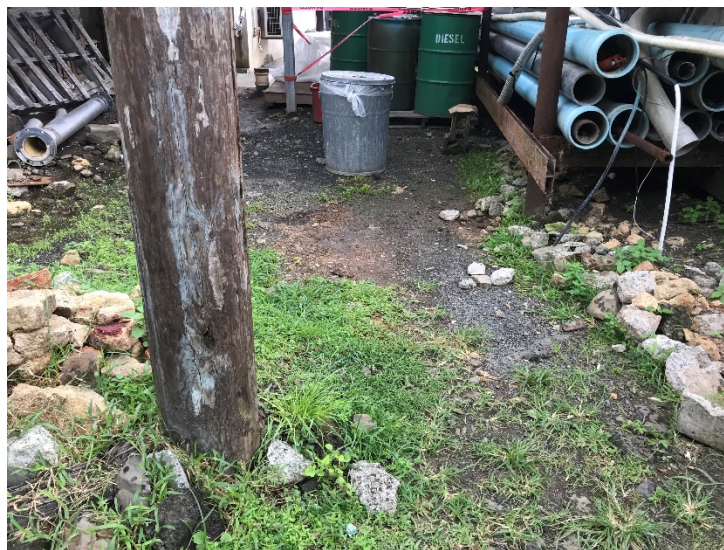
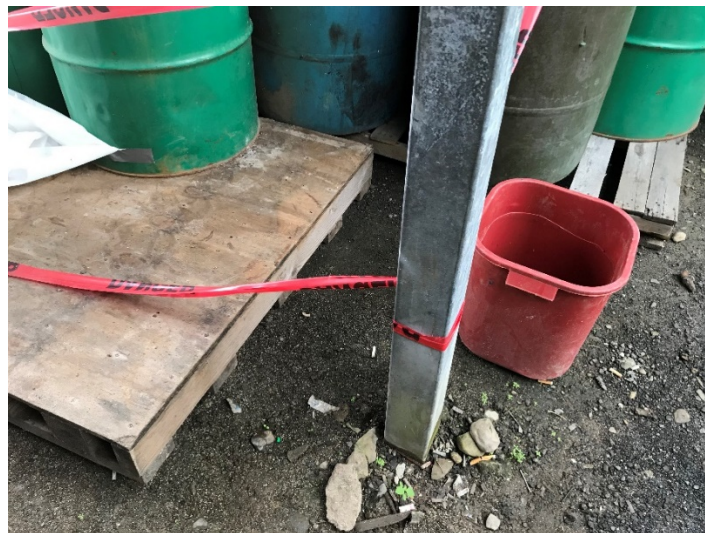
Area near Diesel Storage where Cigarette Butts were discarded

Also there was increased evidence of smoking around diesel storage areas and combustible storage / trash which could be the catalyst for a large fire event.

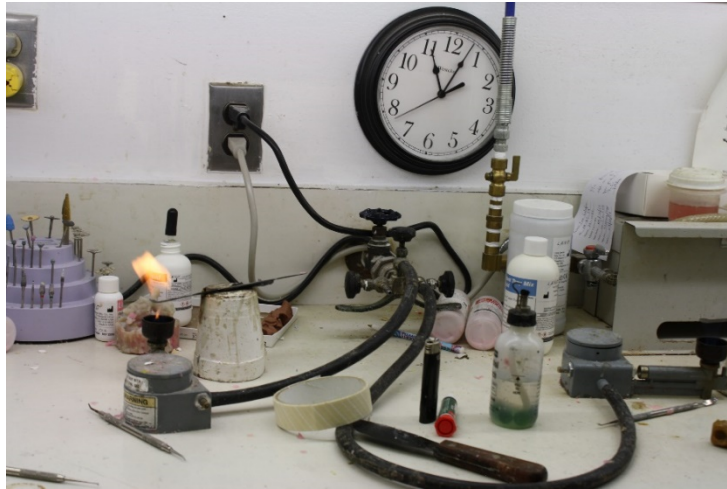
Flammable gas cylinder not secured to structure IAW OSHA Standard 1926; valve protection cap not in place, stored in same room as heating sources. Fixed furniture (broken counters & cabinets) and waste collection is not in compliance with infection control practices. Lacking storage for hazardous materials and chemicals. Insufficient space to meet ABA/ADA requirements.

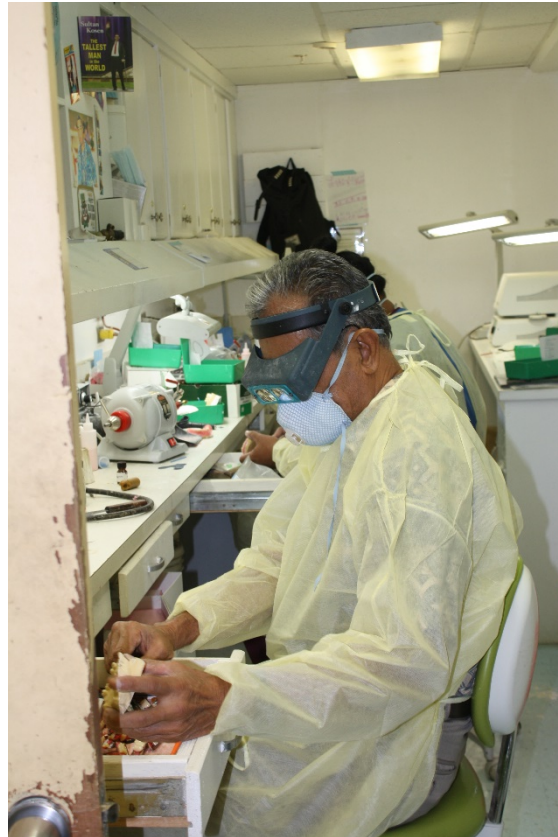
Evacuation hood not working impacting NFPA 101 and safety guidelines on operating open flames in a work space. Space does not appear to meet ABA requirements. Increased risk of personal injury and damage to prosthesis as a result of inadequate work space i.e. equipment and personnel are too close together and work is being done out of drawers.

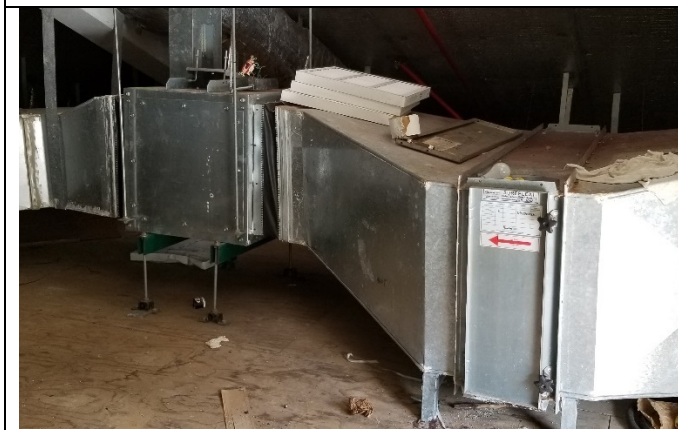
Outside air supply fan (motor missing).

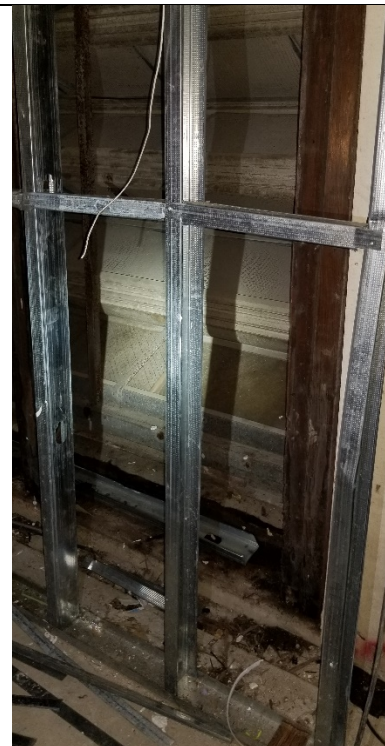
Existing AHU air intakes pulling from the new construction area.

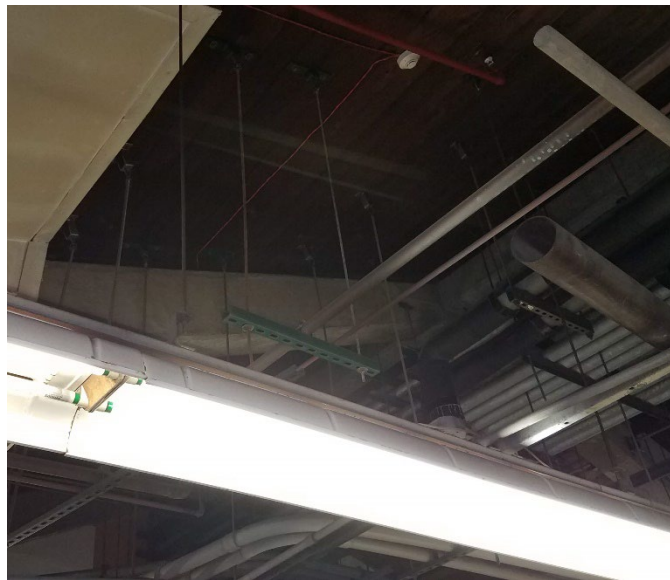
Figure 3: Utilities hung directly to roof decking.

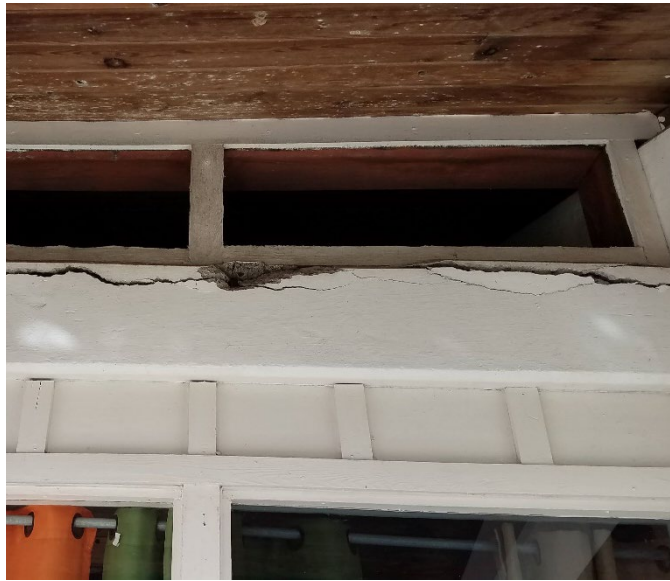
Figure 4: Concrete spalling at bent tie beam, typical.

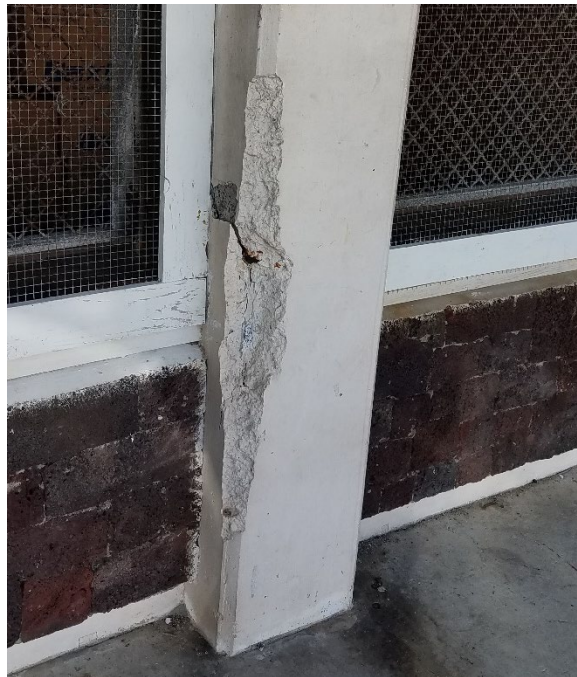
Figure 5: Concrete spalling at bent, typical.

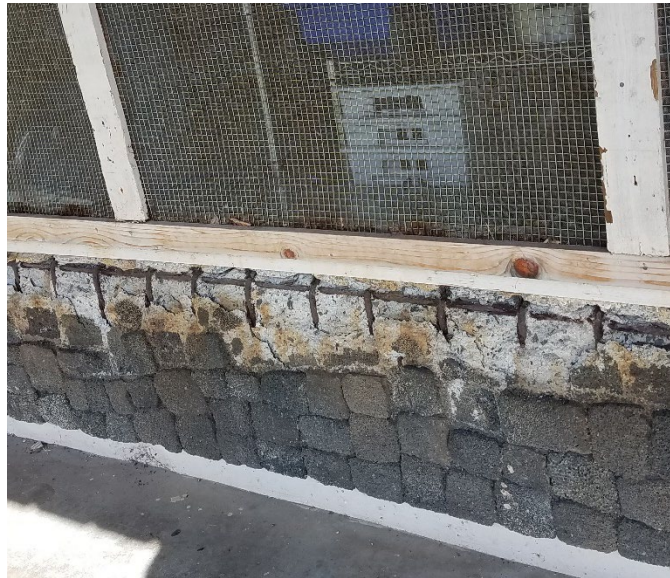
Figure 6: Concrete spalling at kitchen stem wall.
