**Centers for Disease Control and Prevention**

National Institute for Occupational Safety and Health

May 24, 2007
HETA 2006-0308

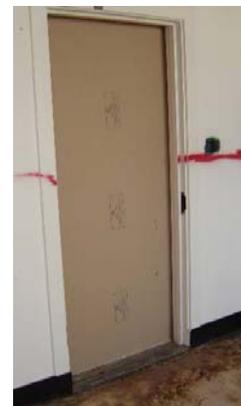
Photo 1: Incomplete construction barricade from the renovation side.

While a majority of the ante rooms, construction and doorway barricades inspected appeared to be well designed and appropriately installed, we noted that numerous barricades installed between the communicating doorways (doors located between an occupied area and the renovation areas) had not been installed consistent with the engineering designs or blueprints for these barriers. The most common finding was an inconsistency in how and whether the barricades had been installed on the construction side of the communicating doorways (Photo 1). The barricade design called for two layers of drywall with a layer of polyethylene between, and fiberglass insulation and sealing tape around the perimeter on each side of the doorway. In addition to the missing barricades on the construction side, we observed that sealing tape was often missing, or was detached, that sometimes an opening was visible at the bottom of the barricade, and sometimes the polyethylene and/or fiberglass layer was absent.

Barricade walls installed in communicating doorways between the modernization area and the occupied area should extend around the complete perimeter of the opening (with no gaps at the floor) and should be consistent with the design criteria in the engineering drawings. Daily inspection of these barriers should be conducted and when deficiencies are found to exist, they should be remedied as soon as possible.

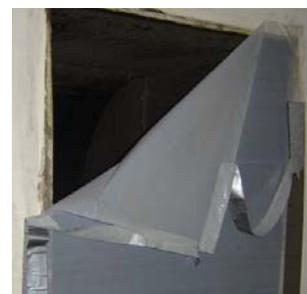
On several of the floors within the construction areas polyethylene sheeting and duct tape was used to seal return air ducts in the hallway. On many floors, the duct tape and polyethylene had come loose. These situations are obvious pathways for air to move from the modernization area to other areas of the building (Photo 2). Tracer smoke provided a visual indication that air was being moved to other areas of the building, most likely the mezzanine area where other central HVAC systems for the MIB are located.

Photo 2: Loose polyethylene sheeting and duct tape allowing an unplanned air pathway.

Hallway return air grilles for the HVAC systems serving the construction area should be protected from dusts generated during the work process using two layers of polyethylene sheeting, each taped and sealed separately around the perimeter of the duct opening. Workers should be trained and knowledgeable in the reasons for this precaution. Daily inspection of all sealed and blocked ductwork (and other unplanned pathways) should be conducted to insure that tape has not come loose or the polyethylene has not been damaged.
