Interagency Aviation Lessons Learned

No. IA LL 15-01

February 17, 2015

Subject: Helicopter Load Management**Area of Concern: Helicopter Operations****Distribution: All Aviation Activities**

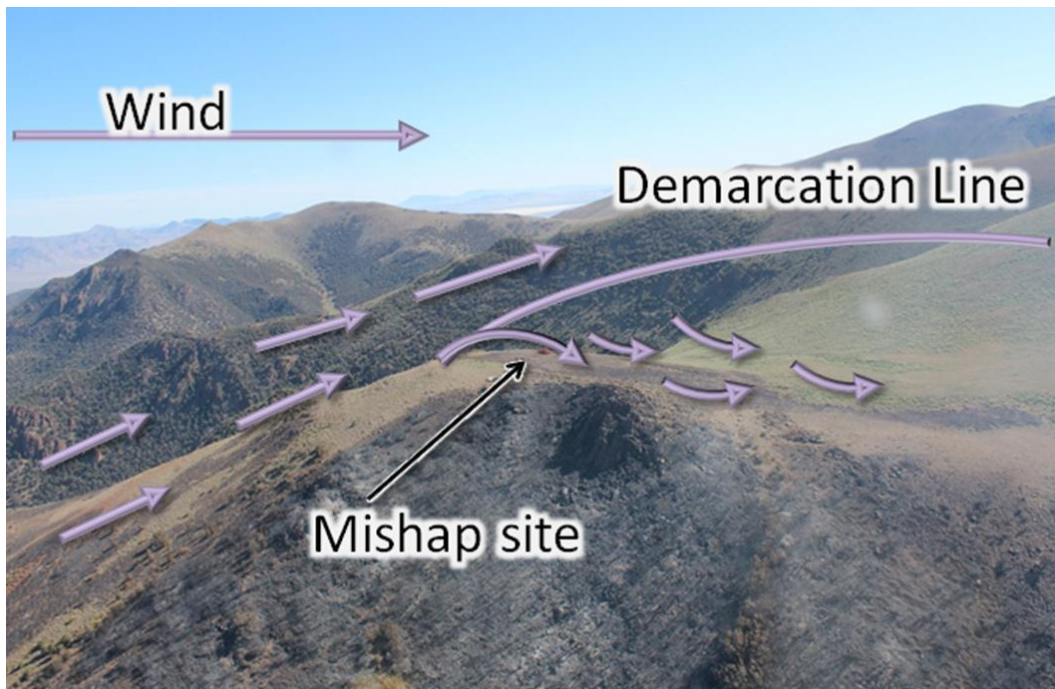
zone was on top of the ridge at an elevation of approximately 9000 feet. The requested landing zone moved the landing area below the ridge where winds were likely to travel downslope. Operating a helicopter with a long line places the helicopter in the environment that is conducive to Loss of Tail Rotor Effectiveness (LTE) due to increased weight and the requirement to HOGE. The pilot was likely experiencing turbulent wind conditions due to the rising terrain in this area. The unstable air mass and surface heating caused moderate winds (10-20 knots) that were measured at the surface. These winds were flowing up over and around the hilltop near the landing area creating updrafts on the windward side of the ridge and downdrafts and turbulence on the leeward side. A demarcation line, or the point that separates the up flow air from the turbulent down flow air, forms at the mountains highest point and extends diagonally upward. The velocity of the wind and slope gradient determines the demarcation line. The higher the wind speed and the steeper the terrain, the steeper the demarcation line angle is and the closer it forms near the crest. This would likely create the turbulent wind conditions near the location that the mishap aircraft would be hovering out of ground effect (HOGE). It's highly conceivable that the down flowing air reduced performance thus increasing the power required which in conjunction with directional winds, contributed to the onset of LTE. As the aircraft slowed to a hover to deliver the sling load, it began to rotate to the left. The pilot attempted to maintain control and to jettison the load, but was unable. The aircraft rotated several times, lost altitude, and impacted the ground.

Figure 1 Wind flow over mountainous terrain contributed to increased performance requirements and the onset of LTE.

The goal in recovery is to gain airspeed without increasing power. Decreasing collective (reducing power) also decreases the power required for antitorque. The problem is that these recovery actions will also result in a substantial loss of altitude which may not be an option when operating in close proximity to the ground. Prudent pilot planning should include a clear escape route in these types of conditions/operations. Although it is not included in the AS350 B3e Rotorcraft Flight Manual, jettisoning the load will reduce weight and subsequently reduce the power required. This action should have been accomplished simultaneously along with the other procedures.
