**US Army Corps
of Engineers®**

**Facilities Condition Assessment
Guam Memorial Hospital
Tamuning, Guam**

08 April 2020

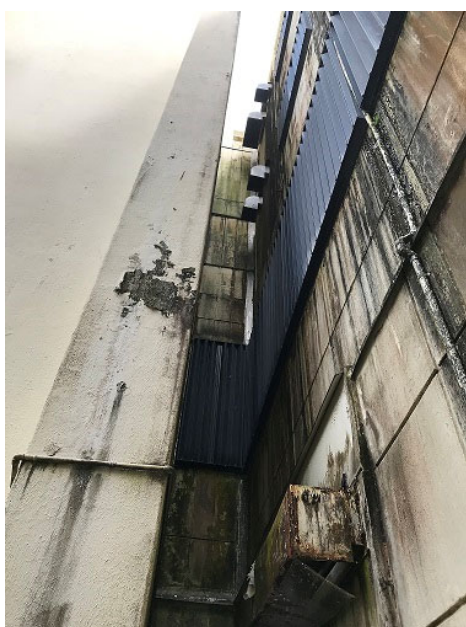
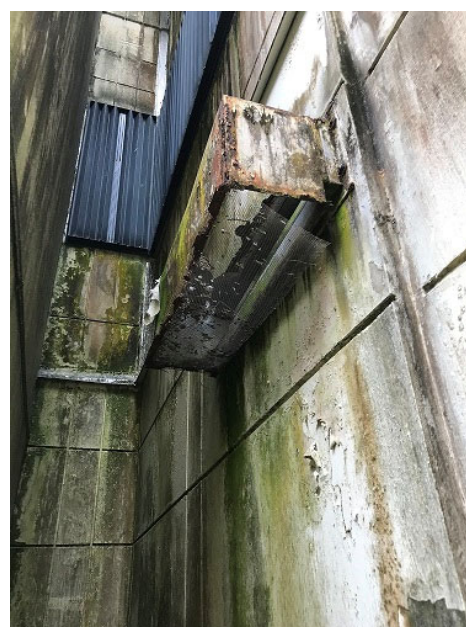
number of the intakes exterior shroud/covering have been removed and then covered. The courtyard exterior walls have numerous abandoned air transfer grilles/ducts thru the exterior walls that the moist humid air infiltrates into the building. Along with other fresh air intakes for AHU on the upper floors, pharmacy exhaust, isolation room exhaust, etc. All have penetration impacts to the integrity of the exterior envelope. These openings allow hot humid/moist outdoor air to enter the plenum area or building. With the exterior wall not adequately sealed at these locations the AHU or occupied space cool air mixes with the hot humid air which generates moisture, condensation and mold growth above the ceiling, on the ceiling, within walls and throughout the building. **PRIORITY Repair: Recommend sealing all penetrations, replace fresh air intakes with more appropriate material for environment along with joint/seal, etc. See Mechanical for additional information.**

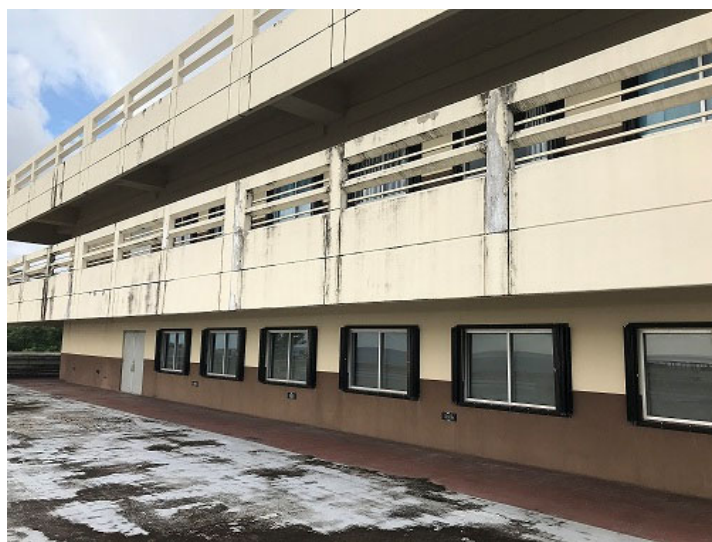
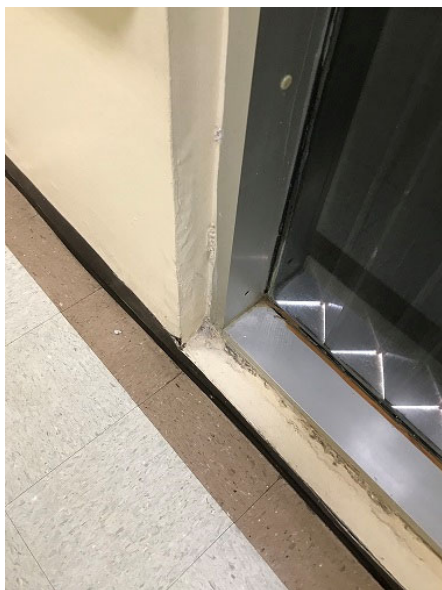
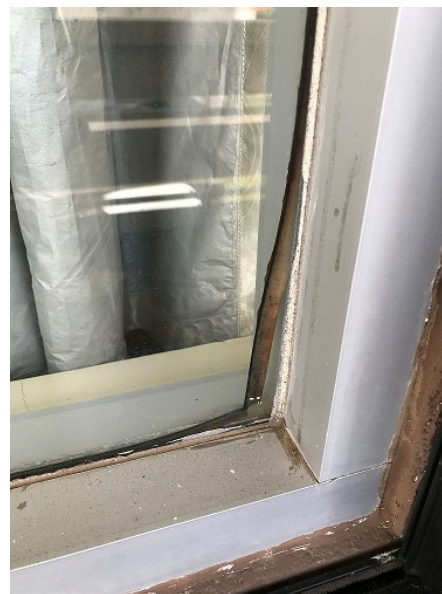
Exterior Windows: Exterior windows are generally in FAIR condition, constructed with single pane (fixed glass) aluminum framed systems either storefront or punched styles throughout the facility. All windows have a steel framed horizontal sliding metal (typhoon) accordion type

shutter system at the exterior. Numerous window sills have rot/decay/deterioration/water damage which appear to be leaking and should be replaced. Others have failed seals or gaskets. Windows that fail or are improperly sealed can cause heat and humidity to seep in, resulting in a rise of interior temperature, which will cause air conditioners to work twice as hard to keep the environment cool. This also creates moisture issues that can lead to the growth of dangerous substances such as mold.

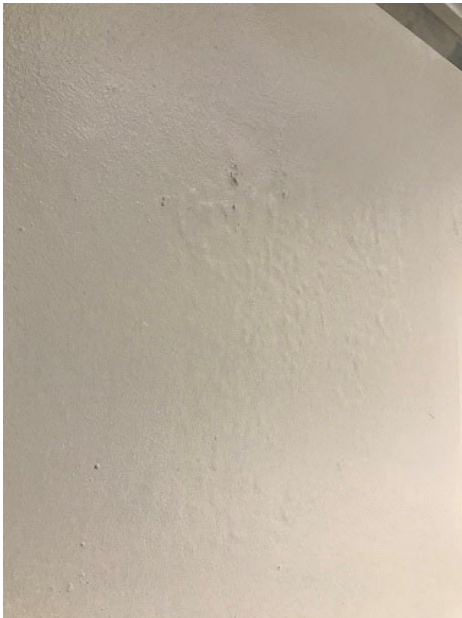
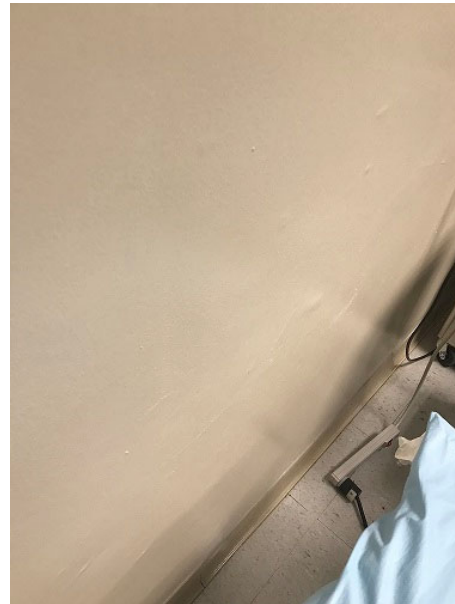
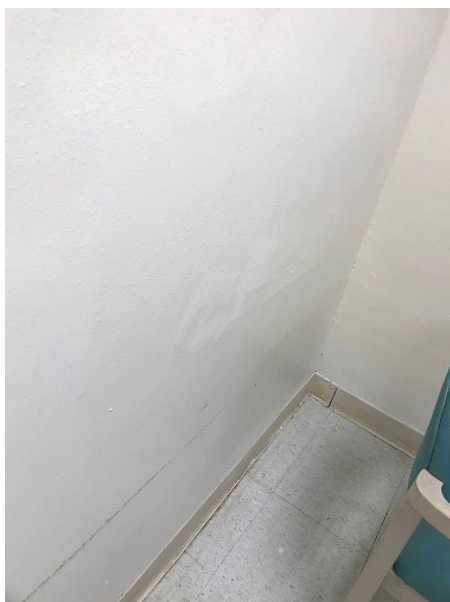
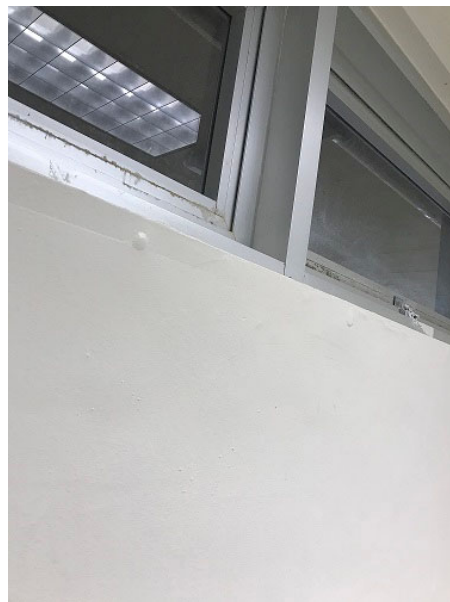
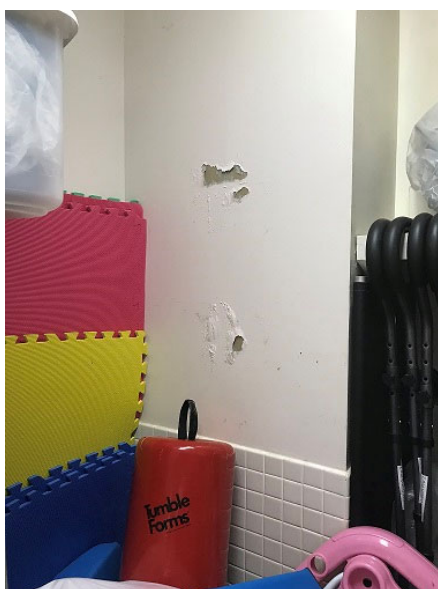
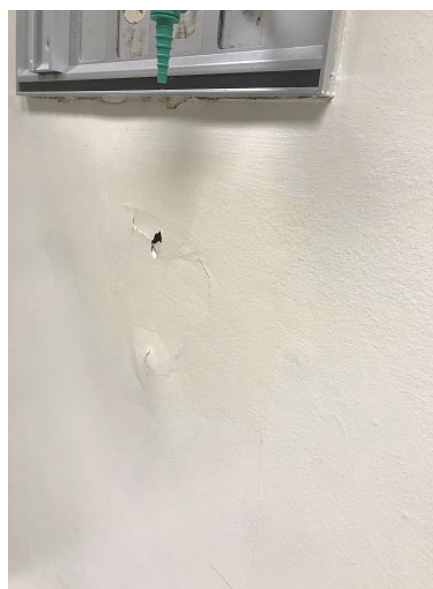
Exterior Windows (Flashing/Weeps/Caulk): Window sill flashing not provided and weeps at exterior are either not existent or sealed with caulk. Most architectural aluminum glazing system are not designed to be totally waterproof. Rather, most systems are designed to control water infiltration under extreme conditions and weep that water back to the exterior. Punched windows, storefront and curtainwall systems differ in many ways: appearance, profiles, wind loads, glazing, thermal performance and how they weep water. **Punched window** can be

PRIORITY Repair: Recommend first and foremost that the exterior windows throughout the facility be replaced with better quality, energy efficient systems with properly installed flashing. As well as the AHU and building pressurization correction (positive). Once that is done, remove damage areas/sections or entire interior wall would be warranted based on severity of damage. The exterior envelope must be sealed with the correction of water infiltration before the interior of the exterior walls can be repaired/replaced.

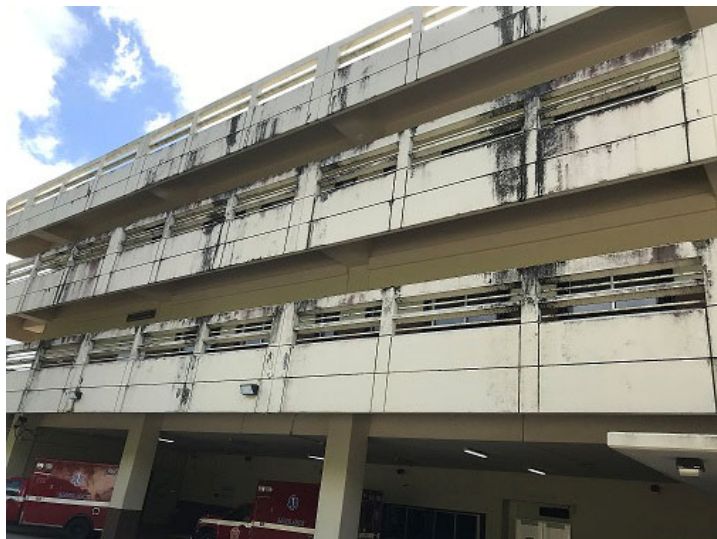
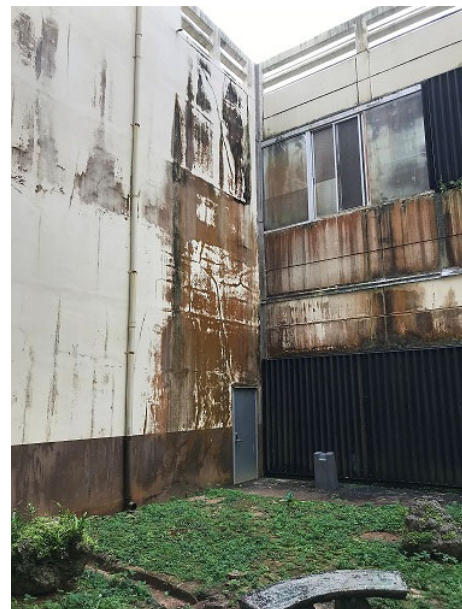
Exterior Wall Finish/Cleaning/Painting: The majority of the buildings has a significant amount of mold growth, peeling paint and discoloration on the exterior surface. The exterior wall itself appears to be in GOOD condition. Guam is located in a tropical extreme humid location. Although some of the mold may be located on the surface, other areas appear to be more significant. Mold feeds on organic materials, such as wood, paper, many fabrics, and even some types of glue. It literally eats away at these materials, causing them to rot and fall apart. Outside mold does not always stay outside. It will eventually find its way thru the envelope and into the building. Outside mold does carry health risks, but the risks are not as great as with inside mold. Although the concentration of mold will be less outside in the open air than it would be indoors. However, that doesn't mean exterior mold cannot lead to health problems. If someone

This mold may be caused from the moist humid conditions/environment, low quality paint, from an inferior, damaged or missing vapor barrier or simply the exterior materials used. Another influence, could be negative pressure rooms located at/near the exterior wall drawing the moisture into the building. Buildings in general should be positively pressured. The GMH facility is actually under negative pressure. **MAJOR SCHEDULED REPLACEMENT (MSR) Repair: Recommend that the entire exterior of the facility be sprayed with chemicals to kill the mold, power washed, then sealed, caulked and painted with a high quality mold resistant paint. Implement a mold prevention/ maintenance plan to clean the exterior regularly.**

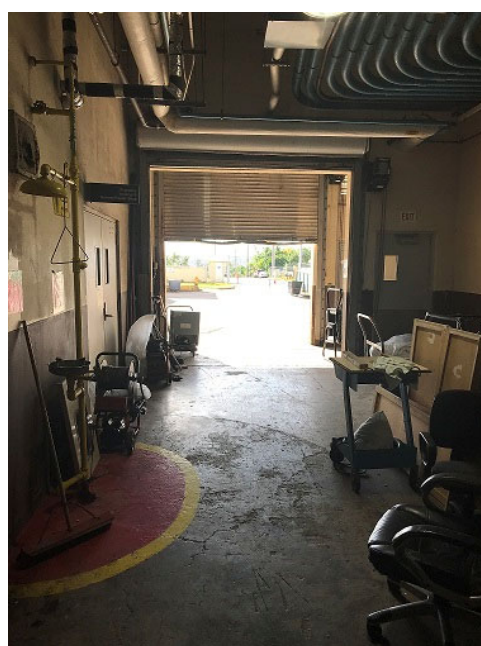
Exterior Doors: Exterior doors have a mixture of either aluminum or hollow metal. Majority of the original building doors are in GOOD condition. Typical door frames are hollow metal. The only issue identified are failed seals probably due to exposure and corrosive environment. A couple of the overhead doors at the central utility plant also needs to be replaced due to condition and damage. **PRIORIT Repair: Recommend replace all man door seals, recondition hardware to either full replacement of overhead coiling CUP doors to reconditioned (oil/lubricate) to replace latches, wheels, bearing and coil springs.**

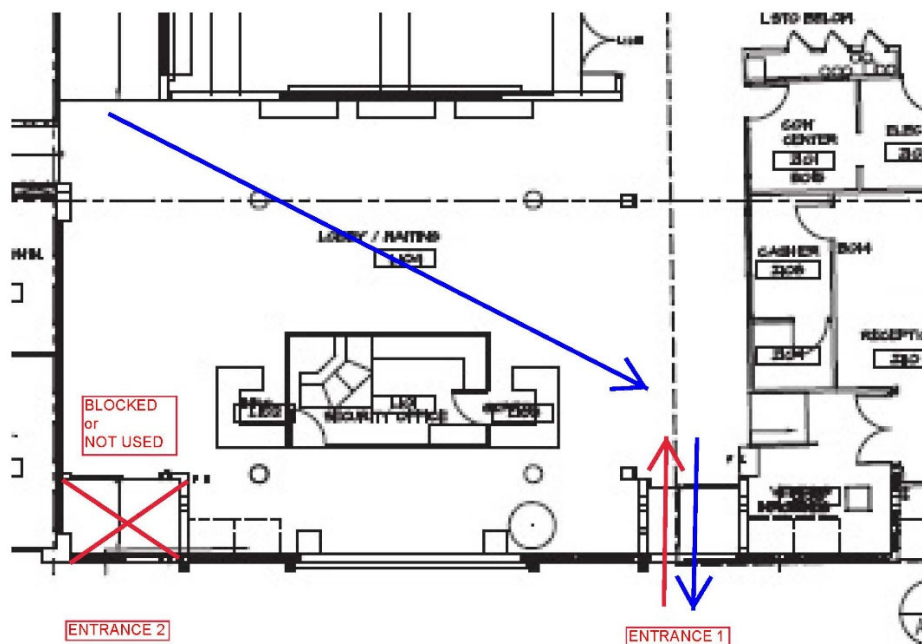
Front Entrance/Vestibules: The hospital front entrance vestibules has both an exterior and interior single sliding door configuration with possible break away feature. However, the door separation depth is only about 6 feet. Both sliding doors open simultaneously when someone approaches at either side (ingress or egress) allowing the hot, humid, moist outdoor air to gust/enter into the building. The arrangement, operation and separation does not function properly as both sets of doors are open simultaneously the majority of the time (duration of the day) due to the traffic conditions. The mechanical air curtain installed does not provide any assistance. The main contributor is that the second set of entrance doors, opposite side of the front entrance, are not in operation. This also significantly increases the egress capacity/occupant load at this single vestibule.

through. ABA specifies the distance between two hinged or pivoted doors in series shall be 48 inches minimum plus the width of the door swinging into the space or about 10 feet. ASHRAE 90.1 also requires a minimum distance of 7'-0" between closed interior and exterior vestibule doors. These minimum separation distance requirements are typically NOT sufficient. The automatic closing speeds of these doors can have a significant impact on door function, timing/sequence and passage. The distance separating the doors combined with a large number of personnel passing through, especially at shift change, can result in both sets of doors staying open continually. Vestibules are provided to reduce infiltration losses (or gains) from wind and stack effects by creating an air lock entry. This has been a recurring problem with most facilities. **PRIORITY Repair: Recommend (1) a building traffic study be completed to include "rush hour" entry and exit volumes to properly configure and size vestibules such that the automated doors are not continuously open. (2) both vestibules will need to be modernized to a greater depth (10 feet +/-) and install new doors, sensors for more ideal operation or sequence and possibly offset of doors/ opening (diagonal) in lieu of aligning. Alternative option for consideration would be a large revolving door with an emergency man door located at both entrances. EMERGENCY Repair: Recommend that the current closed, second vestibule be fixed and placed back in operation so one is dedicated to ingress traffic and the other egress. This would split the usage between two entrances, in lieu of one, reducing the wear and tear and air infiltration until they can be redesigned, reconfigured and updated.**

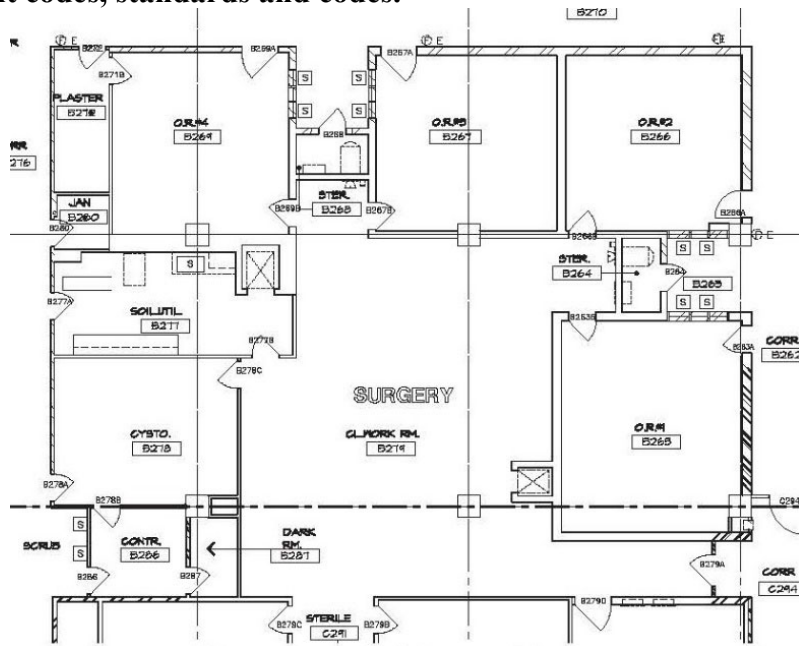
OR Layout: Although the current or existing OR room are functional, they are not compliant with today's newer standards for size, layout, clearance, equipment or flow as the design is outdated and does not comply with current codes or FGI guidelines. **MAJOR SCHEDULED REPLACEMENT (MSR) Repair: Recommend redesign of entire surgical**

suite/department for better flow, adjacencies, space allocation and upgraded OR's to current codes, standards and codes.

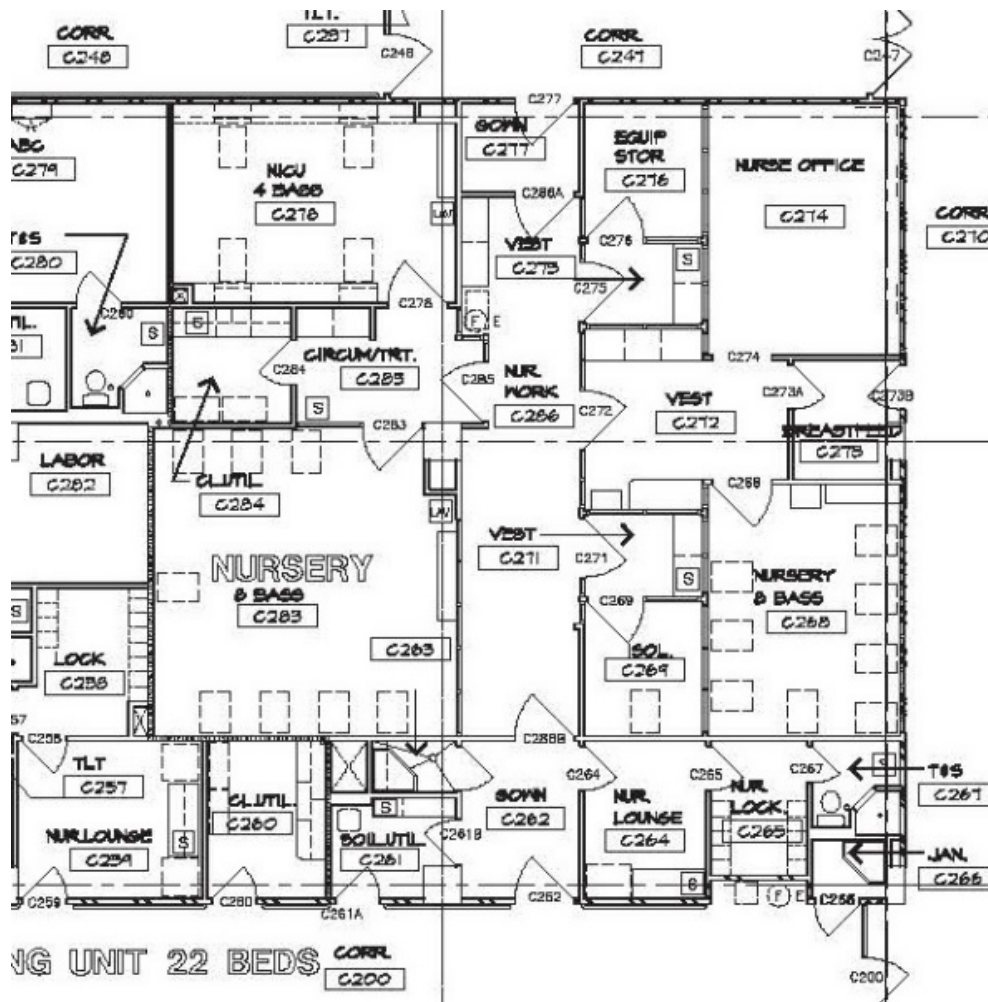
NICU Layout: Although the current or existing NICU rooms are functional, they are not compliant with today's newer standards for size, layout, clearances, equipment, light levels (controls) or flow as the design is outdated and does not comply with current codes or FGI guidelines. **MAJOR SCHEDULED REPLACEMENT (MSR) Repair: Recommend redesign of entire NICU suite/department for better flow, adjacencies, space allocation and upgraded nursery to current codes, standards and codes.**

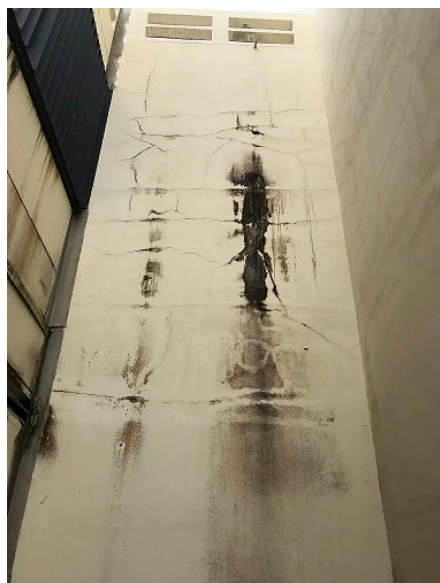
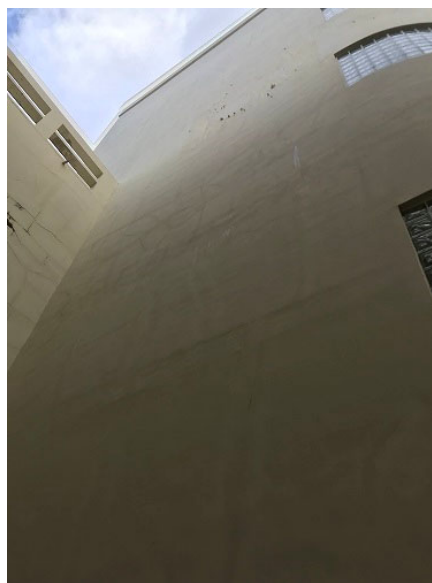
Exterior Stair Walls: Center stair enclosures (#2 & #3) at both north and south ends of building have infill poured in place concrete walls which have significant cracking issues and settlement. A project is currently underway replacing the glass block windows due to failure of rebar and leaks. **PRIORITY Repair: Recommend that a full in-depth structural analysis be conducted on the walls and foundation supporting these stairs. The wall cracks may be injected with epoxy to bond and seal the cracks within the exterior wall. The foundation may need to be expanded/enlarged, reinforced and or even replaced. The foundations could be jacked up/lifted then added concrete could be added for stability and support meeting current seismic requirements.**

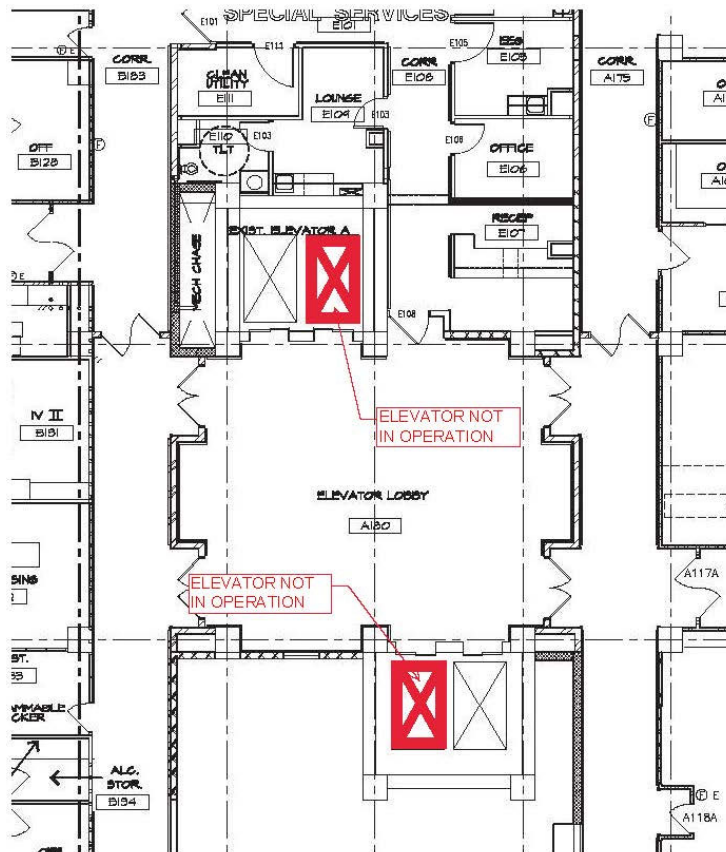
Elevators: Two of the four elevators for the facility were down, not working and under significant repair. Another was down for a short time for maintenance related repairs. The facility did have ISLM in place for the elevators. There is a current awarded project to modernize and replace the existing elevators (motors, gears, ropes, controls, etc.) and update the car/cabs to current standards. (LS03.01.50, NFPA, IBC, etc.) **PRIORITY Repair: Recommend getting this project started as soon as possible to get all elevators up in operation. Elevators are essential for moving patients to/from upper floors and critical departments. Keep all ISLM's in place throughout the construction phase.**

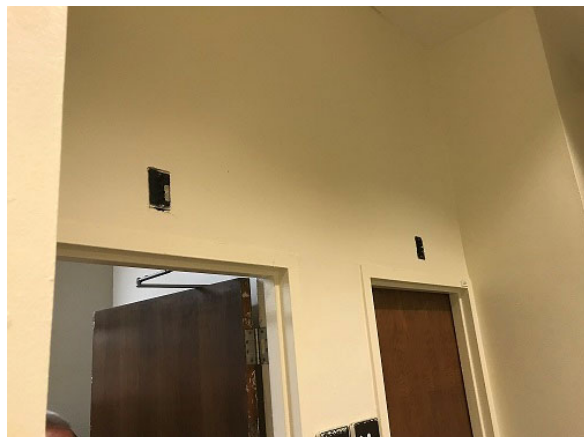
Corridor Wall Penetration: Open wall boxes located in corridor above toilet room doors (men and female). Corridor walls are to limit the passage of smoke per NFPA 101. When devices or other utilities are demolished they should be removed back to source and finished appropriately.
PRIORITY Repair: Recommend removal of wall boxes, wiring back to source and patch/paint walls.

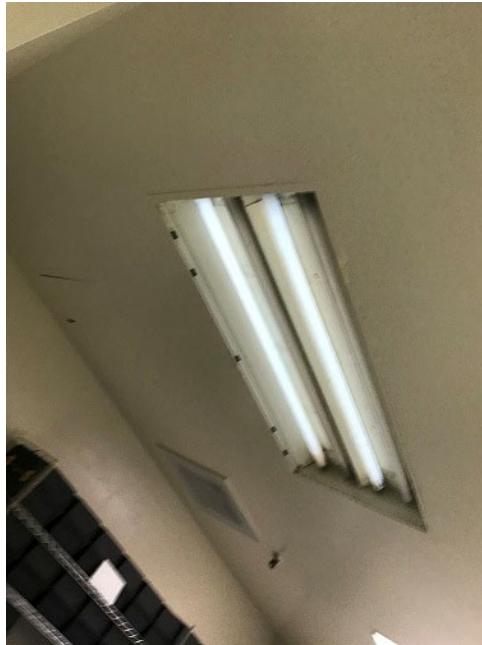
Light Fixture missing Lens (Central Sterile Supply B151). 2x4 light fixture in Central Supply does not have protective lens which has fluorescent bulbs exposed. Safety Risk. **PRIORITY Repair: Recommend installation of new light fixture lens for safety and Infection Control.**

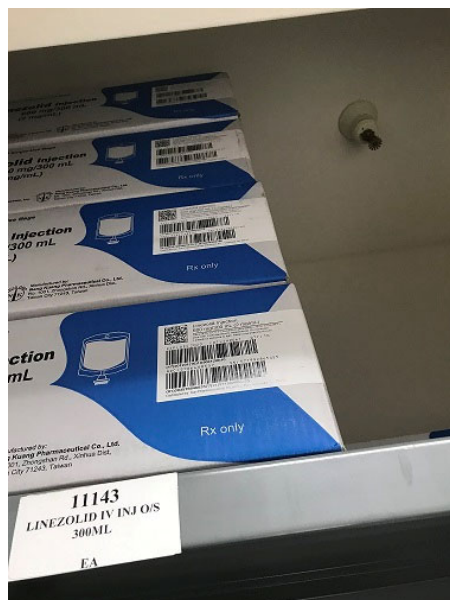
Pharmacy Storage Closet (B122) Sprinkler Obstruction: Supplies are stacked on top shelf of closes potentially blocking sprinkler. At least 18 inches of clearance is required to be maintained below sprinkler deflector to the top of storage. Perimeter wall shelving not located directly under a sprinkler head is permitted. Measurement is within the plane of the room – not a conical distribution from each head. (LS.03.01.35 EP 6 & NFPA 13 Section 8.5.5.3 & 8.6.5.2.1.1).

EMERGENCY Repair: Recommend the removal of staked boxes so the 18 inch clearances are met.

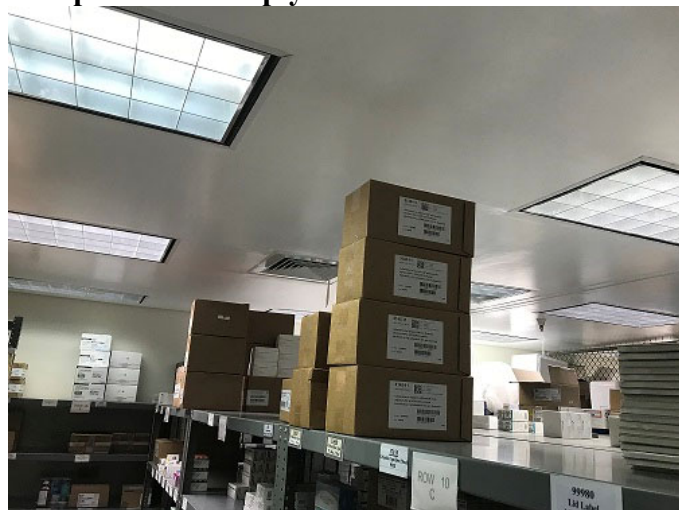
Pharmacy Storage (B125) Sprinkler Clearance (18” Rule): At least 18 inches of clearance is required to be maintained below sprinkler deflector to the top of storage. Perimeter wall shelving not located directly under a sprinkler head is permitted. Measurement is within the plane of the room – not a conical distribution from each head. (LS.03.01.35 EP 6 & NFPA 13 Section 8.5.5.3 & 8.6.5.2.1.1). **EMERGENCY Repair: Recommend Removing/reorganizing storage items on top shelf to comply with the 18 inch clearance requirement.**

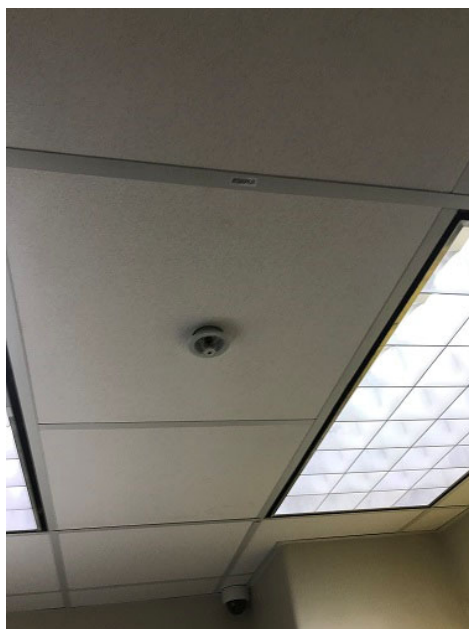
Pharmacy Sprinkler Escutcheon Plate: Lay-in ceiling sprinkler escutcheon falling down which could potentially block or prevent sprinkler activation. NFPA 25 Section 5.2.1. **EMERGENCY Repair: Recommend fixing or installing sprinkler head escutcheon flush with ceiling.**

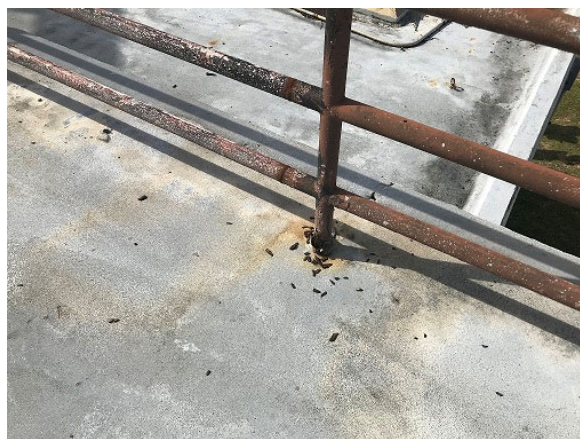
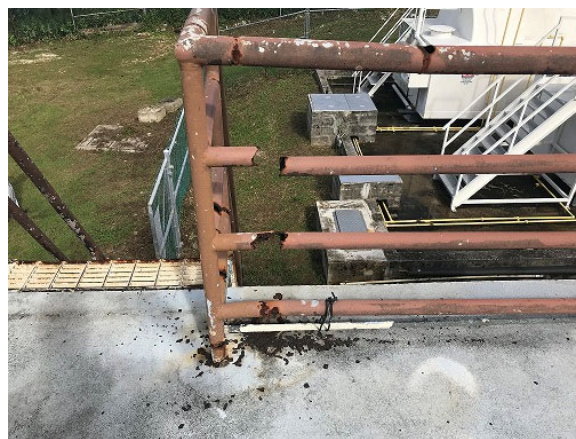
CUP Roof Guardrail (Safety/OSHA). The stairs, stair guard/handrail and roof guardrail system at the power plant has significant signs of corrosion, deterioration and failure. Not only has the exposed fasteners failed, the guardrail vertical supports and horizontal railings are corroded through, broken and weak. There is no way this guardrail system could protect personnel or even support the required horizontal pressure by code. This area should be barricaded for limited/controlled access. Alternative measures such as ILSM as well as potential tie off points may need to be incorporated. This stair and railing system needs immediate attention, removal and replacement. **OSHA violation. EMERGENCY Repair: Recommend removing entire stair/railings and roof guardrail systems and replace with NEW, stainless steel or marine grade aluminum materials due to the corrosive environment. Fasteners, bolts, washers, etc. should also be stainless steel (316 or 316L).**

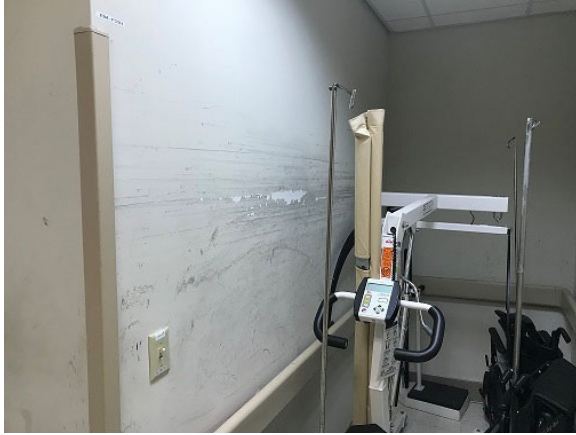
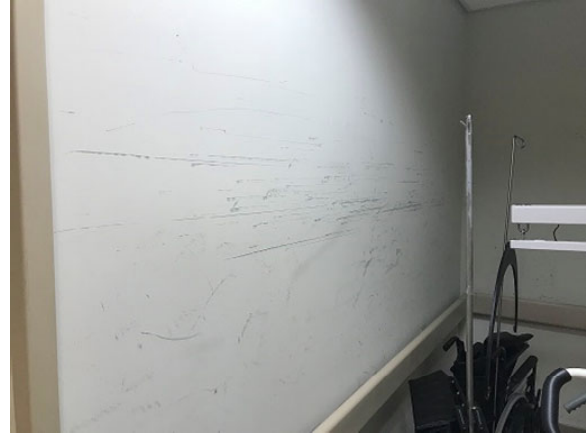
ED Equipment Alcove Wall Damage (F201): Walls have excessive damage due to carts, equipment and/or beds. Drywall no longer has protective qualities or painted surface which now exposes the inner core. Blood or other fluids along with dust and mold can now be easily absorbed into these damaged areas creating a high risk and infection control risk. (EC.02.06.01 EP20) **MAJOR SCHEDULED REPLACEMENT (MSR) Repair: Recommend to Patch and paint damaged walls. Then install wall protection treatment such as acrovyn/FRP panels for durability, impact resistance and easy cleaning.**

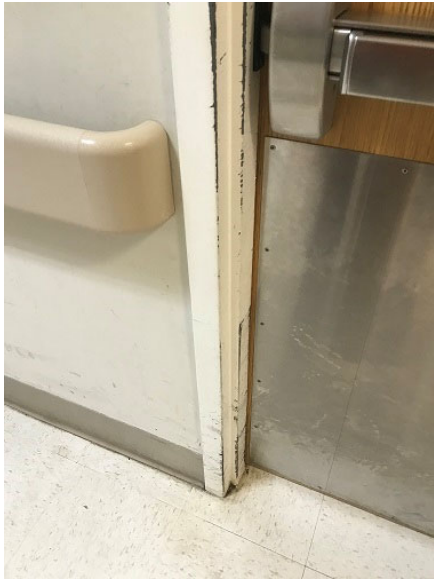
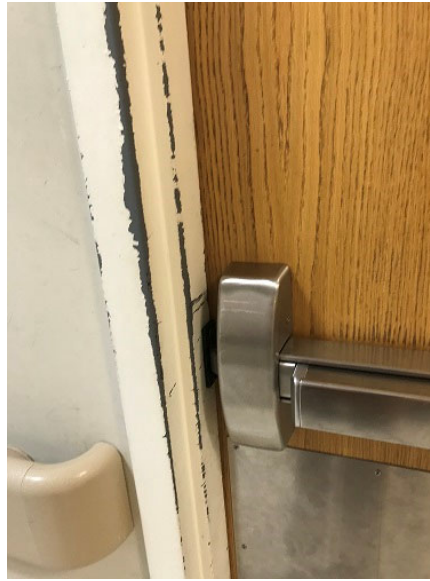
ED Door Frame Damage (F202): Door frame has excessive wear due to carts, equipment and/or cleaning agents used. Frame no longer has protective qualities with painted surface which now exposes the bare metal. (EC.02.06.01 EP20) **MAJOR SCHEDULED REPLACEMENT (MSR) Repair: Recommend painting frames. Additional added protection would be to add door frame protection acrovyn/FRP/stainless steel products for durability, impact resistance and easy cleaning.**

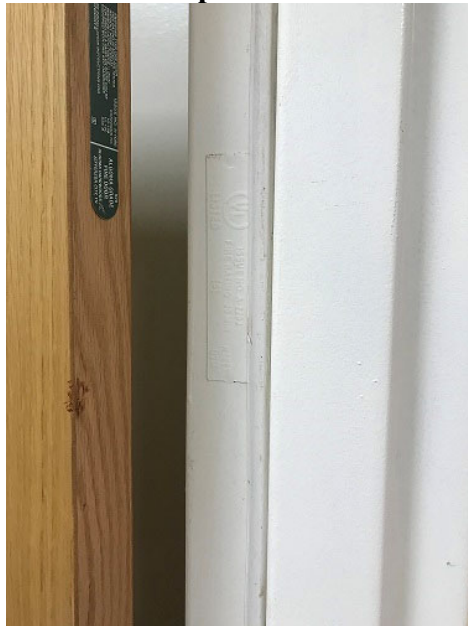
ED Door Label Painted (F202): Door frame has the labels painted over. Labels on fire door assemblies shall be maintained in legible condition, NFPA 101 Section 8.3.3.2.3 and LS02.01.10 EP5 & EP7. On the other hand, some doors that had labels may not necessarily need them based on room type and function of space. **PRIORITY Repair: Recommend removing paint off frame labels for code and TJC compliance.**

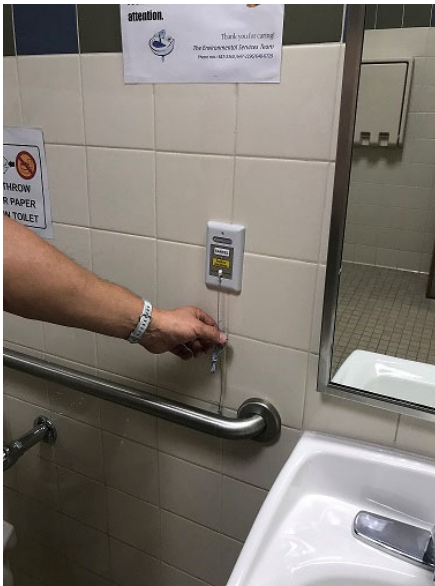
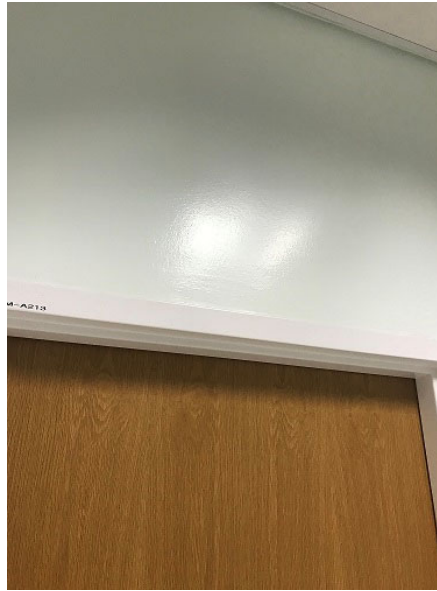
ED Patient Toilet Nurse Call (A213). Nurse call in patient toilet room does not have a dedicated nurse call light located outside the room at the corridor. Typically, NC lights are provided directly outside the room for quick visual identification. When the NC pull chord is activated it actually illuminates the corridor NC light at the end of the corridor at the

decontamination room. **PRIORITY Repair: Recommend installing a NC light on the wall directly above this patient room door similar to all of the other rooms in this area.**

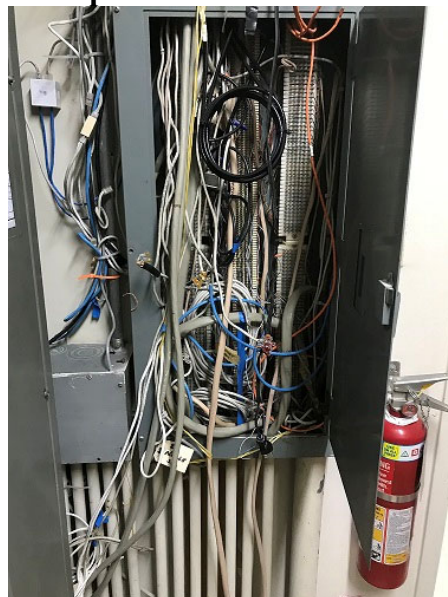
ED Electrical Room (A212). Electrical or COMM panel has a lot of wiring which some appears to be abandoned or not used. Some of the wires actually are routed thru this panel preventing the door to be securely closed. **MAJOR SCHEDULED REPLACEMENT (MSR) Repair: Recommend removing any unnecessary or abandoned wires back to source, clean and organize wiring so the panel can close and secure properly.**

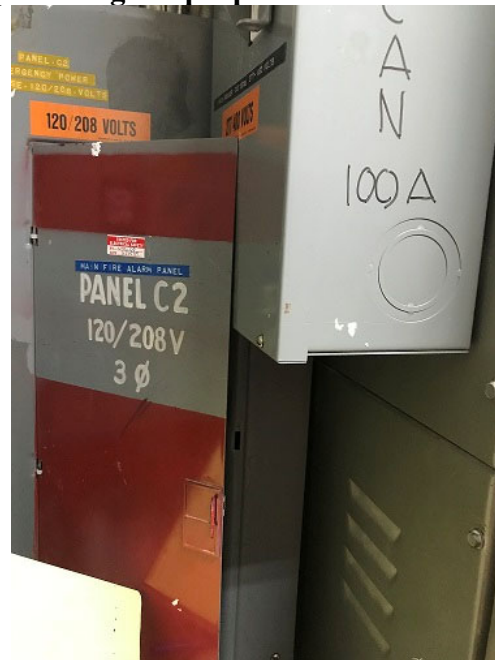
ED Electrical Room (A212). Electrical panel door interference with adjacent panel. Adjacent panel appears to be installed on a locker. Door cannot properly close, be secured/locked or

comply with NEC clearance requirements. Code Violation. **PRIORITY Repair: Recommend that the locker be removed with the relocation, rearrangement of electrical panel with more ideal location providing the proper NEC clearances.**

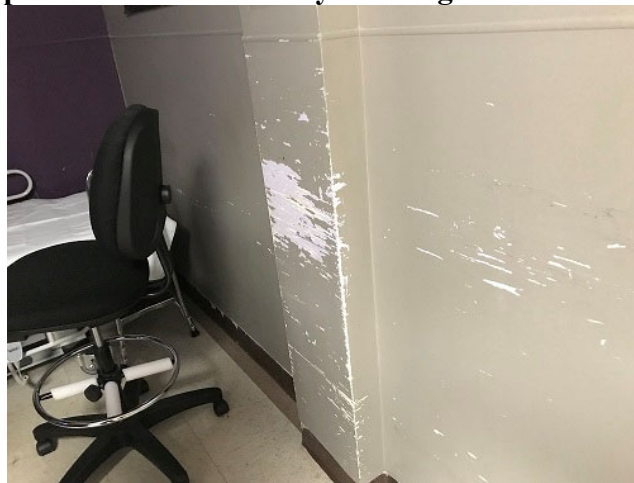
Ultra-Sound Wall Damage (A271). Walls have excessive damage due to carts, equipment and/or beds. Drywall no longer has protective qualities or painted surface which now exposes the inner core. Blood or other fluids along with dust and mold can now be easily absorbed into these damaged areas creating a high risk and infection control risk. (EC.02.06.01 EP20)

MAJOR SCHEDULED REPLACEMENT (MSR) Repair: Recommend patch and paint of damaged walls. Then install wall protection treatment such as acrovyn/FRP panels for durability, impact resistance and easy cleaning.

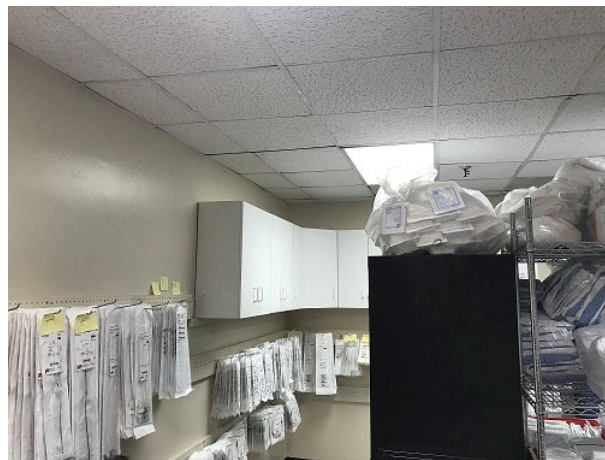
Radiology Storage Sprinkler Clearance (A246): At least 18 inches of clearance is required to be maintained below sprinkler deflector to the top of storage. Perimeter wall shelving not

located directly under a sprinkler head is permitted. Measurement is within the plane of the room – not a conical distribution from each head. (LS.03.01.35 EP 6 & NFPA 13 Section 8.5.5.3 & 8.6.5.2.1.1). **EMERGENCY Repair: Recommend removing/reorganizing storage items on top shelf to comply with the 18 inch clearance requirement.**

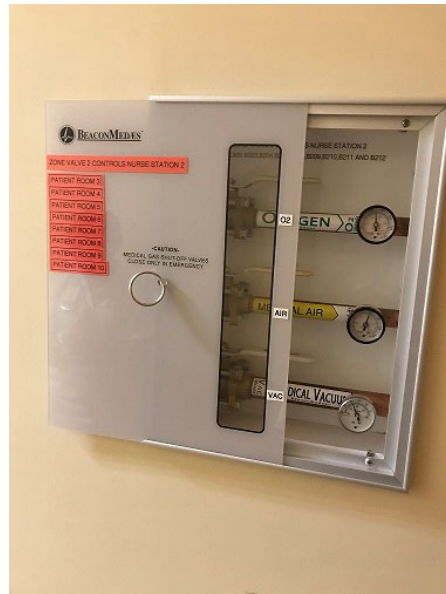
ICU/CCU Staff Corridor Zone Valve Box Labeling: Med gas shutoff zone valve box labeling does not match between cover and interior per EC.02.05.09 EP5. **PRIORITY Repair: Recommend removing non matching labels and update labels to match on the cover and interior of the zone box per code requirements.**

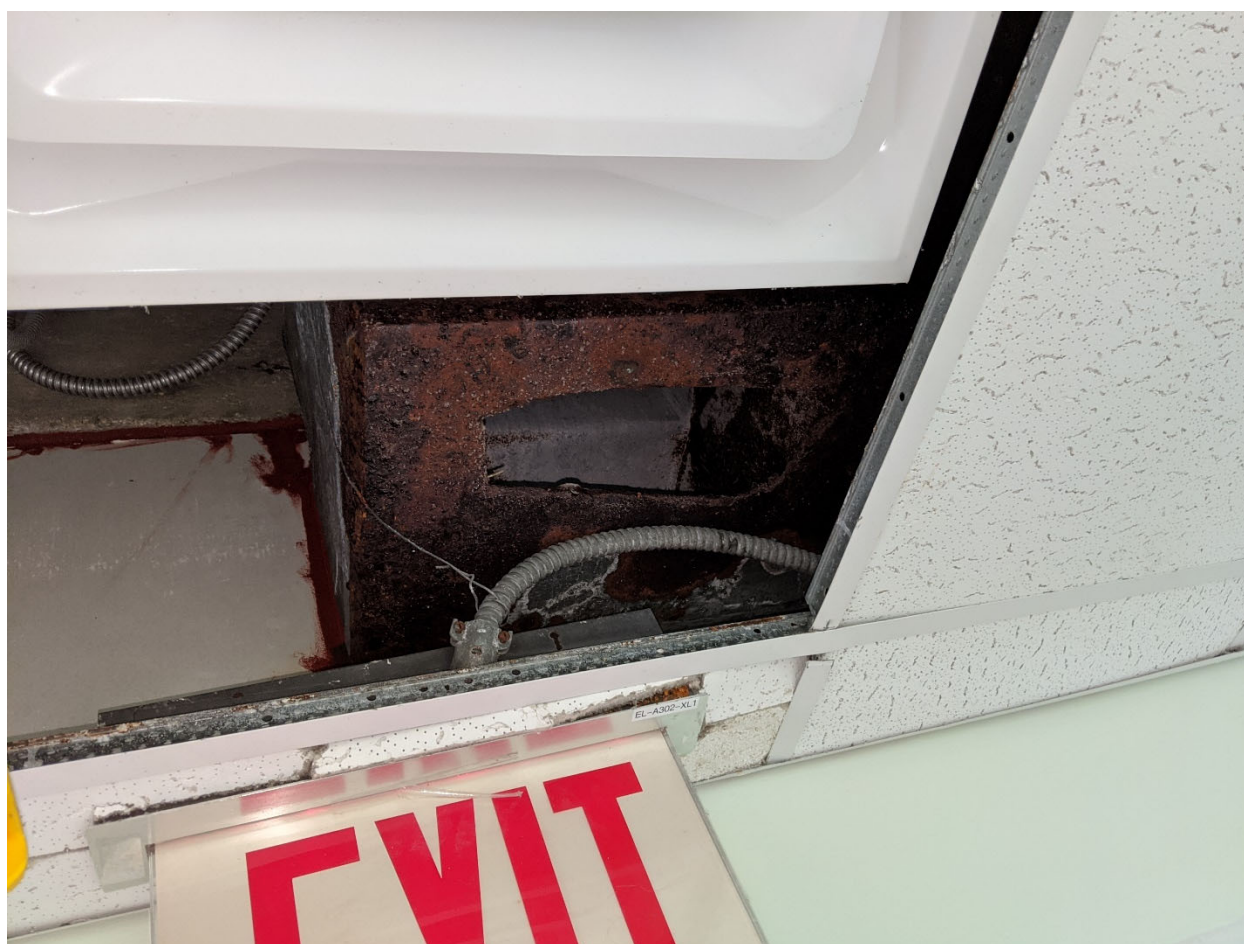
Corroded outside air ductwork drawing air from inside the building.

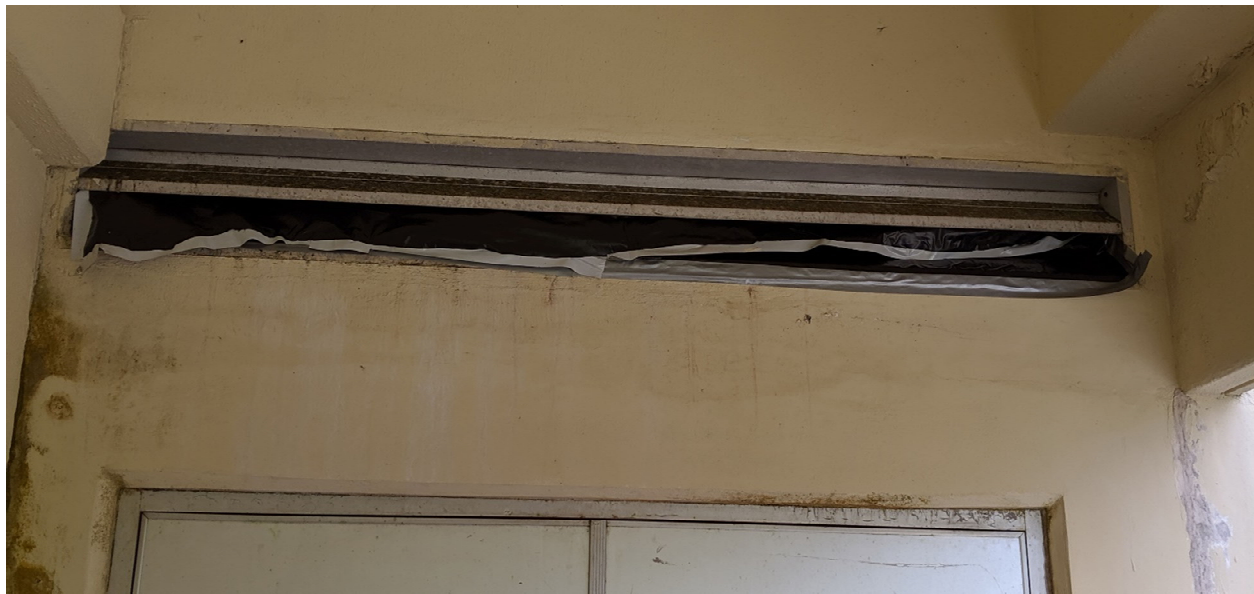
Blocked off outside air intake

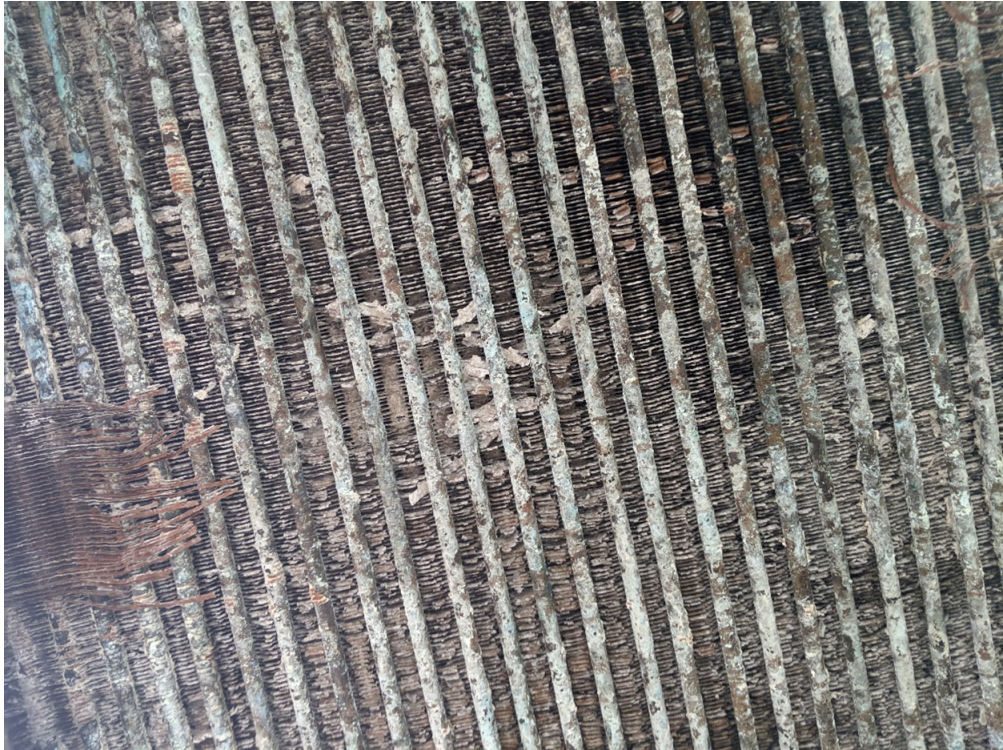
Corroded emergency chiller condenser coils

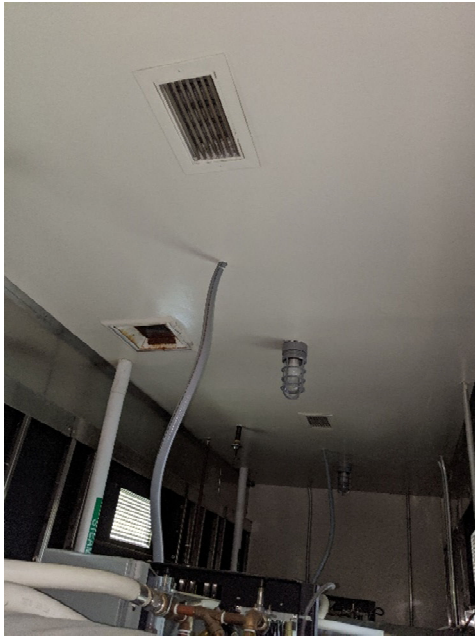
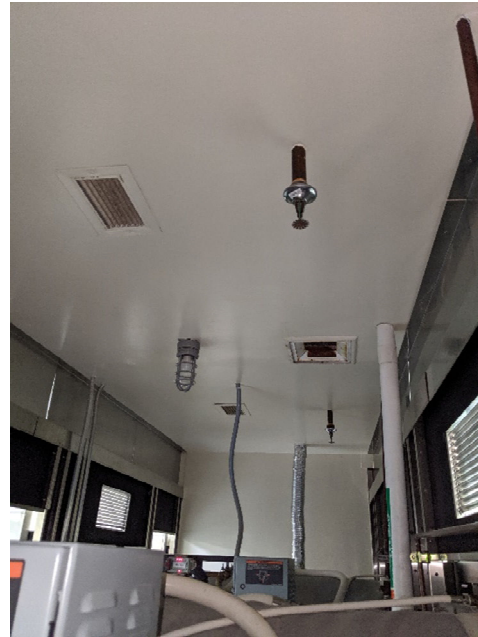
Inadequate exhaust in sterilizer equipment room

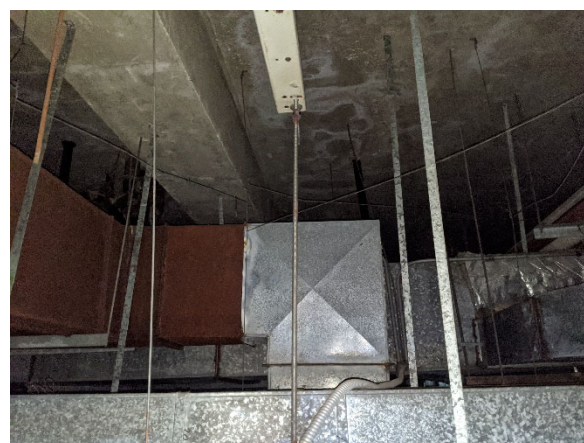
Inappropriate kitchen exhaust duct material

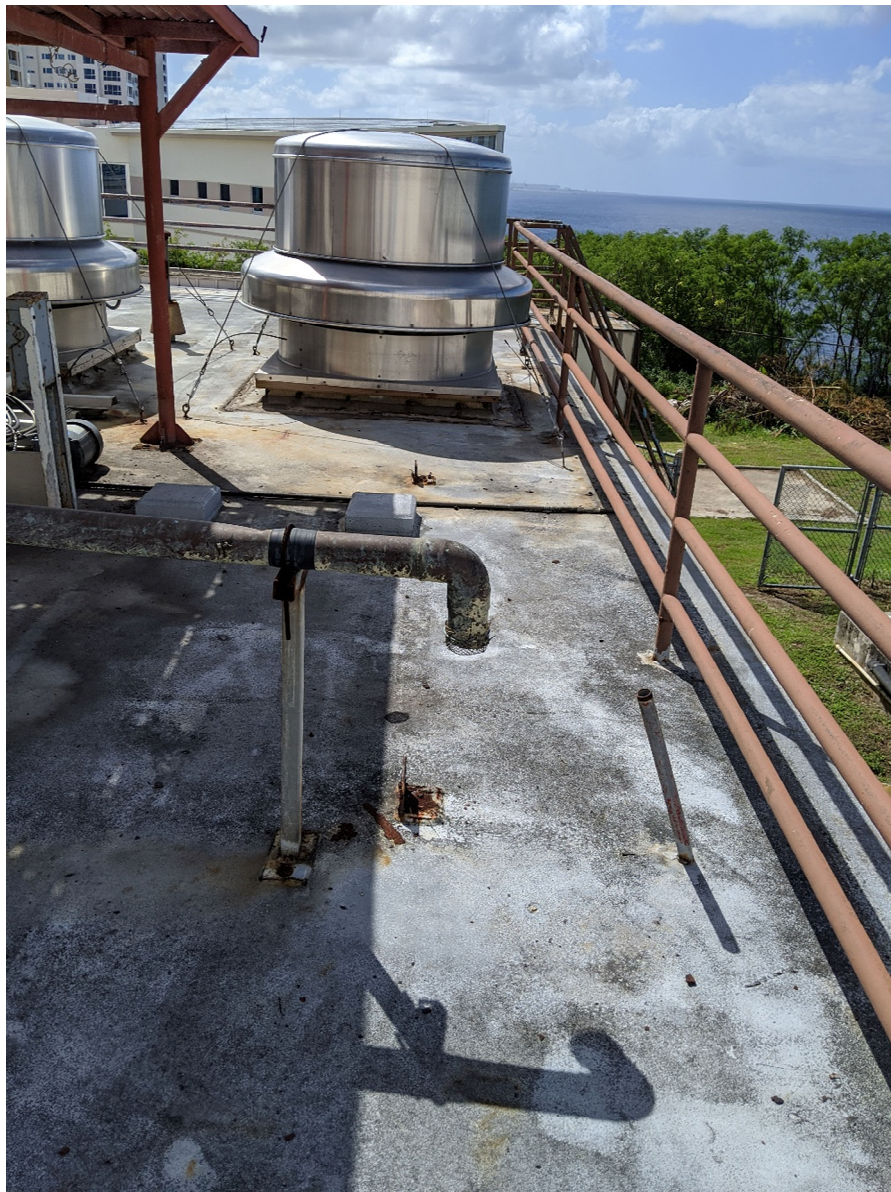
Medical air inlet closer than 25 ft. from exhaust fan discharge
