Department of the Interior Lessons Learned

DOI LL 25-01

Nov 21, 2024

Subject: Pilot Proficiency

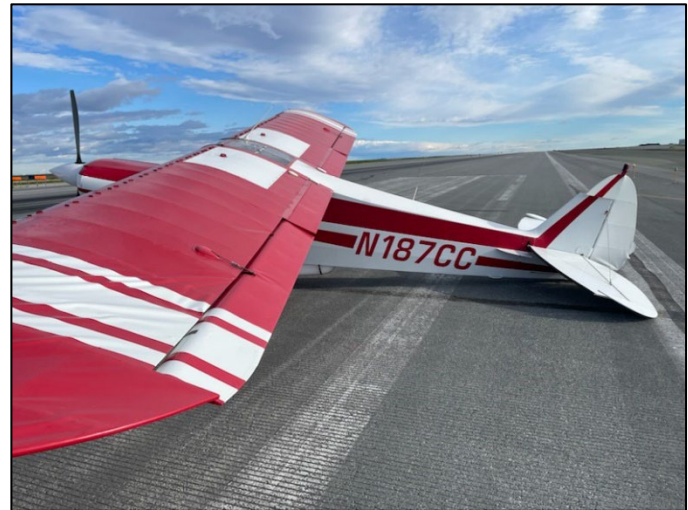
Discussion: On June 10, 2024, a Department of the Interior CC-18 Top Cub on wheels sustained substantial damage during a landing on an asphalt runway. The aircraft turned rapidly after touchdown and the pilot was unable to regain directional control (ground loop). It was determined that the pilot was not proficient with this particular aircraft configuration. While this may seem like a simple explanation for skill-based error, there were other deficiencies in the mission planning and subsequent safety risk management that contributed to the accident.

The flight departed at 6:25 p.m. which was over 12.5 hours into the pilot's crew duty day, with the project leader (aircrew member) in the rear seat. They returned to the airport 2.1 hour later with the winds at 20° right of runway centerline at 5 to 7 knots. The landing approach was normal, but after the tailwheel touched down the aircraft began an un-commanded turn to the right. The pilot applied full left rudder but was unable to arrest the right turn which continued to increase resulting in the left main landing gear strut fracturing and subsequently led to the left wing and horizontal stabilizer striking the runway surface. The brakes were not applied, as most tailwheel pilots avoid using brakes during tailwheel landings, the pilot's feet were positioned high on the rudder pedals. There were no injuries.
