Department of the Interior Lessons Learned

No. DOI LL 25-02

June 17, 2025

Subject: Improper Installation of Flight Controls

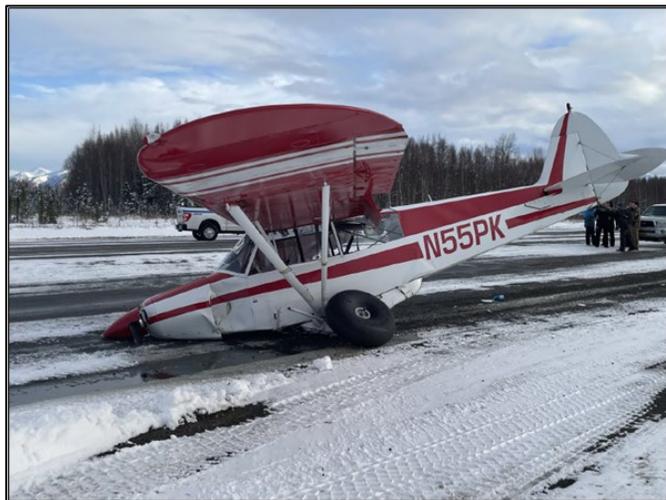
Discussion: Last fall, a Department of the Interior (DOI) pilot experienced a loss of control of a fleet CC18 Top Cub aircraft shortly after takeoff from Lake Hood Airport, Anchorage, Alaska. Immediately after takeoff, the aircraft nose pitched up rapidly, then stalled, descended, and impacted the runway. The pilot sustained serious injuries, and the aircraft sustained substantial damage. The National Transportation Safety Board (NTSB), in coordination with DOI's Office of Aviation Services (OAS), investigated the accident (report number [ANC25LA008](#).) A post-accident examination of the aircraft revealed that the rear flight control stick was installed backward, allowing it to become jammed in certain conditions.

Figure 1. Accident aircraft on the runway.

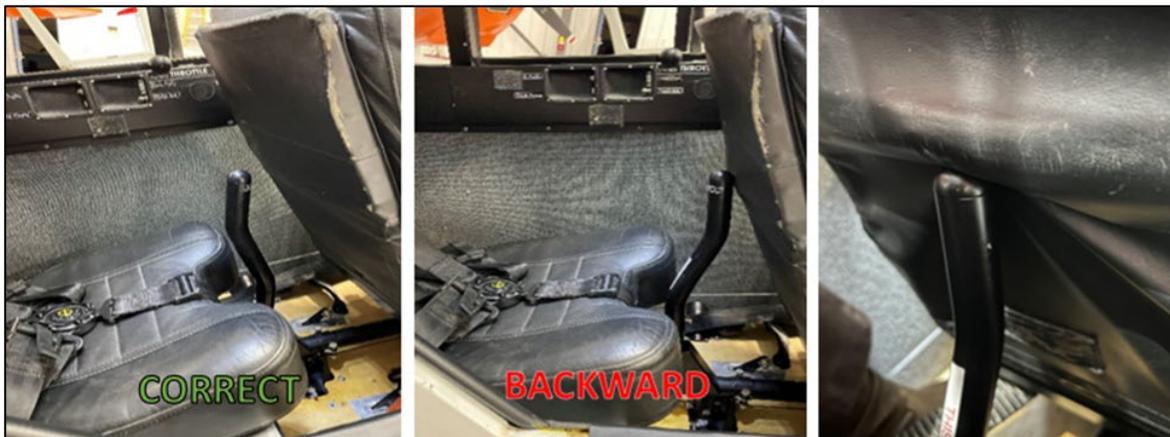
Investigation. The rear flight control stick was designed to be removed and stowed by the pilot. This prevents the rear occupant or cargo from interfering with the flight controls. According to experienced DOI fleet CC18 pilots, most flights are conducted with the rear control stick removed unless a second pilot is occupying the rear seat. When the stick is removed, a CubCrafters cover box is installed over the rear stick stub to prevent objects from falling into the rear flight control mechanisms and to prevent the stick stub from inadvertent movement. The rear stick should be installed with the compound bend toward the rear pilot, but can also be installed incorrectly facing the front seatback. The front seat can be adjusted to various

positions to accommodate pilot height, and clearance distance from the rear controls is dependant on that seat position. The accident aircraft's rear control stick had no placards indicating the proper installation direction, such as "This Side Aft", nor was it required by the aircraft manufacturer. The CubCrafter CC18 POH/AFM Supplement 9.15 Rear Stick Cover Installation does not describe the direction for stick reinstallation, but does state, "Ensure full range of motion (including trim) is met without the rear stick contacting anything."

Three post-accident ground reenactments were conducted with the rear stick installed backward and the pilot seat in the full aft position, as it was during the accident. The reenactments revealed that, during the flight control check for "free and correct" movement, the front seat pilot's forward stick control authority was partially limited, and some binding was experienced as the rear control stick contacted the front seatback. After simulating takeoff, when forward stick pressure was applied, the stick became lodged under the horizontal frame of the pilot's seatback and could not be moved in any direction until the pilot leaned forward and removed pressure from the seatback (refer to Figure 2). It is conceivable that the accident pilot did not perceive that the rear stick was hitting his seat back due to his lack of experience in this aircraft model.

Figure 2. Rear stick installed correctly (left), installed backward (center) and jammed under seatback frame (right).

1. **The DOI Office of Aviation Services published Safety Alert 25-01** ([DOI Aviation Safety Alert 25-01 Top Cub Rear Flight Control Stick Installation](#)) which recommends POH/AFM Supplement 9.15 review, appropriate rear stick placarding, proper preflight inspections and flight control checks.

- a. Check free and correct motion (flight controls are moving up, down, left, and right as they should). Many pilots use a box pattern for this check. It's important to check each corner of "the box" rather than a cursory sweep.

- d. Make sure no foreign object debris could jam your controls, especially in the rear seat area of a tandem aircraft. Rear stick covers should be installed when sticks are removed.
