Department of the Interior Accident Prevention Bulletin

No. DOI APB 26-01

Subject: Fleet Aircraft Alterations

Area of Concern: Unapproved Aircraft Alterations

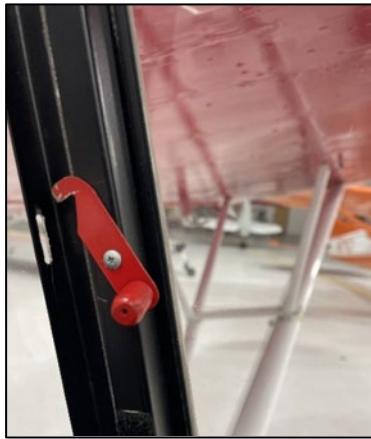
Figure 1. Top Cub Window Latch

[**SAFECOM #26-0094**](#). During a Top Cub preflight inspection for a maintenance check flight, an **improvised side window latching mechanism** was observed (Figure 1). This alteration was not entered into any work order or OAS-2 logbook and did not use approved parts or installation methods. While likely intended to prevent window movement in flight, the modification introduced new hazards, including the potential for impeded egress and impact injury risks. This undocumented “work-around” was not compliant with FAA or OAS maintenance requirements and resulted in an unairworthy aircraft.

- Ensure compliance with DOI aircraft maintenance policies and FAA standards.
- All DOI fleet aircraft alterations shall be performed in accordance with 351 DM 2, 2.4A(6). [351 DM 2- Aircraft Equipment and Maintenance](#)
- Alaska Region personnel coordinate all maintenance through Fleet Services in accordance with [OPM-03](#). Modifications are to be performed at the Alaska OAS Repair Station or as directed by the Regional Director in accordance with [OPM-14](#).

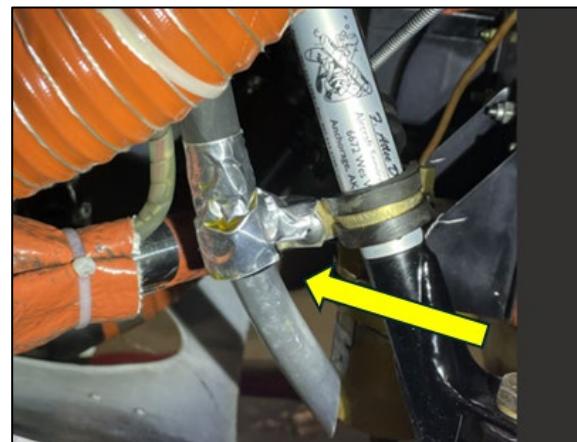
[**SAFECOM #22-0049**](#). An aircraft operating in cold conditions experienced a **crankshaft oil seal failure** and significant in-flight oil loss. The failure resulted from breather whistle holes being taped over with aluminum tape. When the breather tube subsequently froze, oil system over-pressurization occurred. More recently, aluminum tape was again discovered covering a fleet aircraft breather tube hole during a carding inspection (Figure 2). This unauthorized “work-around,” intended to reduce oil splatter in the engine compartment, is not a manufacturer-approved

Figure 2. Oil Breather Tube Hole Taped Over

procedure and presents a serious risk of catastrophic engine power loss.

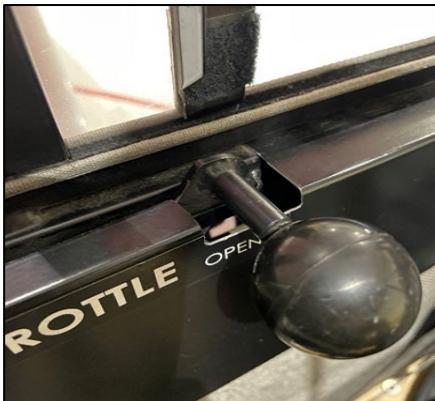
Figure 3. Notch in Throttle Panel

SAFECOM 25-0885. During an operation on floats, **the throttle became stuck in the full power position**. Fortunately, the pilot was able to shut the aircraft down. Post flight inspection revealed the rear seat throttle was physically stuck in an (unapproved) throttle panel cut out notch/modification (Figure 3). Both the front and rear panels had been modified by an unknown individual and these alterations were undocumented.
