Interagency Aviation Accident Prevention Bulletin

No. IA APB 22-02

January 11, 2022

Subject: NWCG Equipment Technology Committee (ETC) Advisory 22-01, Inspection of 3,000lb Cargo Nets

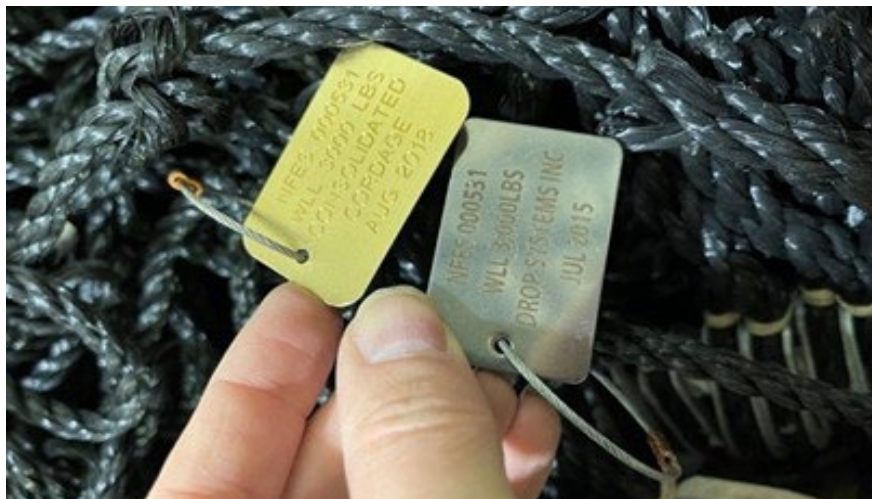
- A single “Consolidated Cordage” tag, or
- Two tags – One tag which states “Consolidated Cordage.” The other which states “Drop Systems.” (Figure 1).

Figure 1 – Sample image of cargo net with two different tags from different manufacturers.

Remove these nets from service and inspect as follows:

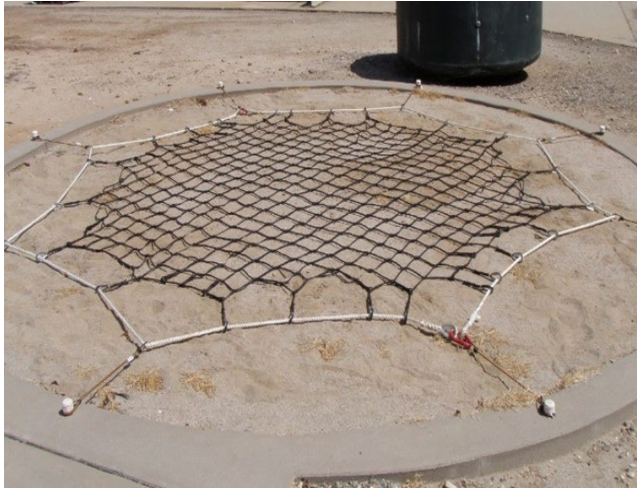
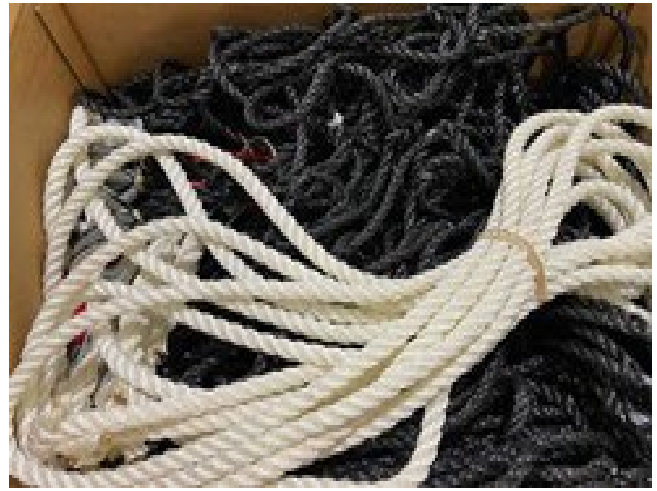
1. Verify that nets have perimeter ropes installed. Perimeter ropes are twisted white nylon with two pear links (Figure 2).

Figure 2 – Sample of NFES #000531 cargo net with perimeter rope attached correctly.

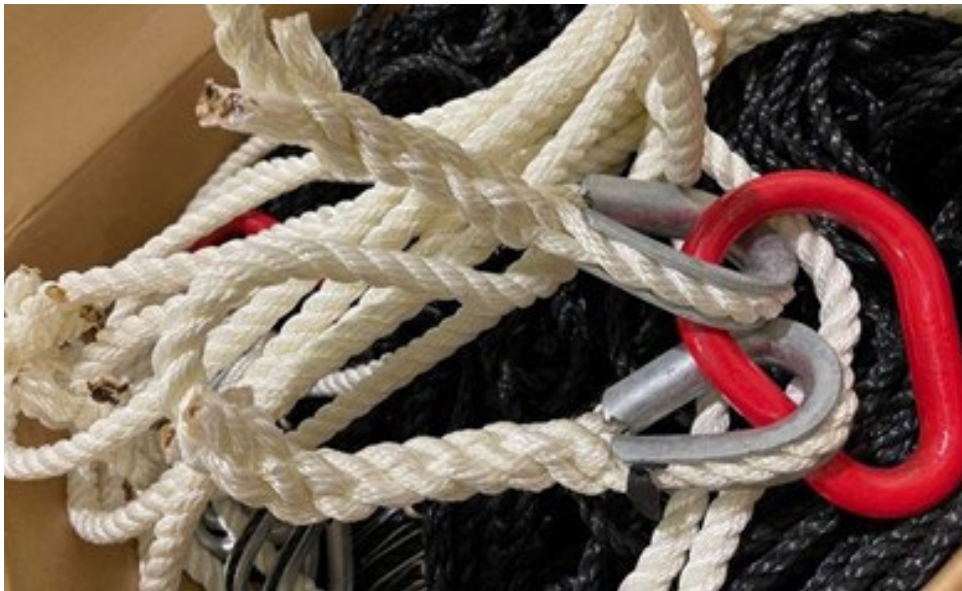
2. Verify that nets show indication that the perimeter ropes have been treated with a polyurethane coating.
3. Verify that perimeter rope terminations have been “heat cut” to eliminate fraying (Figure 3).

Figure 3 – Sample of a correctly manufactured net with perimeter rope strand ends “heat cut” to eliminate fraying.

4. If the inspection does not reveal any problems with the perimeter rope, return the net to service.
5. If the inspection reveals problems with the perimeter rope as described in steps 1-3, remove from service, and use the following procedure to notify DLA and return affected units to the DLA Depot:
 - a. If non-conforming nets are found, email Barry Smith at barry.smith@dla.mil.
 - b. Submit a Supply Discrepancy Report (SDR) requesting credit and disposal instructions. Do not send the cargo nets to the depot until instructed to do so in the SDR reply from DLA.
