# Interagency Aviation TECH BULLETIN

No. IA TB 22-01

**Subject:** Malfunctioning Matrice 600 propellers

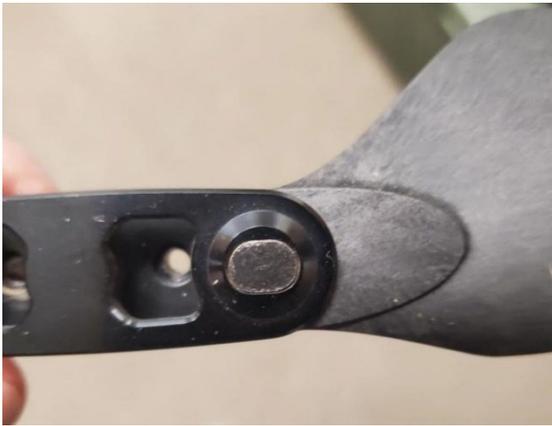
We have experienced an increasing number of Matrice 600 prop shears in flight. There are two versions of props within the Matrice 600 fleet. The “new style” props have a rounded T-head and a nut on the bottom (Figure 1). The second version, “old style” (Figure 2) props have a hex-screw head on the top that threads into the bottom prop plate.

Figure 1 – New style T-head.

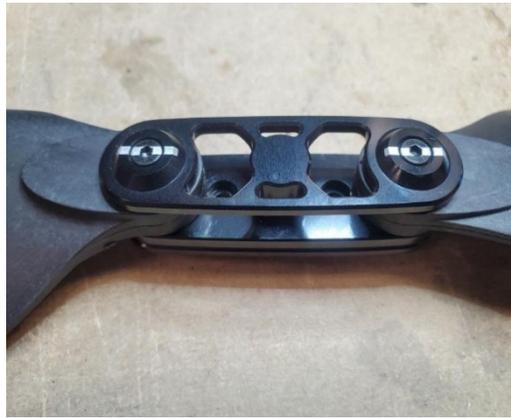
Figure 2 – Old style hex head.

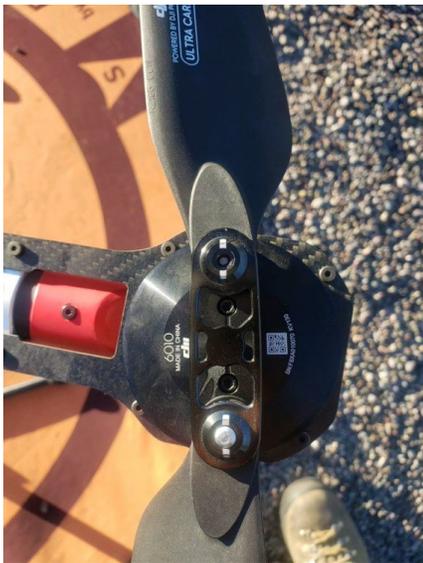
The “old style” props experience problems with bolt heads shearing off, caused by the head of the screw being very thin and breaking (Figure 3). Typically, this was not a catastrophic failure; props would be noticeably loose and fixed by replacement. Aircraft were still able to complete the mission and return to launch area without the operator noticing the issue in flight. Fixing the “old style” props is a simple fix: replace the thin-head screws with a new screw with a thicker head.

Figure 4 – Old prop style shear.

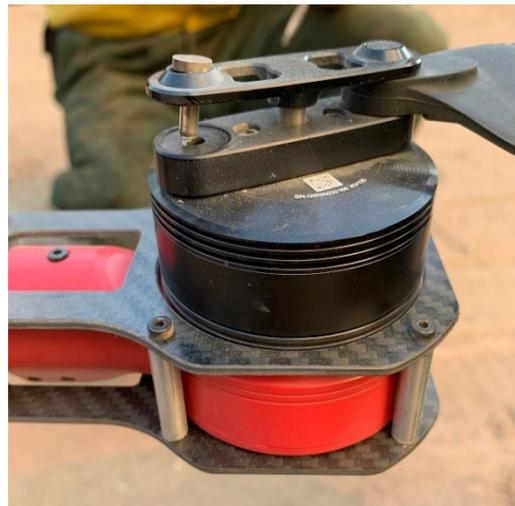
Prop shears occurring with the “new style” props are more problematic and are causing the aircraft to crash. Fixing the “new style” props is more challenging because the part holding the prop on is an atypical threaded fastener with a T-head. Reports indicate the T-head fastener is shearing off at the bottom, where the nut holds it in place (Figure 4). This has resulted in a total loss of one prop and motor, causing aircraft to lose altitude until impact.

Figure 3 – New style prop shear.

- After every flight RPIC shall check the tension of each prop, both horizontal and vertical. Any irregularities require further inspection and/or replacement. Remove the prop from the motor housing and inspect the T-head and nut for loosening and cracking.
- Do not use the aircraft in adverse weather conditions including wind speeds exceeding 18 mph.
- Use High Altitude props when operating above 8,200 ft.
- Payload not to exceed 11 lbs. and only fly with number of ignition spheres and glycol needed to complete the mission.
