Majuro Water Supply and Distribution System Analysis

Majuro Atoll The Republic of Marshall Islands

Majuro Water Supply and Distribution Analysis

Prepared by the Technical Service Center, Bureau of Reclamation for the Office of Insular Affairs and the Majuro Water and Sewer Company

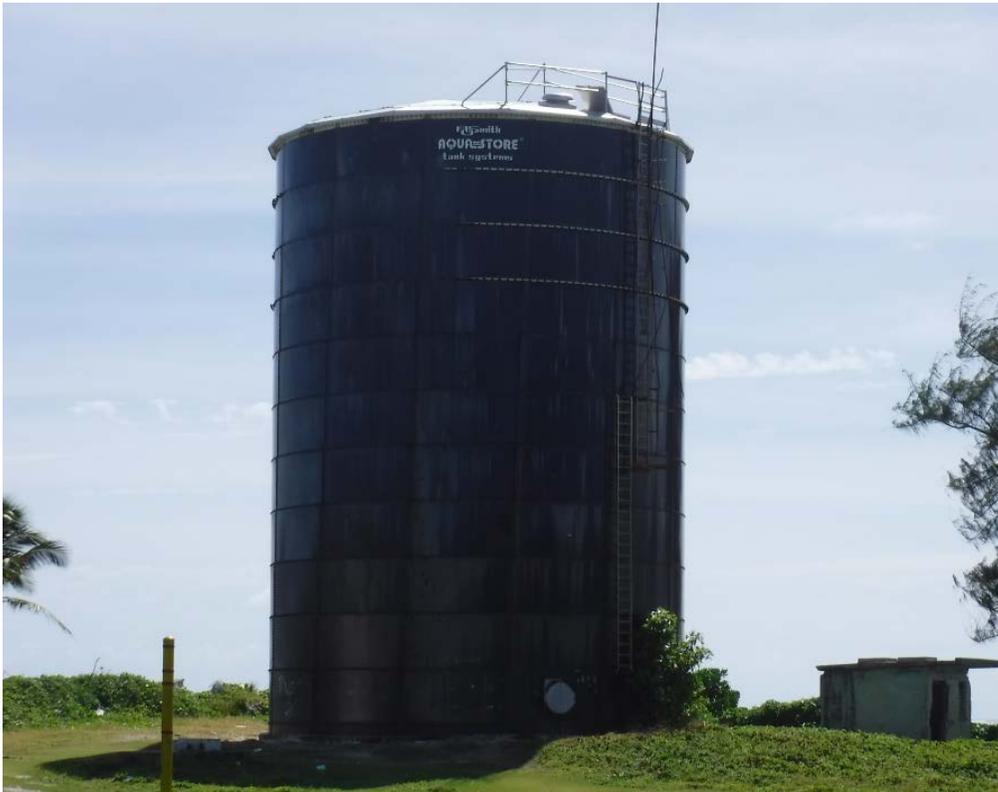
The abandoned 400,000-gallon standpipe close to the Marshall Island High School campus (Figure 15) is included in the model. No as-built drawings for the standpipe were available. Based on world imagery and on-site observation, it was estimated the standpipe is approximately 35 feet in diameter and 55 feet high.

Figure 15: Abandoned 400,000-gallon standpipe (Reclamation, 2020).

The standpipe has been abandoned because the system pressures were insufficient to fill the tank, and suggestions to replace this with a new standpipe are included in Section 6. *System Improvements*. The existing standpipe cannot be used due to its current lack of structural integrity and is not in any condition to be refitted or repaired. The standpipe is not incorporated into the Existing Conditions Scenario, and its replacement is included in the Improved Conditions Scenario.

The new concrete standpipe would need to have an orifice plate or other flow control device to limit the flow when filling the standpipe. During the low-demand periods in the Rita area, excess flow would fill the standpipe. During the high-demand periods when the system pressure in the Rita area is lower than the pressure head inside the standpipe, flow would be discharged by gravity from the standpipe to supplement the demands of the Rita area. Figure 29 shows how standpipes work. Figure 30 shows the filling and emptying of the standpipe after integrating to the improved DUD system.

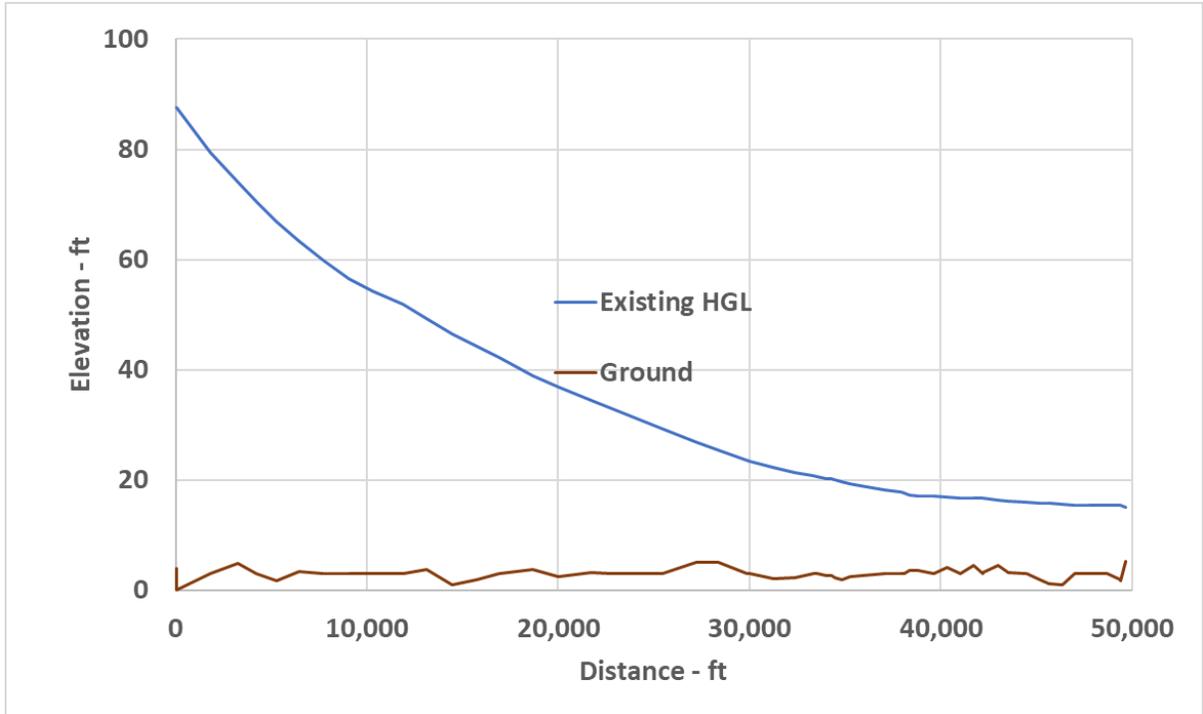
There is a high rate of system pressure drop over the long stretch of service areas from the airport to Rita. The Rita area at the end of the DUD system frequently gets little to no pressure. With no pressure, there is no water delivery. The Existing Conditions Scenario model results corroborate the low service pressures throughout the DUD system, as demonstrated in Figure 24.

Figure 24: HGL and ground profiles in the Existing Conditions Scenario.

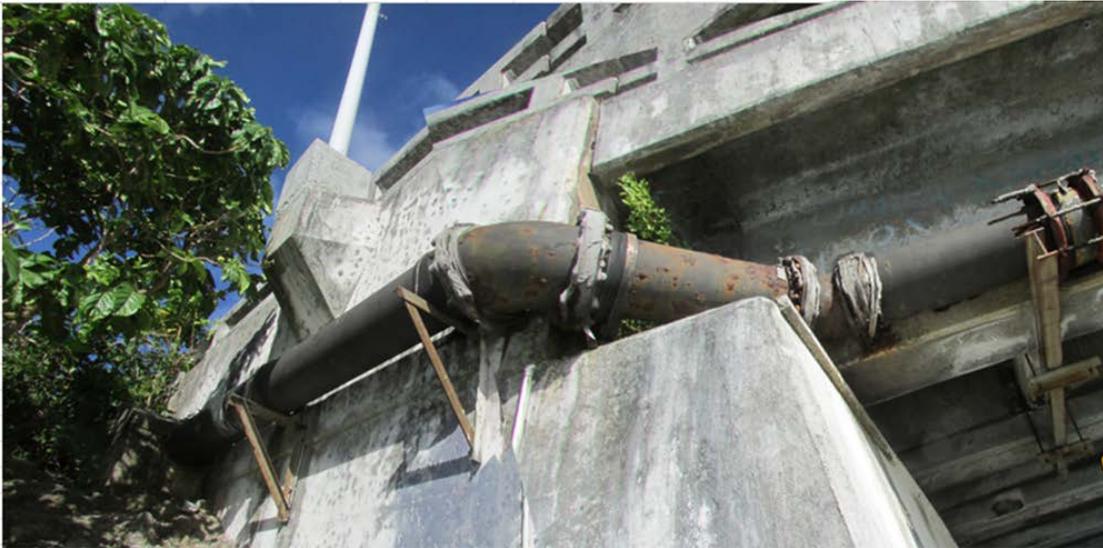
Figure 27: Ductile iron pipe with wrapped joints at bridge crossing.

This segment of pipe needs to be replaced as soon as possible to prevent a potential pipe failure, which would completely shut down the transmission main for a long time.

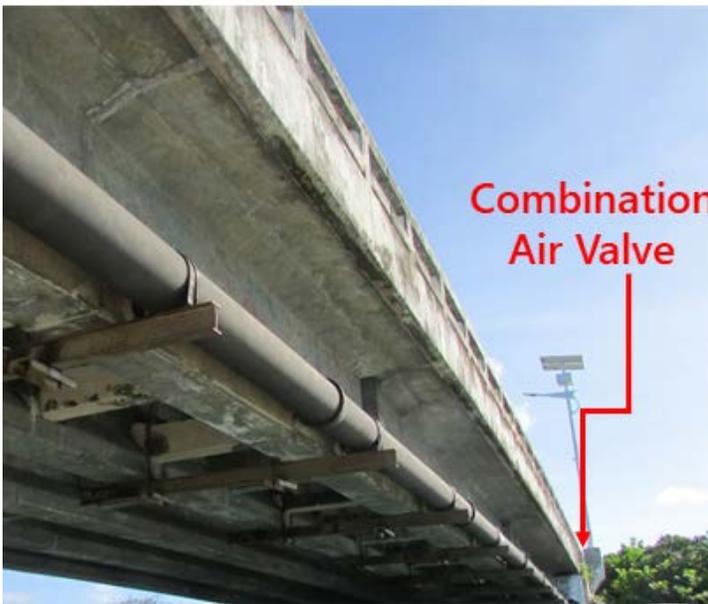
Air valves are generally installed at the high points of the pipelines where the air tends to accumulate. For the DUD system, the only noticeable high point is at the bridge. Because installing an air valve at the high point of the middle of the bridge span would be difficult, TSC recommends installing a combination air valve on the ascending stretch near the abutment of the bridge (Figure 32).

Figure 32: Place an air valve at the bridge abutment, rather than the actual high point.
