Interagency Aviation Lessons Learned

No. IALL 07-05

FY 07 ANC07LA077

Cessna 185 (floats)

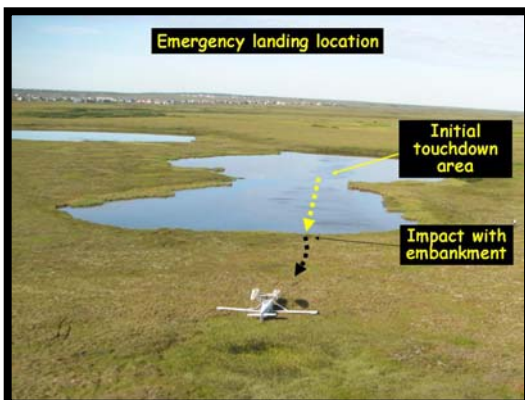
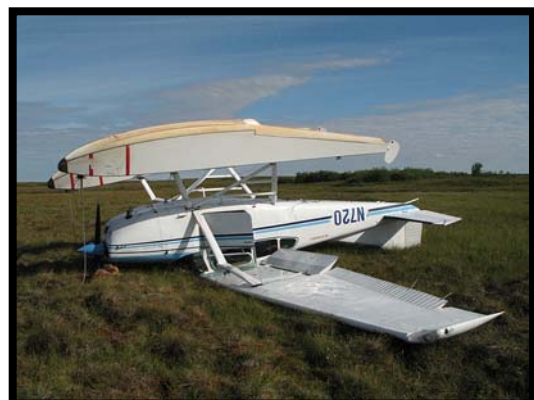
The pilot made an emergency landing on a small pond, but due to the size of the pond after touchdown the aircraft left the pond, hit an embankment became briefly airborne and flipped over.

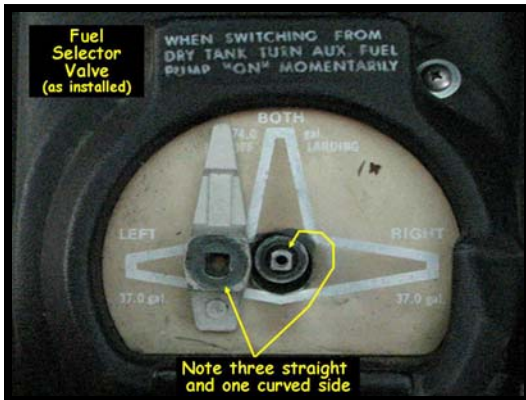
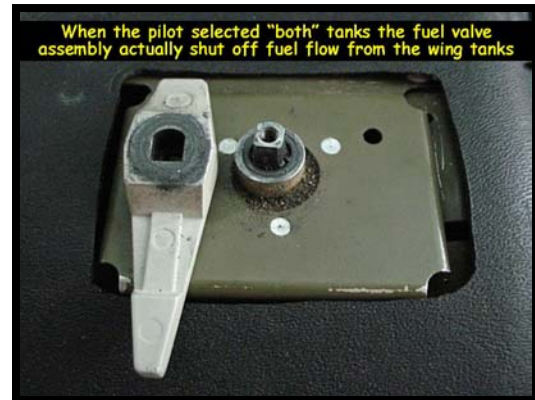
The investigation determined that rather than fuel exhaustion due to lack of fuel quantity, the engine actually failed due to fuel starvation as a result of the improper installation of the fuel selector lever during the 100-hour inspection.

Narrative (con't): Although the mechanics had used the appropriate checklist, the manufacturer's maintenance manual, and good cross-checking of each other's work, the fuel selector lever was installed 180 degrees out of phase so that when the pilot selected "both" he actually had turned off all fuel from the wing tanks.

The fuel selector valve assembly is designed to prevent improper installation (dog house shape). However, the assembly on this aircraft was worn enough that it easily permitted the lever on this aircraft to be improperly re-installed. Inspections of other fleet aircraft revealed no similar excessive wear or improper installation of this assembly. The NTSB is coordinating with Cessna to follow-up on this flight hazard.
