# Interagency Aviation Safety Alert

No. IA 08-05

**Subject:** Bell 407 Seats

**Area of Concern:** Bell 407 Helicopter Operations

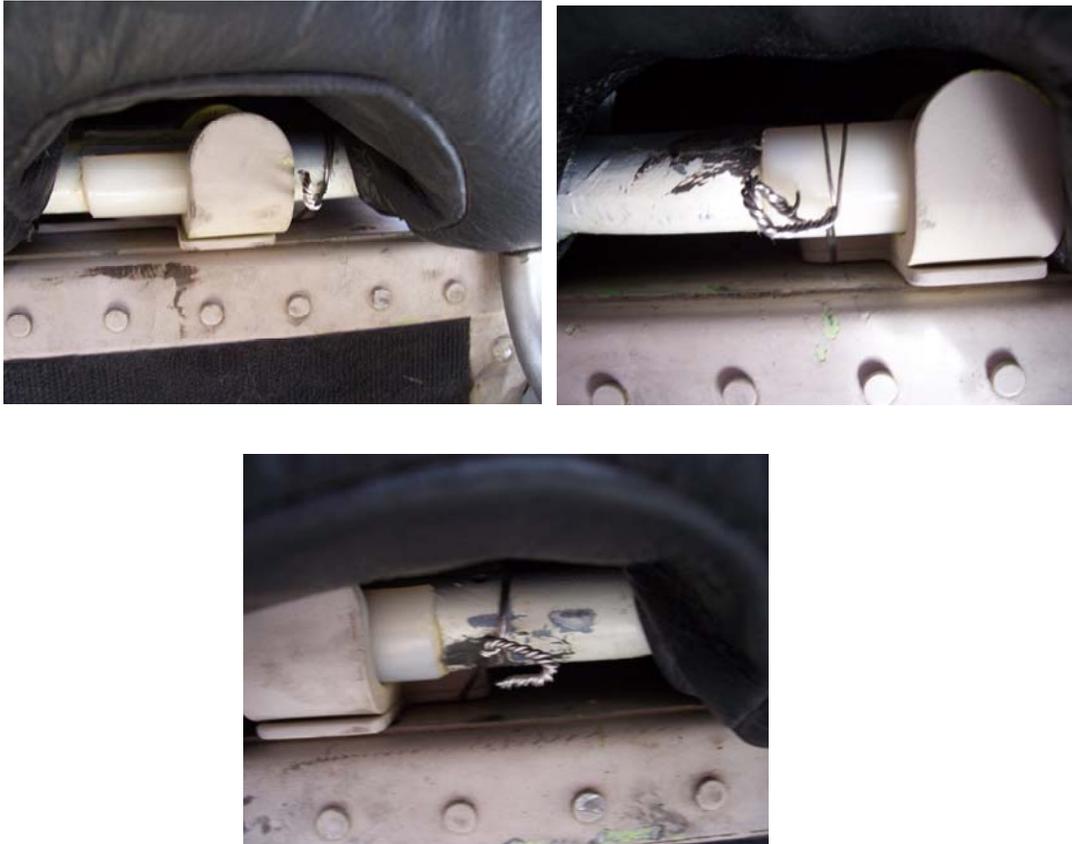
The next page shows the photos of the safety wiring of the seats.

1. Reinstall the seat cushions to the original factory seat configuration, or
2. Have contractor maintenance personnel secure seat cushion in accordance with 14 CFR Part 43 Part 1 and Appendix A (minor alteration) which can be signed off by an A&P mechanic.

The following is an example of a log book description of the corrective action by an A&P mechanic: "Added safety wire security to rear fwd facing seat bottoms, right and left attach fixtures of Bell Rear Seat Modification Kit, #CT-407-04-61; reference Bell Technical Bulletin #407-04-61 Rev. A - Installed double .025 safety wire through attach fixture and around seat forward cross bar in two places. A/C returned to service..." Signed off by an A&P.
