Interagency Aviation Safety Alert

No. IA 09-03

Subject: Sky Genie Inspection

Area of Concern: Rappel Operations

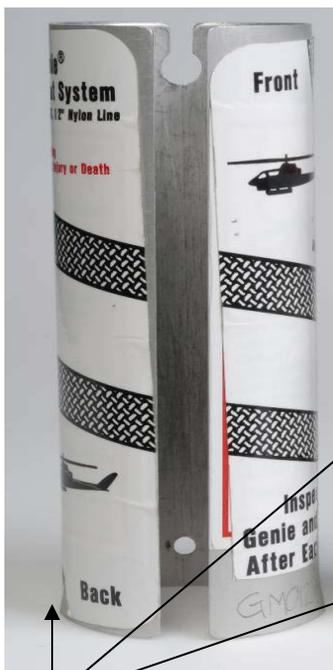
Discussion: On May 6, 2009, an Emergency Tie Off (ETO) procedure was being demonstrated by a spotter during rappel training. Before the ETO was demonstrated, an inspection of the Sky Genie was conducted and a 5/8 inch crack on the cover was discovered. The crack was located at the bottom, on the front of the cover (figures 1,2 & 3). The Sky Genie has never been used for operational rappels, only for tower training. It was placed into service just two days prior to the crack being found. The manufactured date was 09/07 and purchased the previous fall.

Fig.1 Location of crack

Recommendations: Discussions with the manufacturer are ongoing at this time, to evaluate whether this is a one time quality control issue or if there are indications of the failure to continue. In the meantime, please inspect all Sky Genies and, if found defective, immediately pull from service and report your findings to Tim Lynch, MTDC at 406-329-3958. And don't forget to submit a SAFECOM. Any questions regarding the inspections can be directed to Tim Lynch at 406-329-3958 or Vince Welbaum at 208-387-5634.

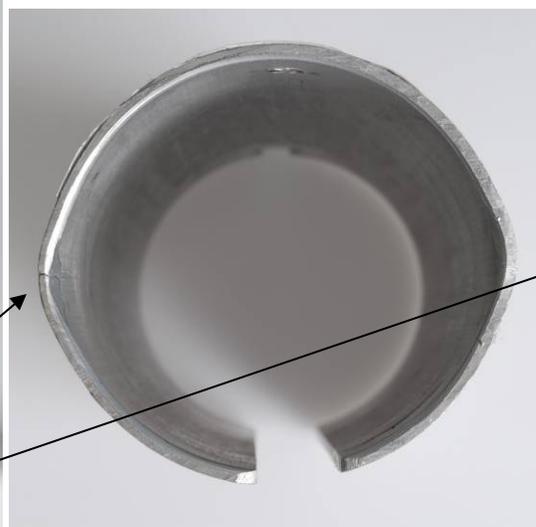
Fig 2. Bottom view of cover

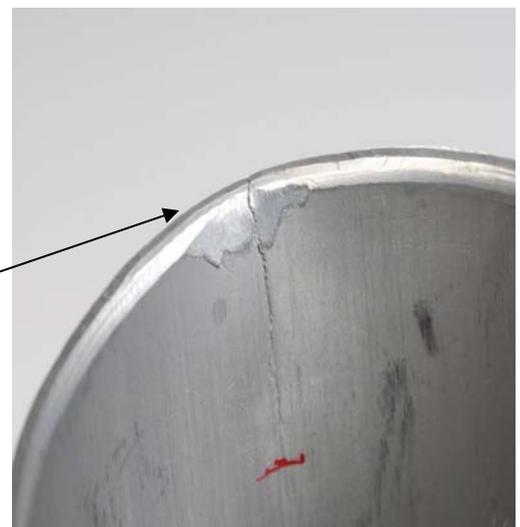
Fig 3. Crack close up — Bottom view

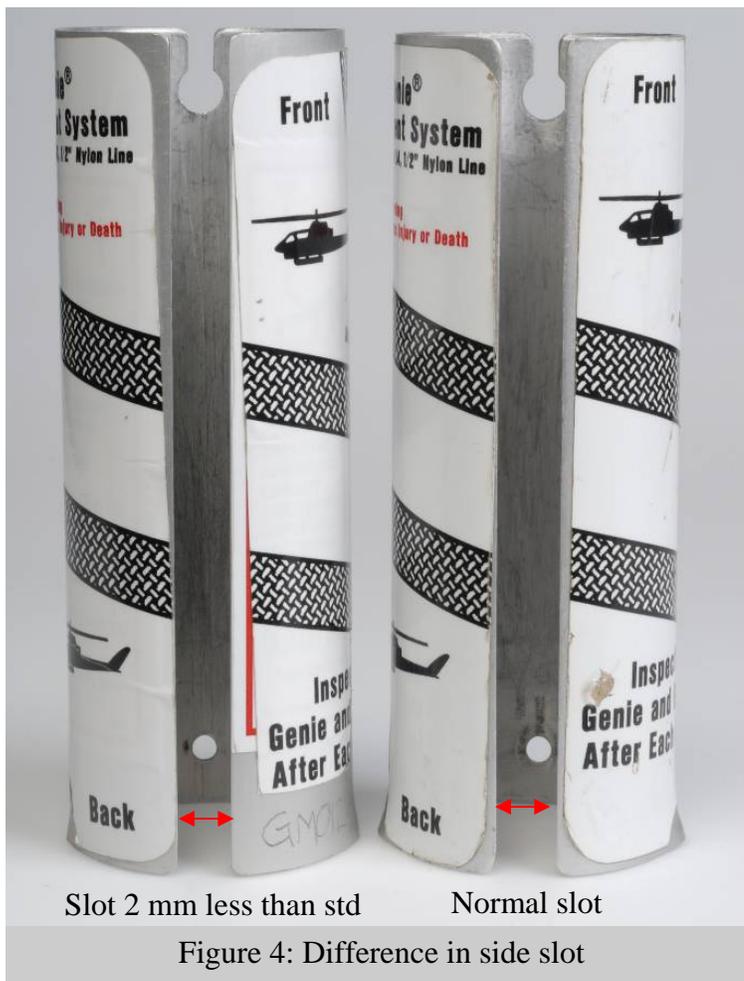
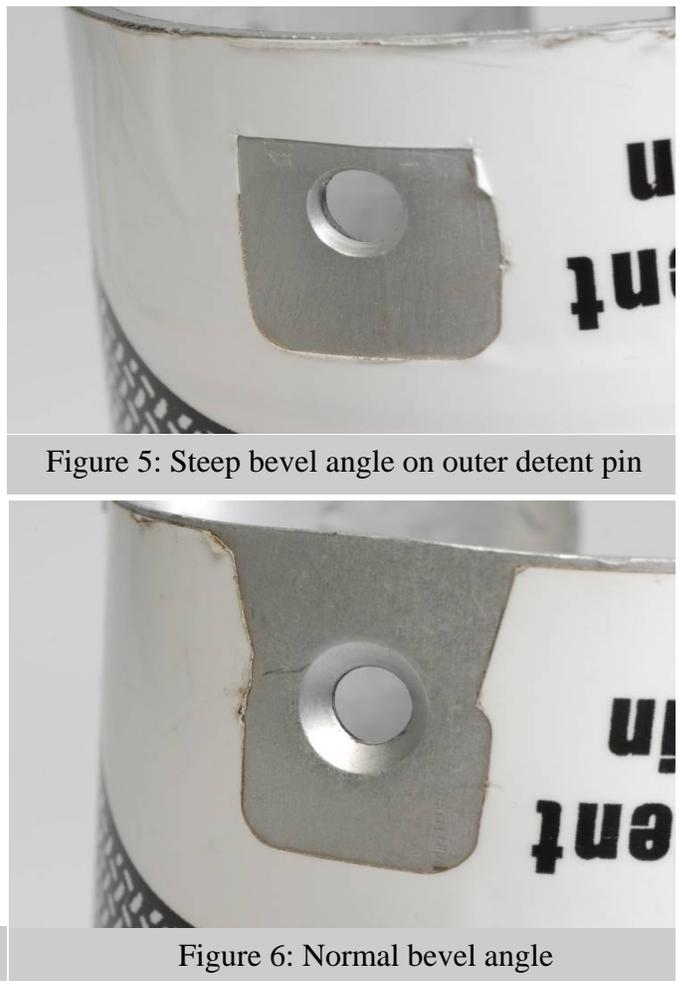
As mentioned earlier, when comparing the cover with another, several anomalies became apparent. The cover of this Sky Genie fits more tightly around the Sky Genie shaft than most covers. The circumference of the cover is visibly less than standard, and the width of the slot that runs the length of the cover is 2 mm narrower than standard

(Figure 4).

The outer face of the detent pin hole of this Sky Genie cover (Figure 5) has been beveled at a much steeper angle than other Sky Genie covers (figure 6). Combined with the tight-fitting cover, the lack of beveling makes it difficult to depress the detent pin enough to remove the cover.

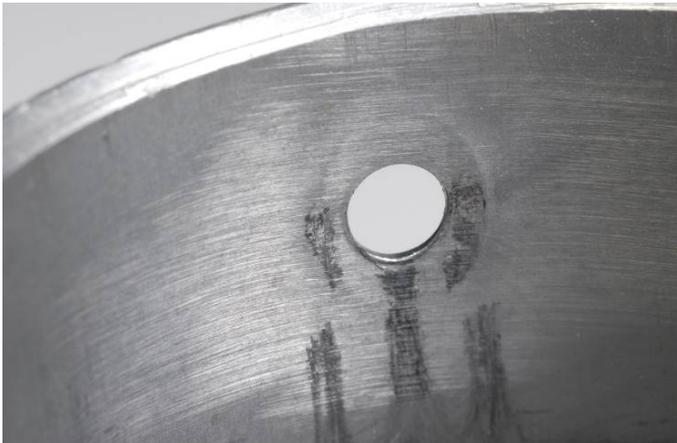
This cover was not finished to the same standard as most Sky Genies. There is less beveling and no finish buffing on the upper and lower ends of the cover. Additionally, there is no finish buffing on the inside of the flares, thumbscrew hole, detent pin hole, and center slot, which means that burrs and sharp edges are present in these areas (see Figures 7 and 8 on page 3).

Figure 7. Normal cover shows marks from finish buffing in inside of flares, holes and edges

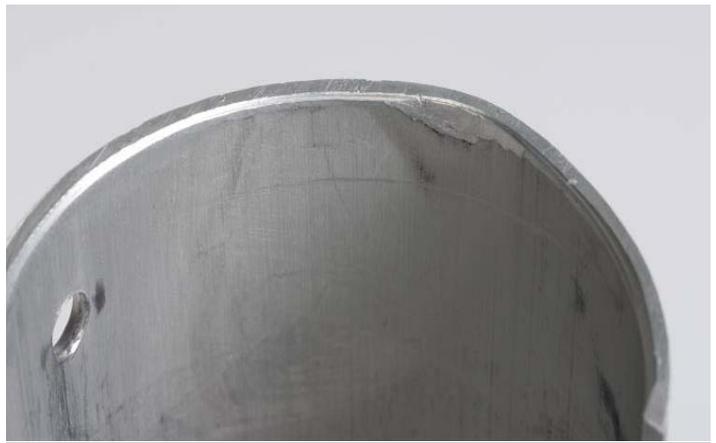
Figure 8. No finish buffing on inside of cover with crack

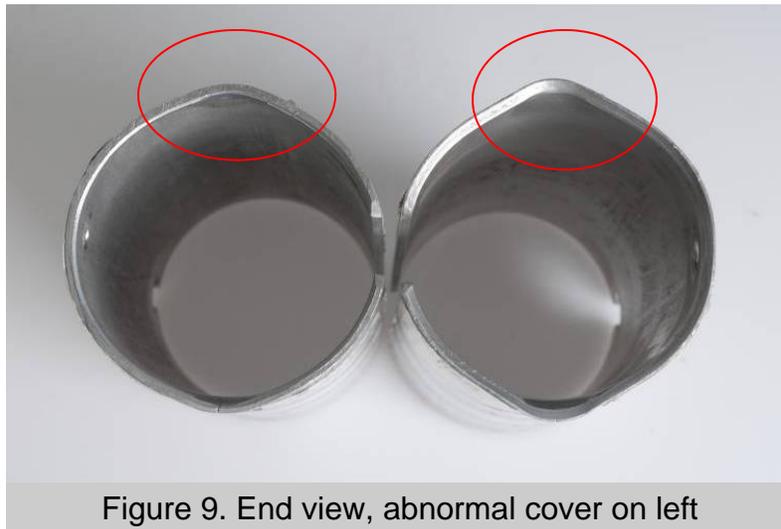
Finally, the two flared areas at the bottom of this Sky Genie cover are flared less than on the standard covers (Figure 9).

Figure 9. End view, abnormal cover on left
