# Interagency Aviation Safety Alert

No. IASA 11-03

Date: June 10, 2011

**Subject:** Helicopter Loss of Tail Rotor Effectiveness

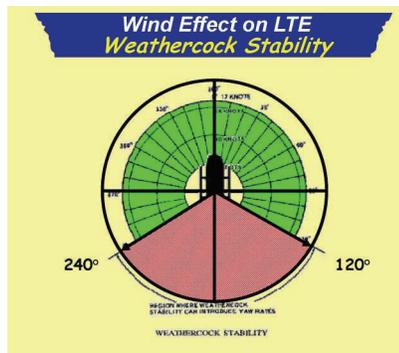
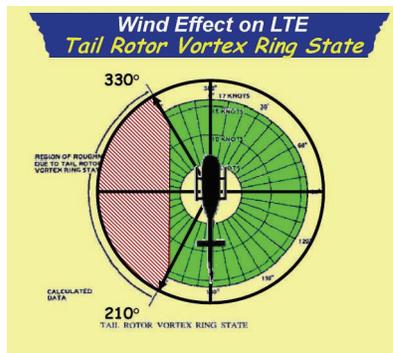
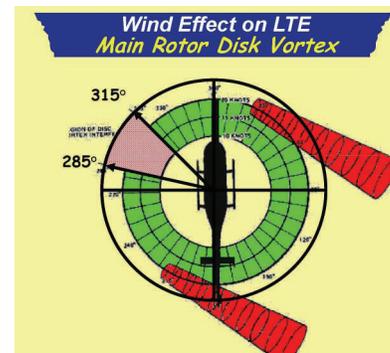
AC 90-95 also warns pilots to be alert to certain wind conditions when operating at low airspeeds (generally below effective translational lift):

Winds from each of these regions creates tail rotor thrust variations and increases the pilot’s workload.

While pilots must always comply with the procedures listed in their aircraft's operating manual AC 90-95 recommends the following techniques to recover from LTE :

- Apply full pedal opposite of the direction of the turn.
- Increase airspeed.
- Reduce power if altitude permits.

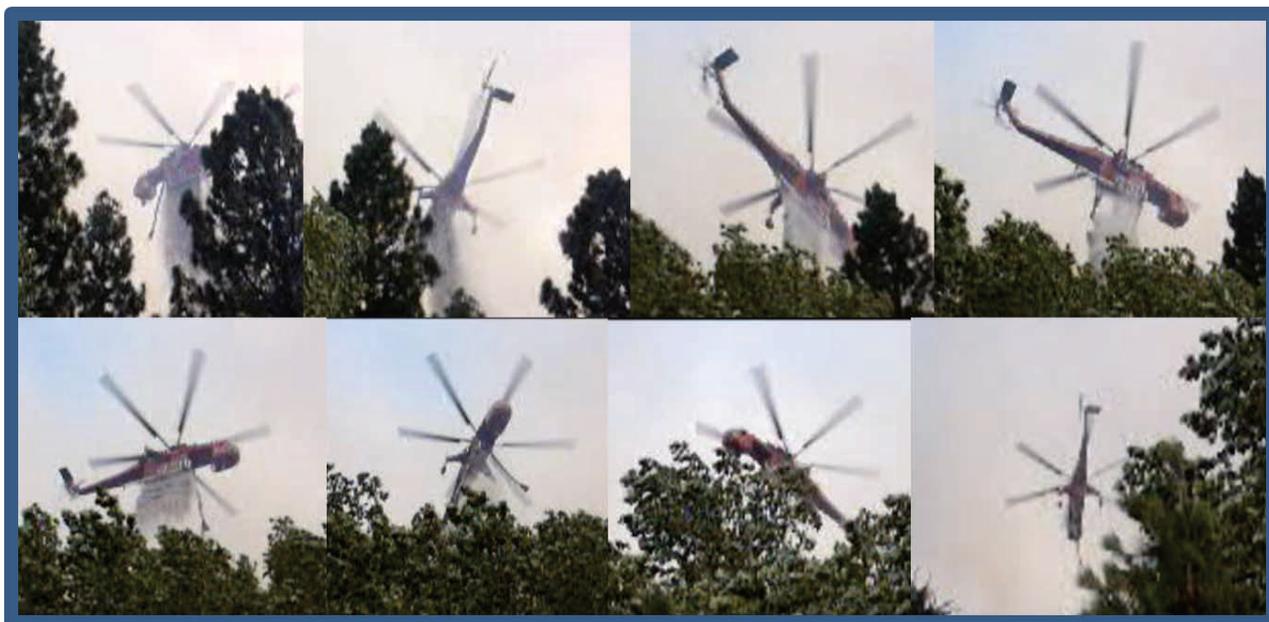
The images below are from a video of an LTE event in 2004. Click on the picture to view the video.
