Department of the Interior

Lessons Learned

No. DOI 10-02

Subject: Devil is in the Detail

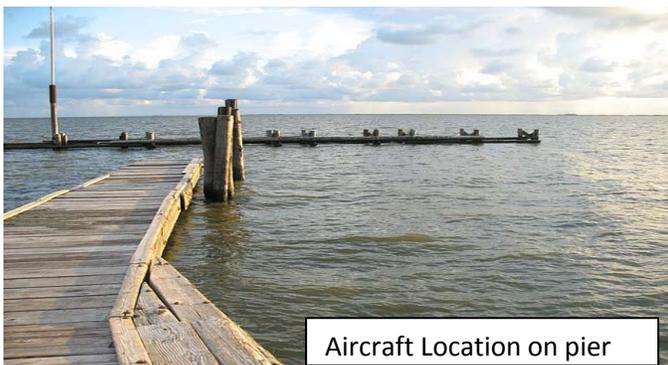
Risk assessment of primary & alternative actions. A thorough risk assessment of the mission to include all phases of launch and recovery should be completed as part of the preflight planning process. In this incident, further risk assessment should have been given to the location of the aircraft on the dock, the location of the wooden pilings/obstructions, wind direction/velocity, and departure route.

Aircraft Location on pier

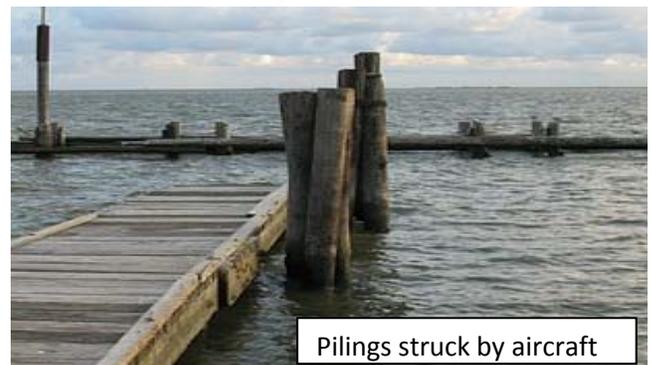
On July 26, 2010, a Soloy Cessna 206 was being launched from a commercial marina using two ground personnel to push the aircraft away from the dock with a 14 knot quartering headwind blowing away from the dock. The pilot elected to have the ground crew hold the aircraft by the forward strut until the engine was started and then push the aircraft away from the dock. There were no handling ropes attached to the aircraft and the water rudders were not extended in the water. The engine was started but the ground crew was unable to push the aircraft far enough from the dock and the aircraft quickly weathercocked into the wind. As a result, the aircraft possessed insufficient speed to provide the pilot with any control of the aircraft and began to drift. When the pilot realized the aircraft was about to hit the vertical wood pilings located in front of the aircraft, he immediately shut down the engine. The spinner and free-wheeling propeller struck the piling, bending one blade and denting the spinner cap.

Pilings struck by aircraft
