UNITED STATES DEPARTMENT OF THE INTERIOR AVIATION MANAGEMENT

TECH BULLETIN

NUMBER: 05-02

SUBJECT: Dromader Fuel Compensation Needle

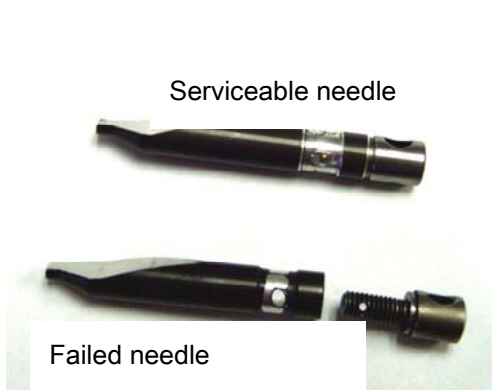
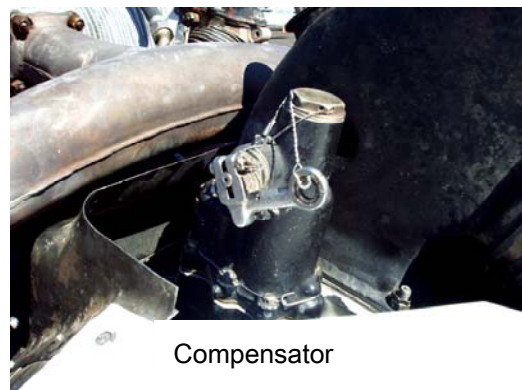
DISCUSSION: The SEAT program has had an incident-with-potential with regard to a failure of the fuel compensator needle inside the altitude compensator attached to the top of the carburetor on an M-18 Dromader. The needle is comprised of three parts: the tapered needle, the attachment cap that is screwed into the barrel of the needle, and a brass rivet locking the assembly together. This assembly is fit tight with no play. As you can see in the picture below, the rivet hole in the needle is elongated. What you cannot see is that the threads in the barrel of the needle are non-existent (possibly due to vibration). When the needle failed, it caused the mixture to go to the full lean position, starving the engine of fuel and shutting it down. This happened in flight. Luckily, the engine restarted (twice) and the aircraft landed safely.

RECOMMENDATION: Inspect your aircraft's carburetor by removing the compensator from the top of the carburetor, and inspect the fuel compensation needle for serviceability. Record the results and any necessary action in the appropriate maintenance log. Notify a DOI AM maintenance inspector of the results and provide the aircraft registration and serial number.
