**FINAL PHASE 1 MARSH MONITORING INSPECTION REPORT  
FOR ALCOA RESTORATION MARSH ON POWDERHORN LAKE**

December 2008

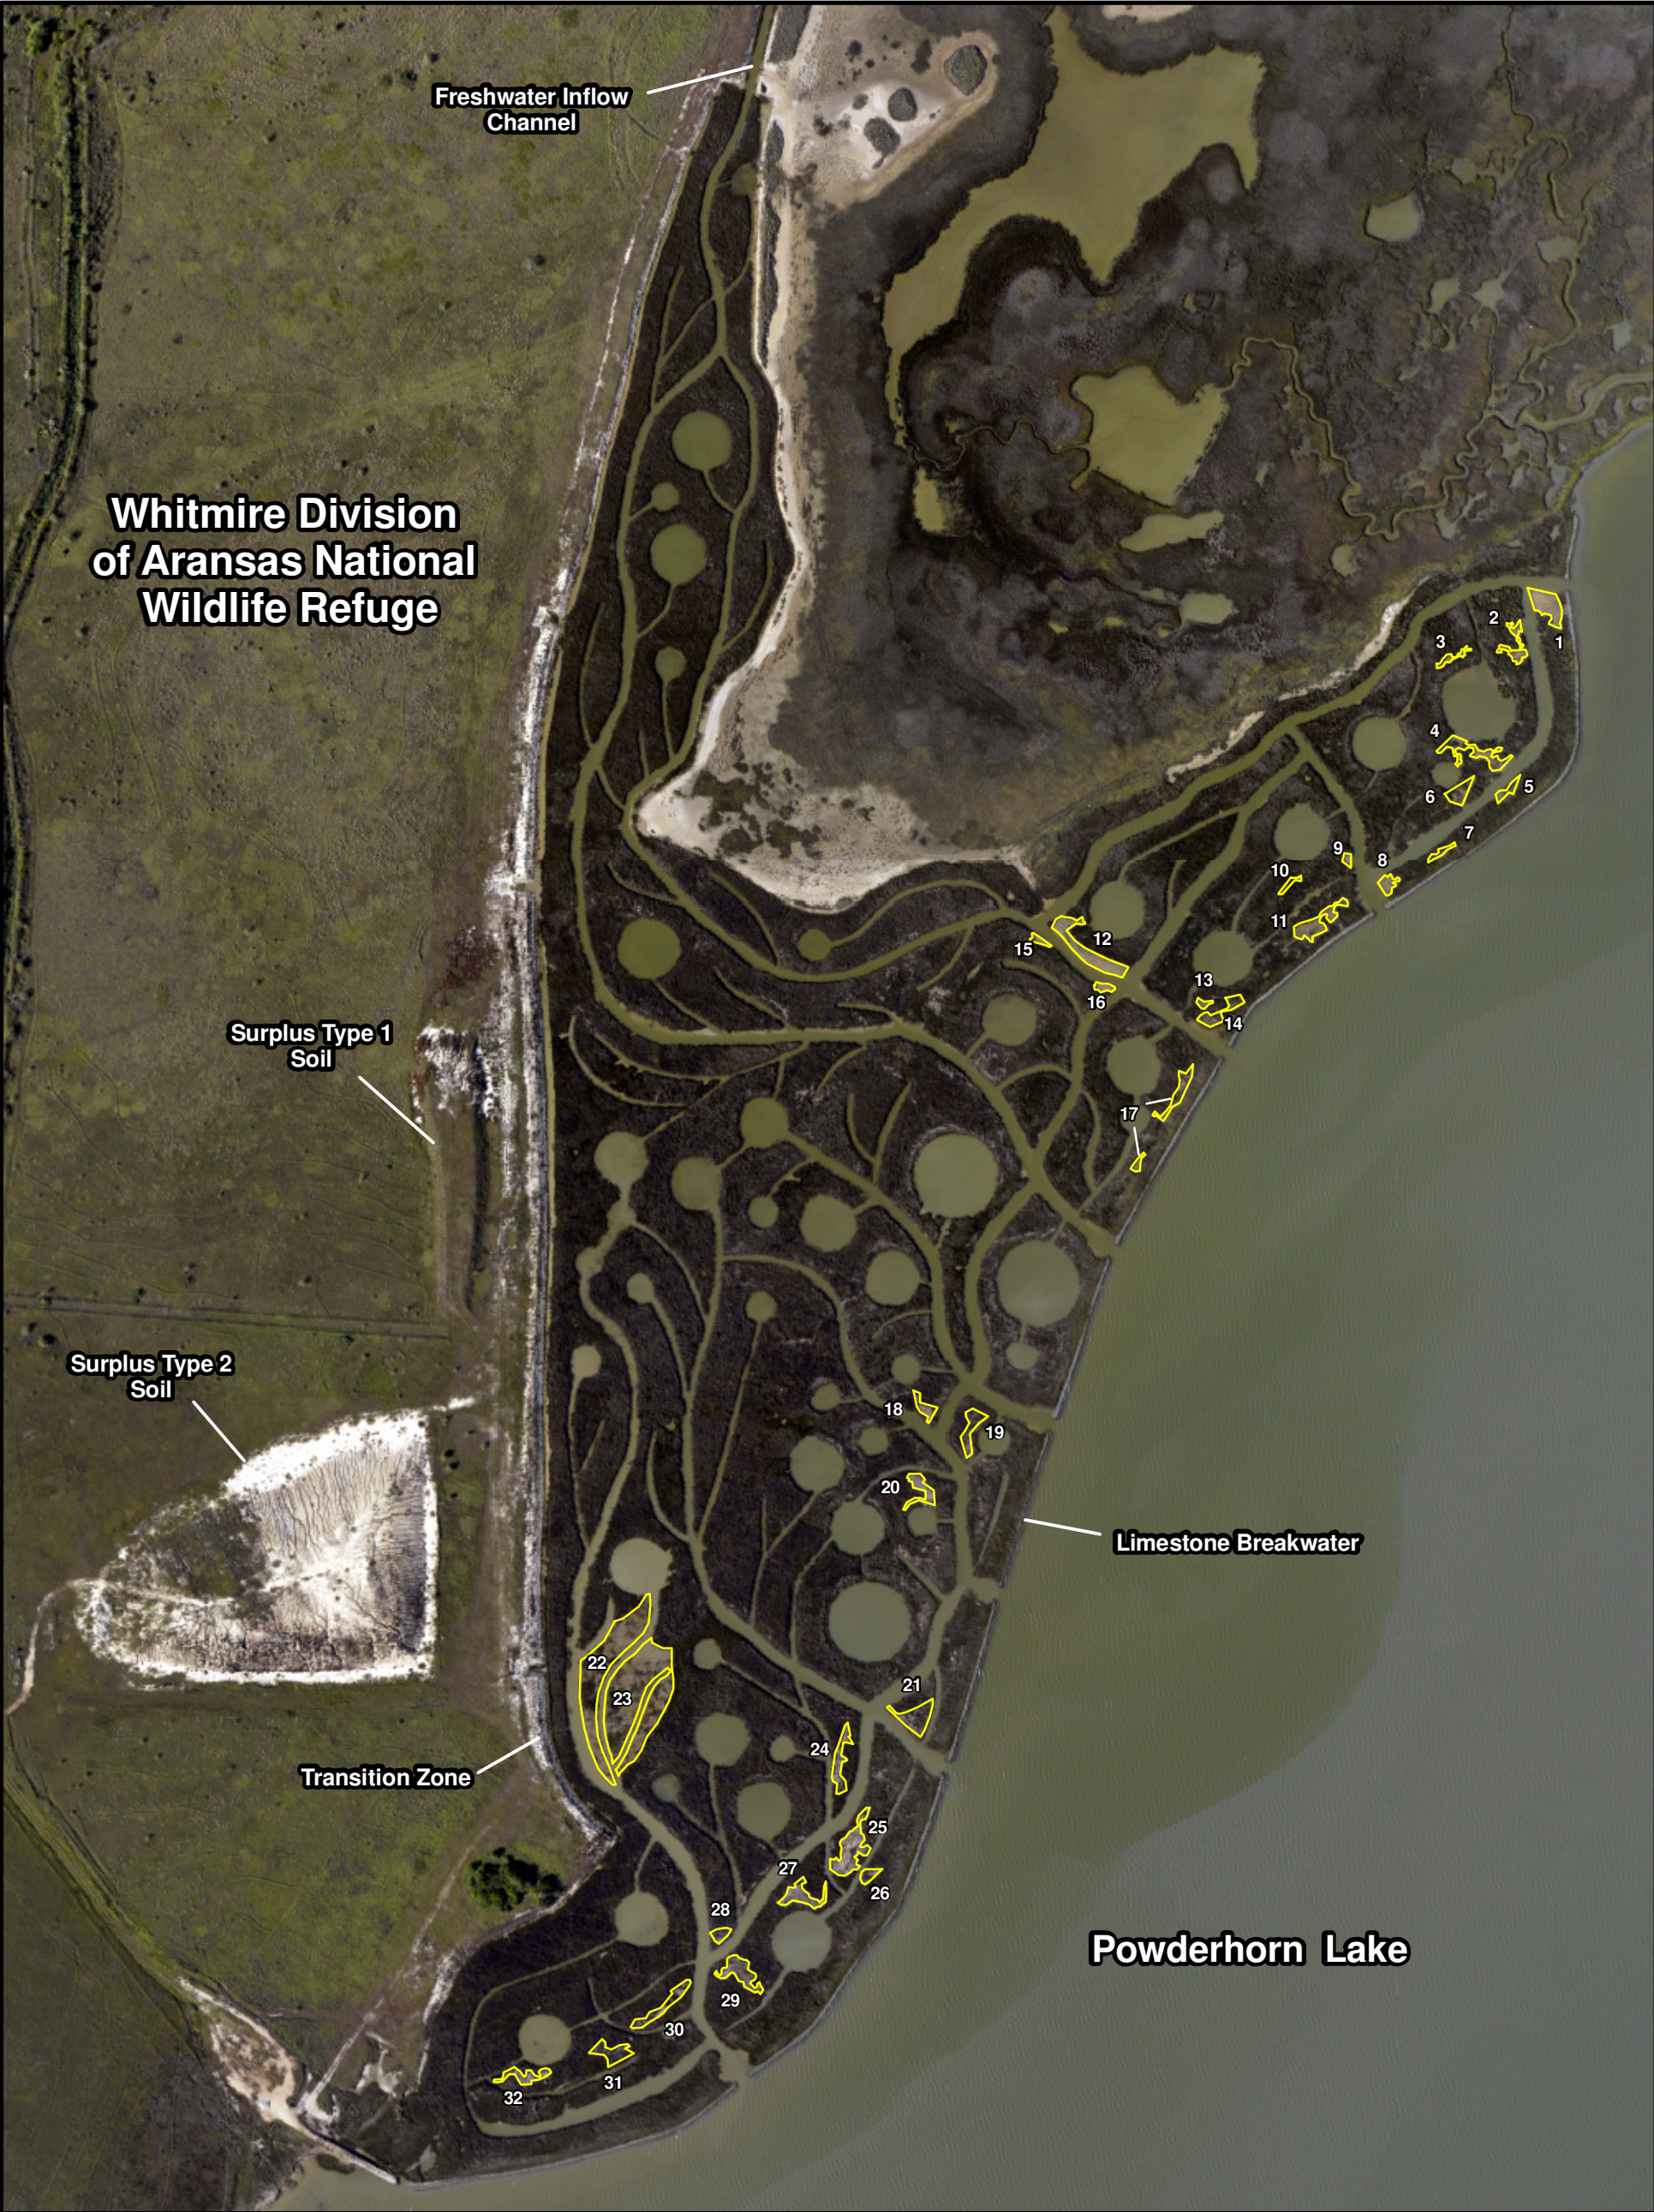
Areas that were identified as potential problem areas were evaluated during the walk-through inspection. The inspectors found that there were two primary reasons for the discoloration of marsh areas on the aerial photograph. First, there were a few areas where vegetation was sparse and soil was exposed. Some of these spots were shallow depressions that held water, and some had clay soils on the surface. Most of these areas are remnants of the elevation correction work that was conducted in Parcels K and L during October of 2007 (Photos 1 and 2). These areas are listed in Table 2 as sites 1 through 16. The combined size of all the bare areas that were left by the elevation correction work is less than ½ acre (0.485 acre). There was some evidence that the open spots are being used as loafing and feeding areas by shorebirds and waterfowl. The lightly vegetated areas are described in Table 2.

The lightly colored areas observed in the southeast portion of the marsh (Figure 2) were actually large mats of dead cordgrass stems pushed together by the storm tides that preceded Hurricane Ike (13 September 2008). Dead grass stems from the 2007 grass crop were dislodged from planting beds near the breakwater and pushed into piles forming grass mats. The formation of grass mats by unusually high tides is not uncommon. The mats were perched on top of the existing vegetation and were covering the vegetation growing underneath (Photos 3 and 4). These areas are listed in Table 2 as sites 18-21 and 24-32.

Marsh Channels - The only channel that exhibited greater than expected sedimentation was the channel that parallels the western shoreline and the transition zone (Figure 2). Sand and silt washed down from the surrounding upland areas and soil eroded from the Type 1 and Type 2 surplus soil piles have accumulated in the channel. Sediment was exposed in the lower portion of the channel (Parcel D, and the boundary between Parcels E and F)(Figure 5) on the day of the inspection (Photos 7 and 8). The sediments were exposed because of the unusually low tides that had developed in Powderhorn Lake and the Alcoa marsh. A combination of low winter tides and north winds pushed the water out of the marsh. The water level was so low that it was difficult to accurately determine water surface elevation on the tide gauges. There was very little water around the base of the gauge in Parcel D and oysters that had attached to the pole were obscuring the gauge (Photo 9).

The aerial photograph shows that some of the planting beds near the mouths of the primary channels have receded and the adjacent channels have expanded (Figure 2). During the inspection, scientists found that the edge of the cordgrass beds had retreated but the soil on the planting beds did not show signs of excessive erosion (Photos 8, 9, 10, and 11). The retreating grass lines were probably caused by the moderately high wave action that continuously passes through the gap in the breakwater from Powderhorn Lake. The wave energy has kept emergent grass from growing on the beds, and created intertidal mud flats which are serving as open

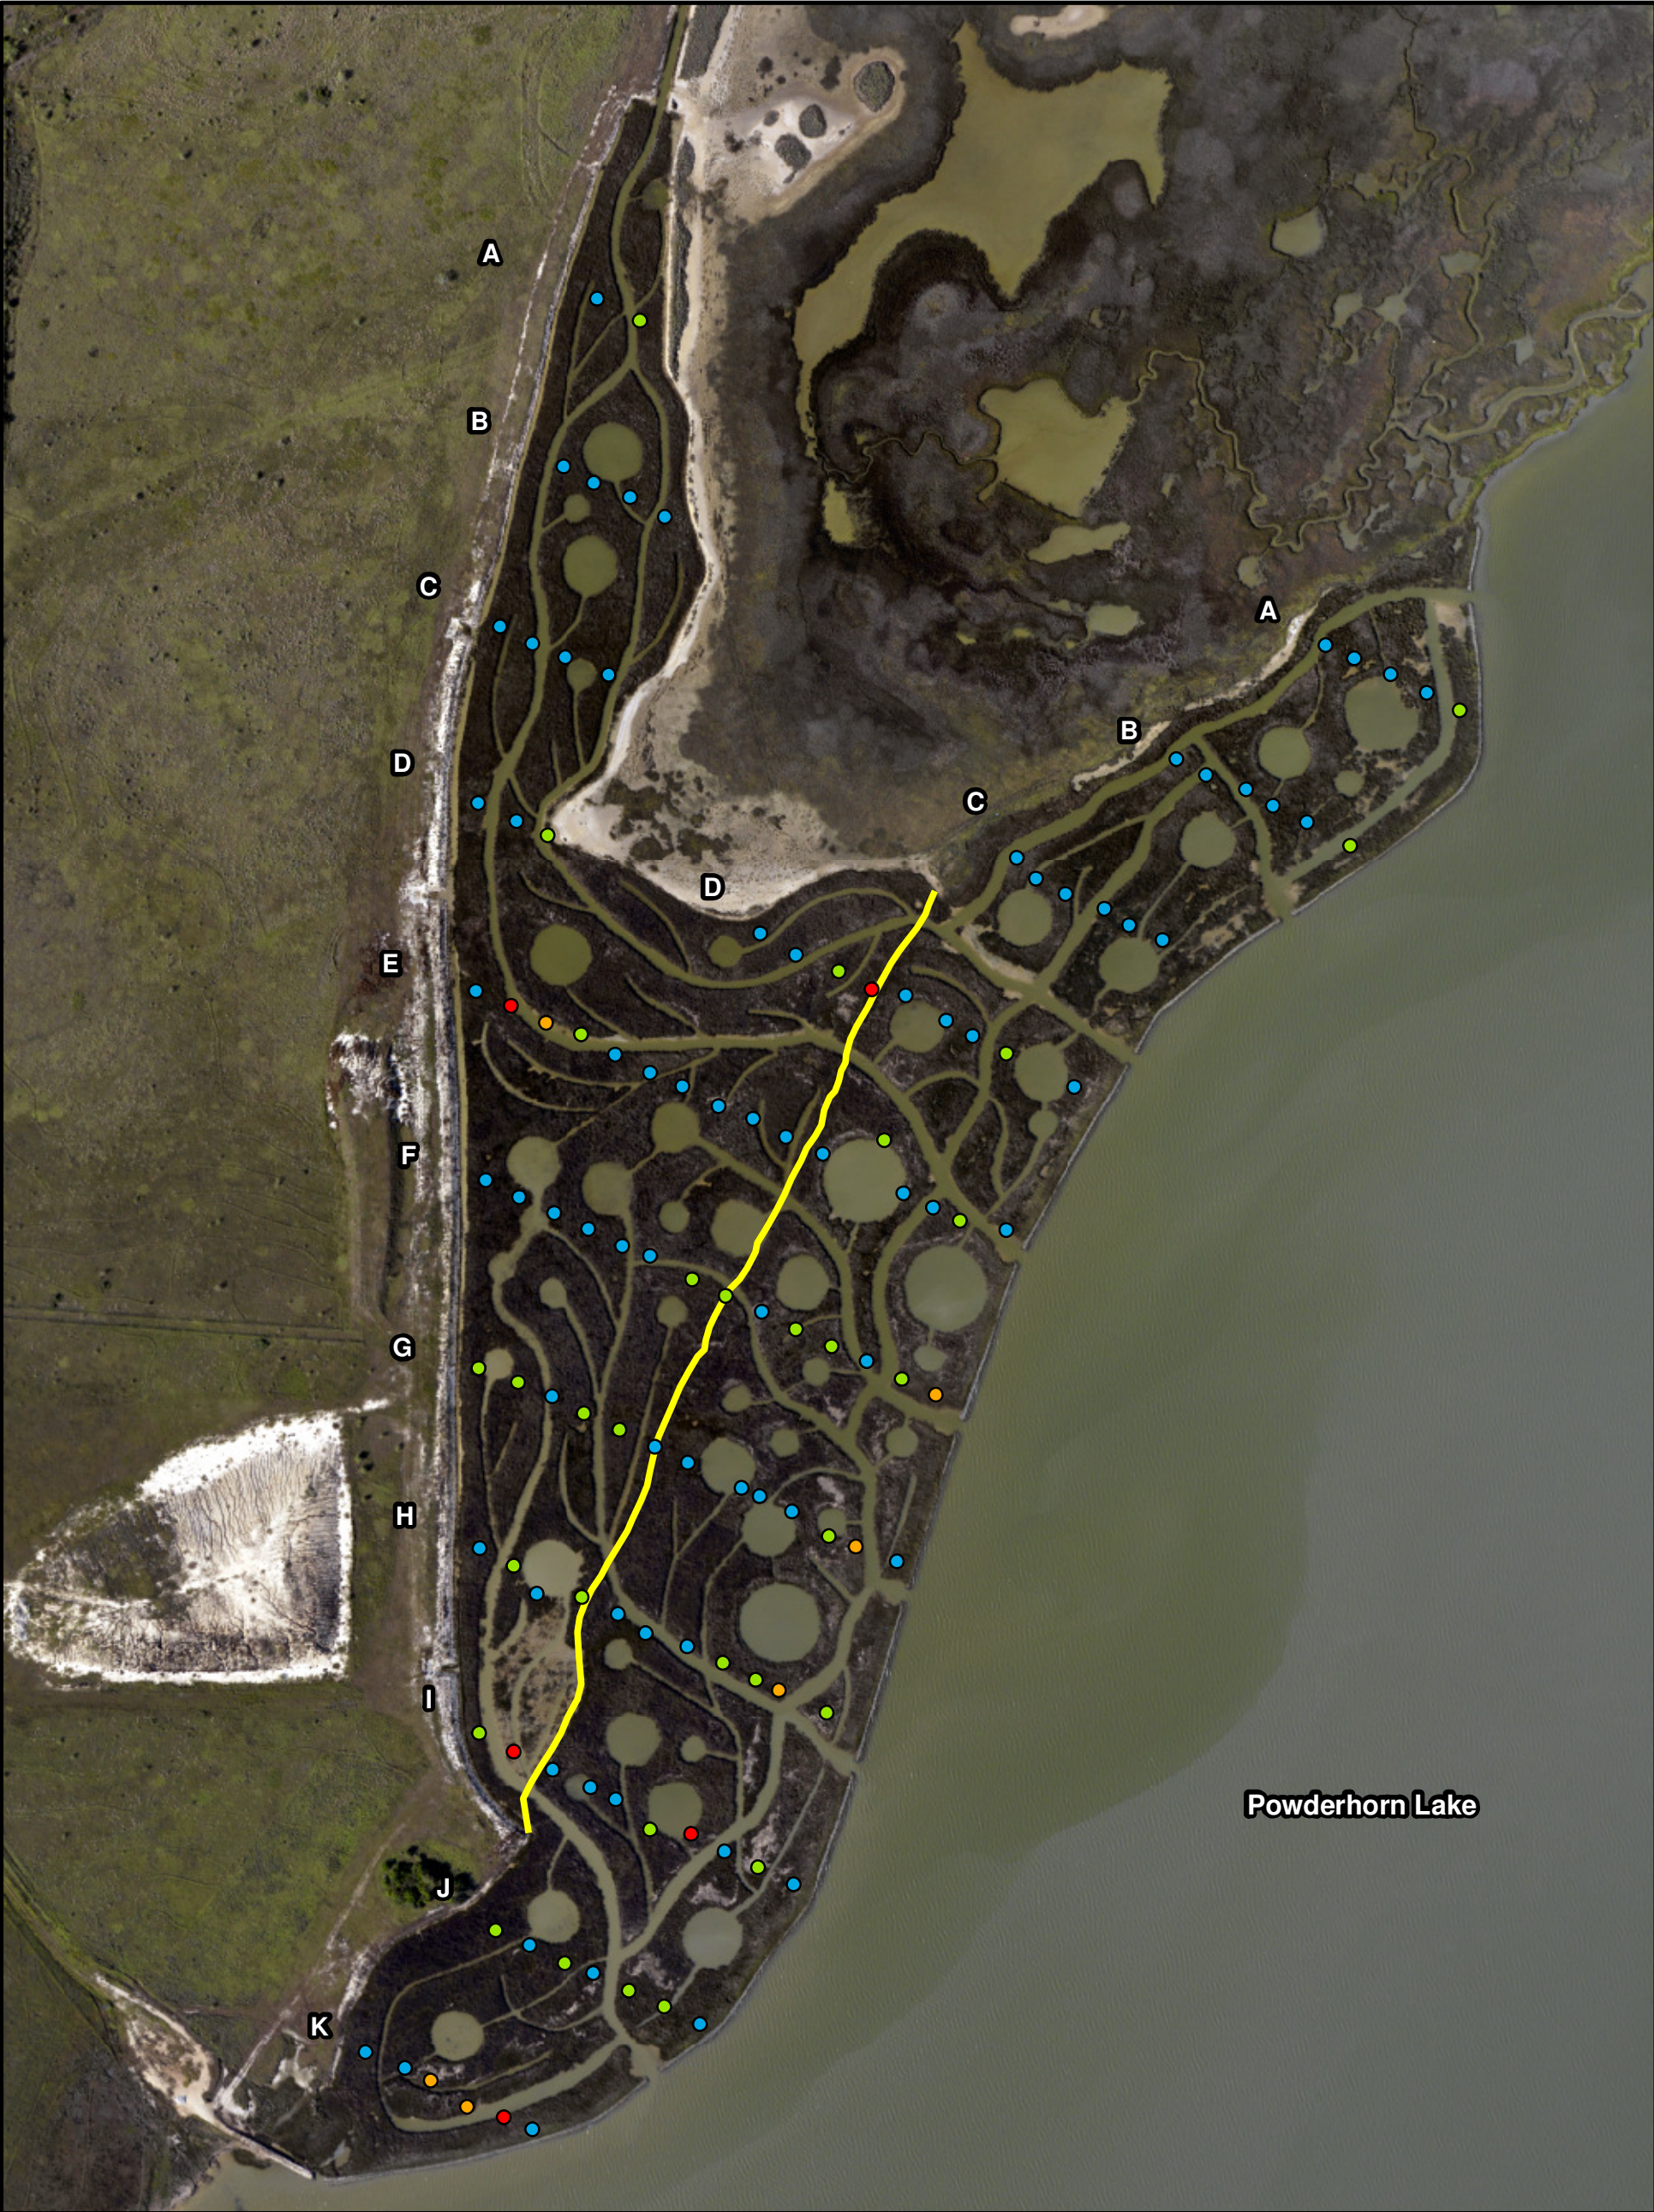
The percent foliar cover estimates developed for sample points on the marsh transects (Figure 3) were averaged to determine a percent foliar cover for the entire marsh. The average percent foliar cover for all of the Alcoa marsh was 85.5%. The average percent foliar cover for sample points within the Onshore Marsh was 85.2%. The average percent foliar cover for sample points within the Offshore Marsh was 85.7%. Foliar Cover estimates for the two marsh sections are presented in Tables 3 and 4.

Both the Onshore and Offshore marsh sections exceeded their respective Performance Criteria of 75% foliar cover.

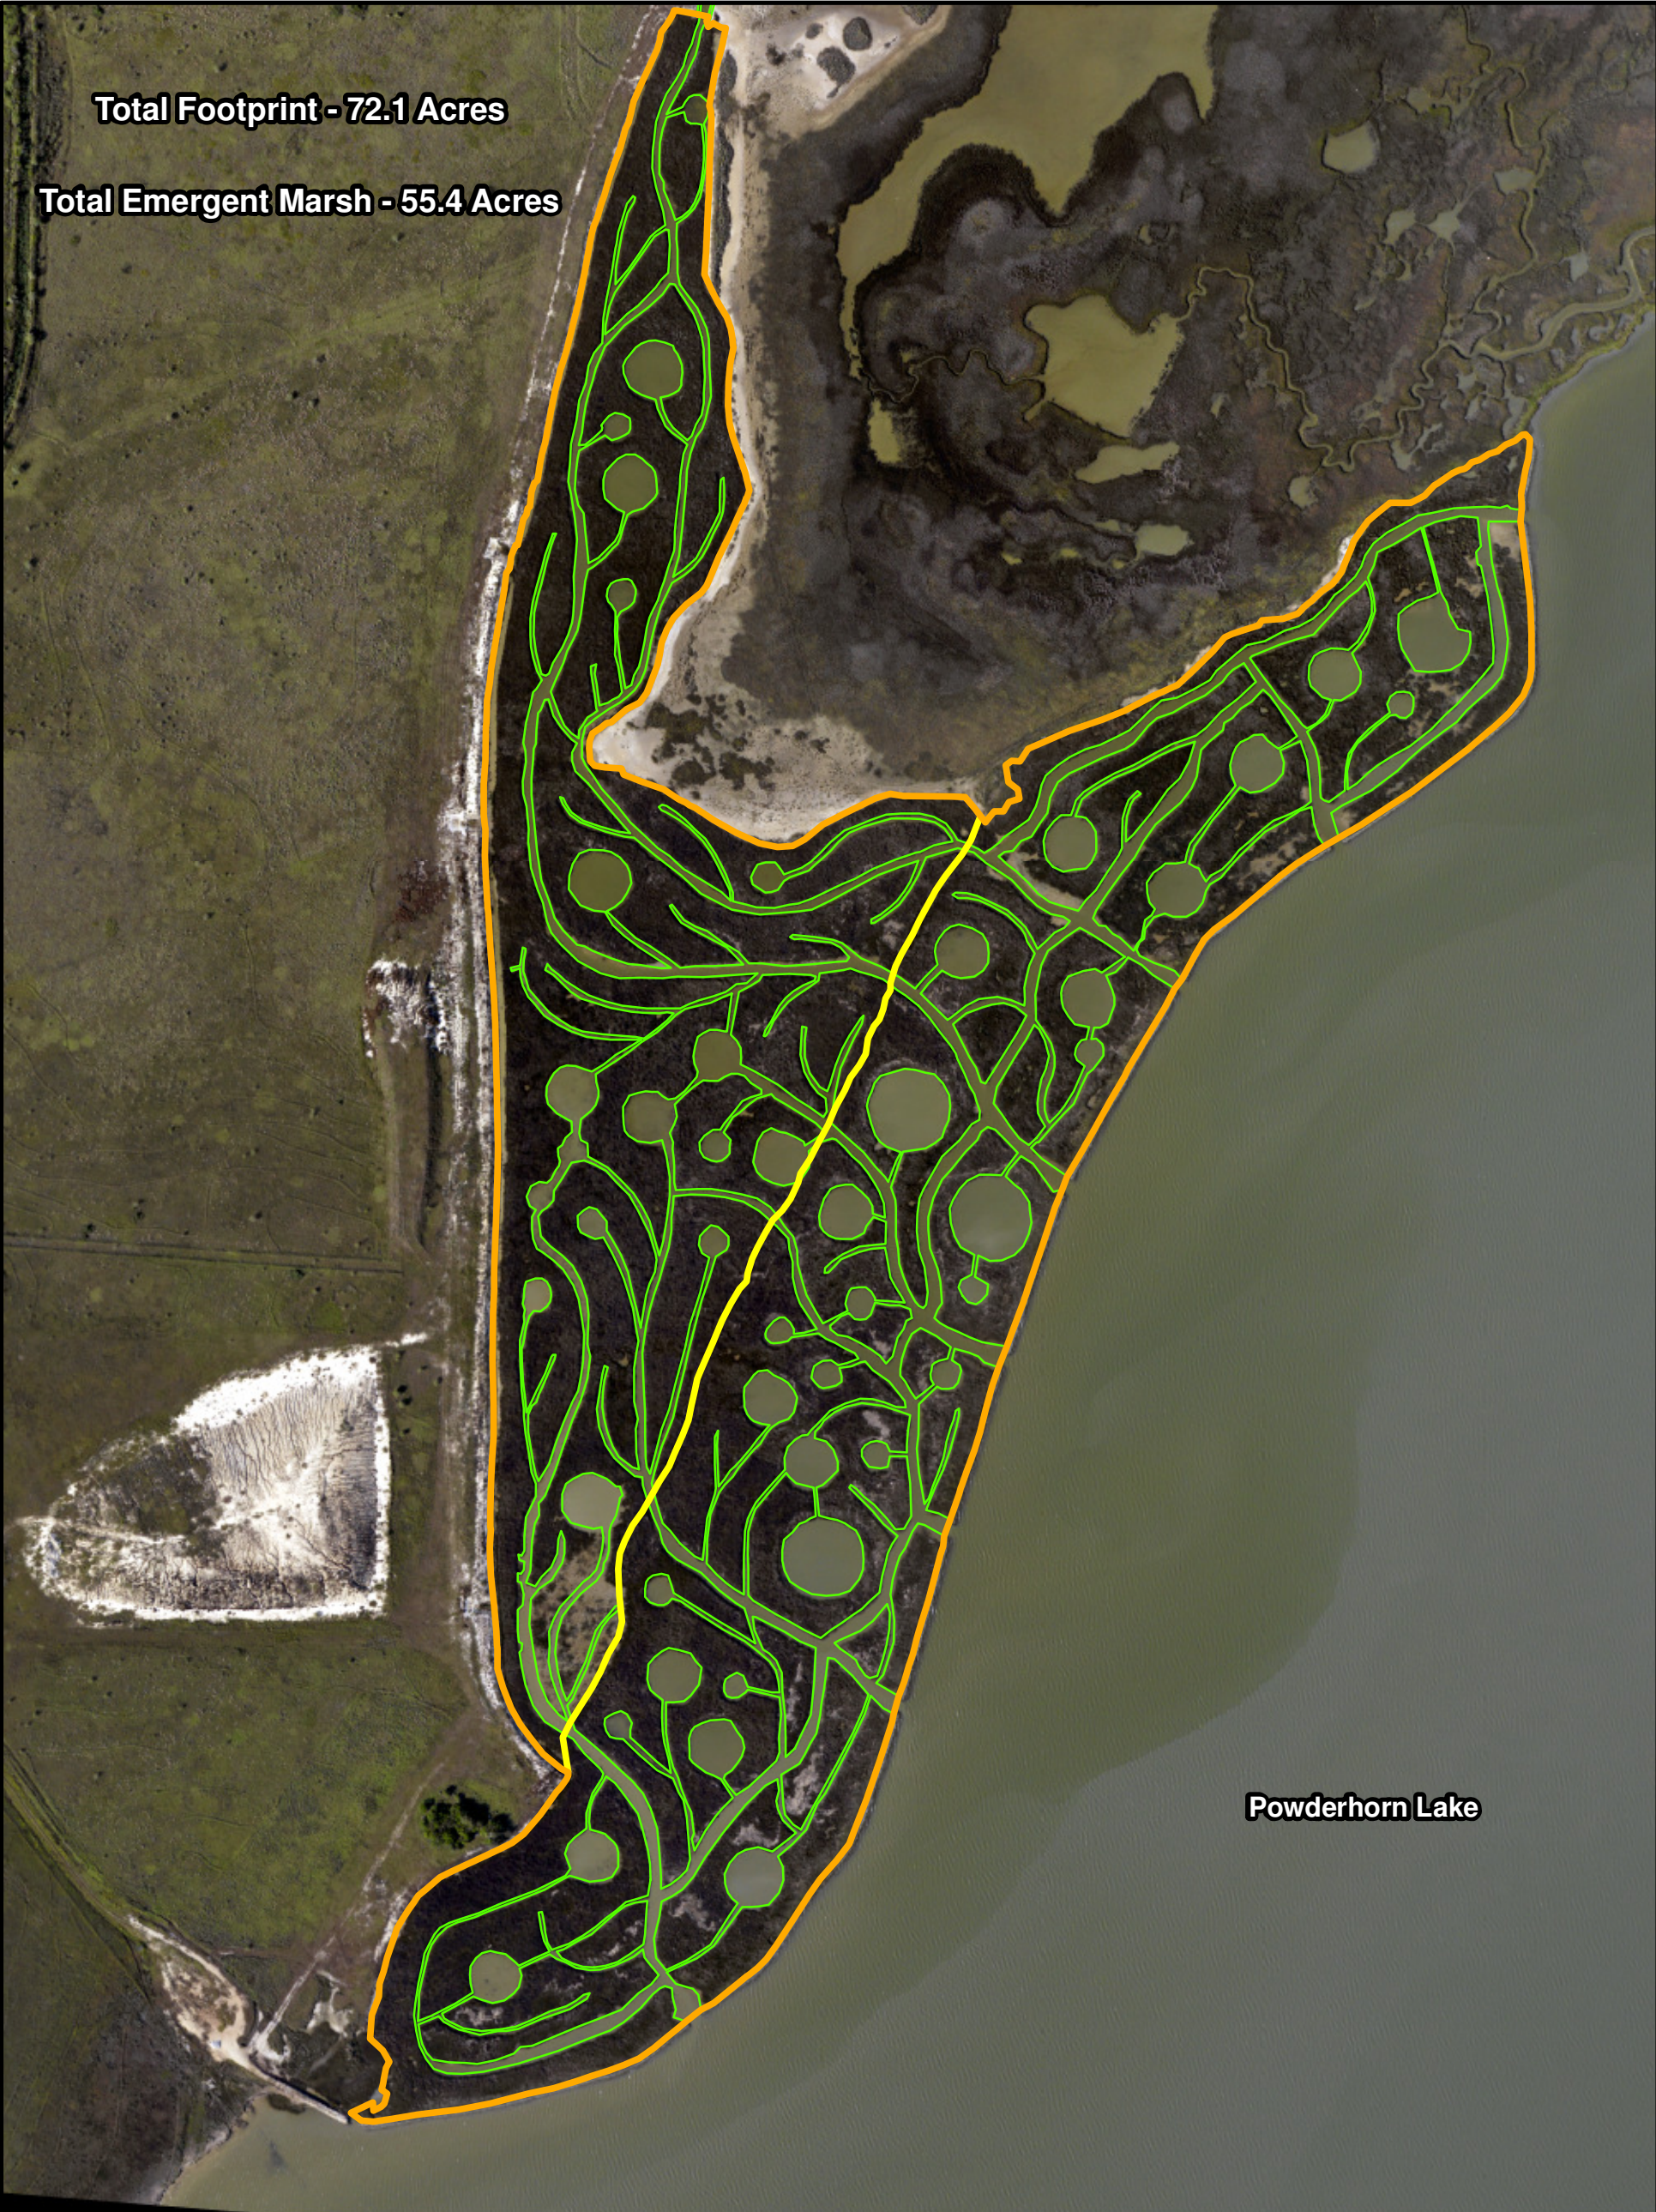
After carefully outlining the marsh perimeter, ponds and channels on the aerial photograph, it was determined that the entire marsh system, including ponds and channels, but excluding the breakwater and freshwater inflow channel, was 72.1 acres. Alcoa was required to construct 69.3 acres of intertidal saltmarsh. Most of the excess marsh (2.8 acres) was created by expansion of the original planting beds on the west side of the marsh into the channel excavated outside marsh perimeter to contain eroded soil. The “sacrificial channel” has filled with soil eroded from the adjacent uplands and is now covered with smooth cordgrass.

The portion of the marsh covered with emergent grass (excluding ponds and channels) was found to be 55.4 acres. Alcoa was required to construct no less than 45 acres of emergent grass beds between elevation +0.5 ft NGVD and +1.6 ft NGVD. These data show that Alcoa has exceeded the marsh acreage requirements specified in the MIP.
