# Interagency Aviation Accident Prevention Bulletin

No. IAAPB 16-04

Date: July 22, 2016

**Subject:** Premo MK III Plastic Sphere Dispenser (PSD) Machine Plexiglass Sphere Chute Cover Cracks

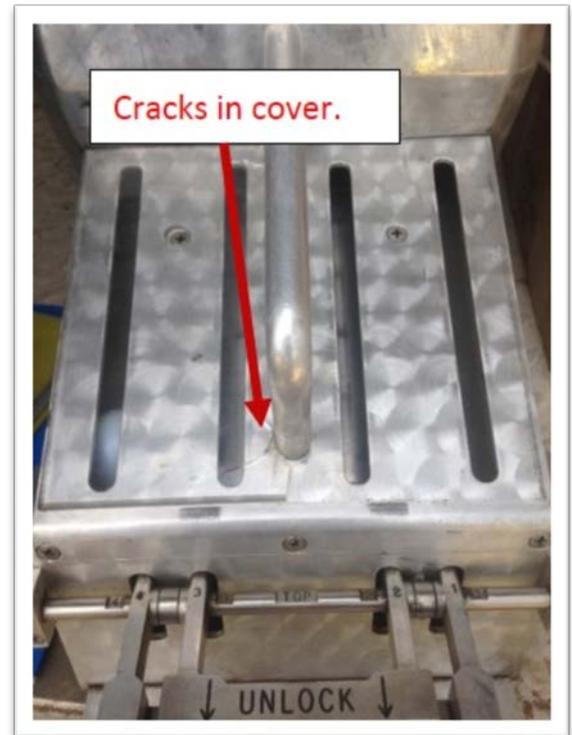
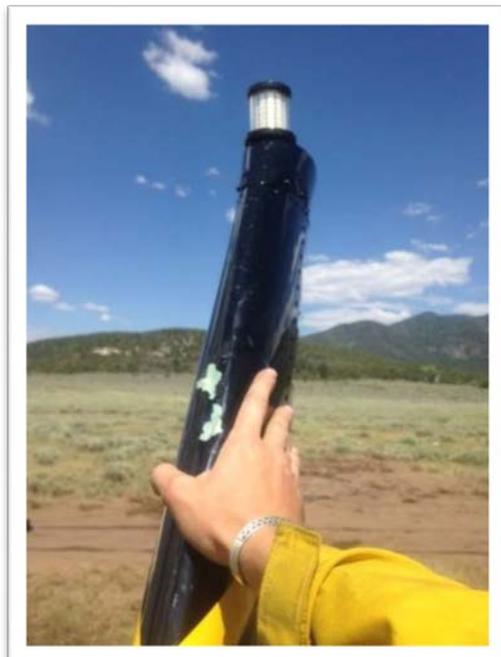
That afternoon while the helicopter was being washed, two dents were discovered on the vertical stabilizer fin six inches below the anti-collision light. They were approximately one inch wide and three inches in length with a depth ranging from 1/8 - 1/4 inch. It is believed that the sprayer used to wash the aircraft removed the paint chips that were covering the dents.

The mechanic conducted a visual and structural inspection and sent pictures to the contractor's Director of Maintenance. The Helicopter Manager informed the home unit Aviation Officer, Regional Helicopter Operations Specialist (HOS), and the DOI Maintenance Inspector of the damage to the aircraft. The mechanic received word from Director of Maintenance that the damage was beyond serviceable limits and the stabilizer fin required replacement.

It cannot be determined for sure that the piece of plexiglass that departed the aircraft on June 26 struck the tail fin and caused the damage that was discovered during the aircraft wash.

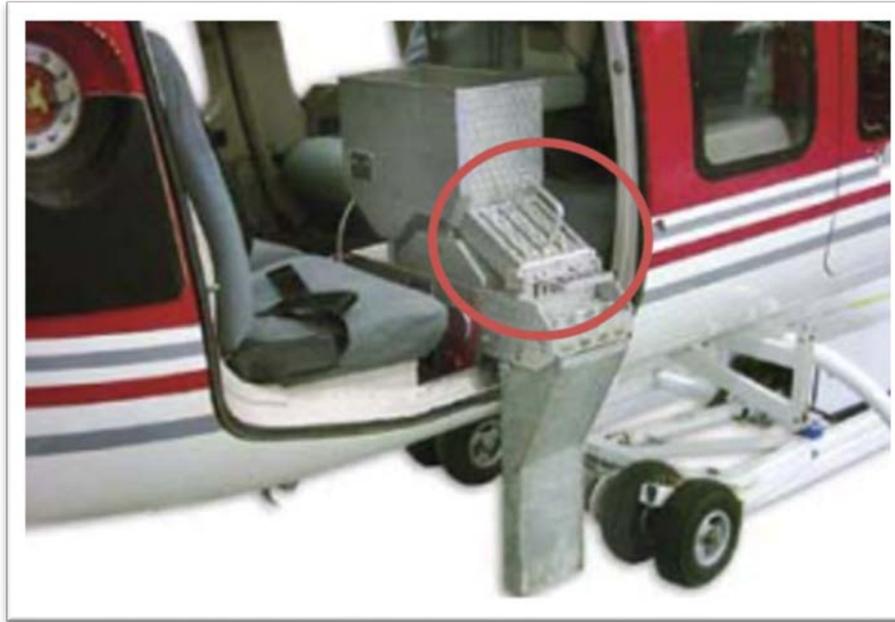
**Discussion:** On June 26, 2016 an AS350 B3 was returning to the helibase after completing PSD operations when a 3"x 5" piece of plexiglass that covers the sphere chute on the machine broke and flew off. The qualified Plastic Sphere Dispenser Operator (PLDO) was aware that the sphere dust cover was cracked prior to launching on the mission, yet he felt there was no threat since that crack had been present for many years. After landing, the crew performed a post flight inspection but failed to identify any aircraft damage.

The photo shows the Premo Mk III installed in a helicopter. The location of the chute plexiglass cover is indicated by the circle.

Several other sphere covers with cracks were later discovered by regional helicopter operations staff within the region where this occurred. If the sphere chute plexiglass cover has any cracks, take the PSD machine out of service until the cover is replaced. The replacement covers are available to order (approximately \$15) from:
