## Interagency Aviation Lessons Learned

No. IA LL 19-01 Date: August 20, 2019 Page 1 of 2

**Subject: The Importance of Preflight and Postflight Inspections**

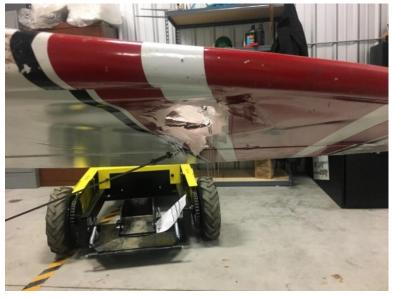
The landing at the airport was uneventful. Upon shutdown and postflight inspection of the aircraft on the ramp, the pilot observed a tennis ball size hole in the fabric of the left horizontal stabilizer and impact damage to the leading edge. The damage rendered the aircraft unairworthy.

By failing to conduct a thorough post or preflight inspection at the off-airport landing site, the pilot placed both himself and the biologist at risk by operating an unairworthy aircraft. Assuming the damage was present before takeoff, the pilot would not have been in compliance with 14 CFR 91.7 Civil Aircraft Airworthiness which states:

This accident highlighted an issue with the Department of Interior Manual (DM) wherein it states that the pilot must conduct an inspection of the aircraft at the start of the fly day and an inspection of the aircraft after the last flight of the day. Obviously this is not "best practice" and a change to the DM has been submitted.
