# Interagency Aviation TECH BULLETIN

IA TB 19-01

May 23, 2019

**Subject:** Aero Commander 690 Vertical Fin Attachment Bulkhead Cracks

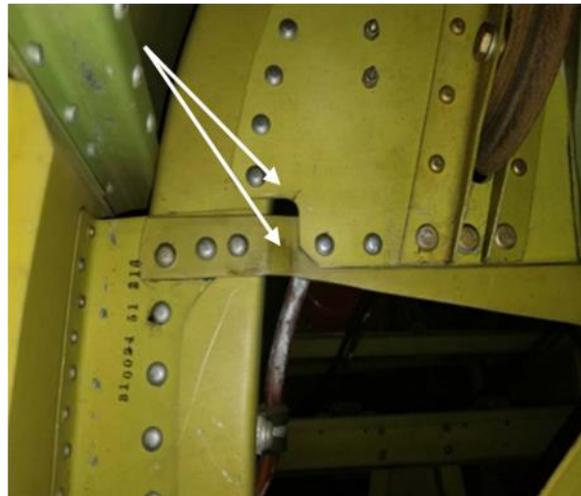
A Service Bulletin (SB 234) was written to address area cracking (shown in figures 1-4) but was never published. Operators are advised to pay particular attention to fuselage station 386.82 for cracking and the forward vertical attachment brace (90 degree Extrusion) hardware for loss of torque. During the subject inspection, the hardware for the vertical supports was “finger tight.”

Figure 1. Cracks in aircraft bulkhead.

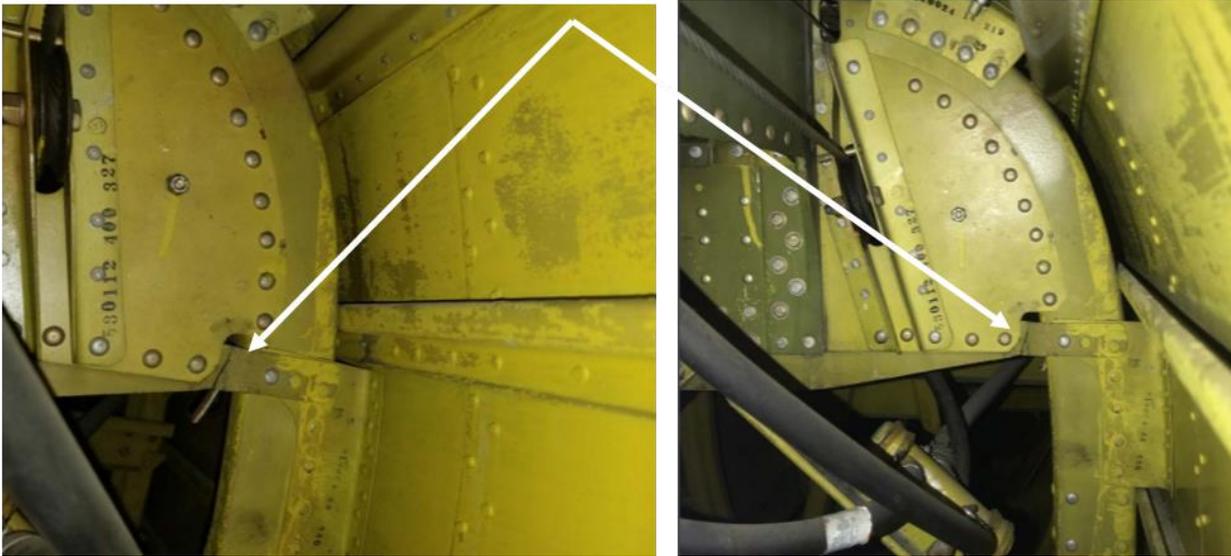
Figure 2 and 3. Cracks in aircraft bulkhead.

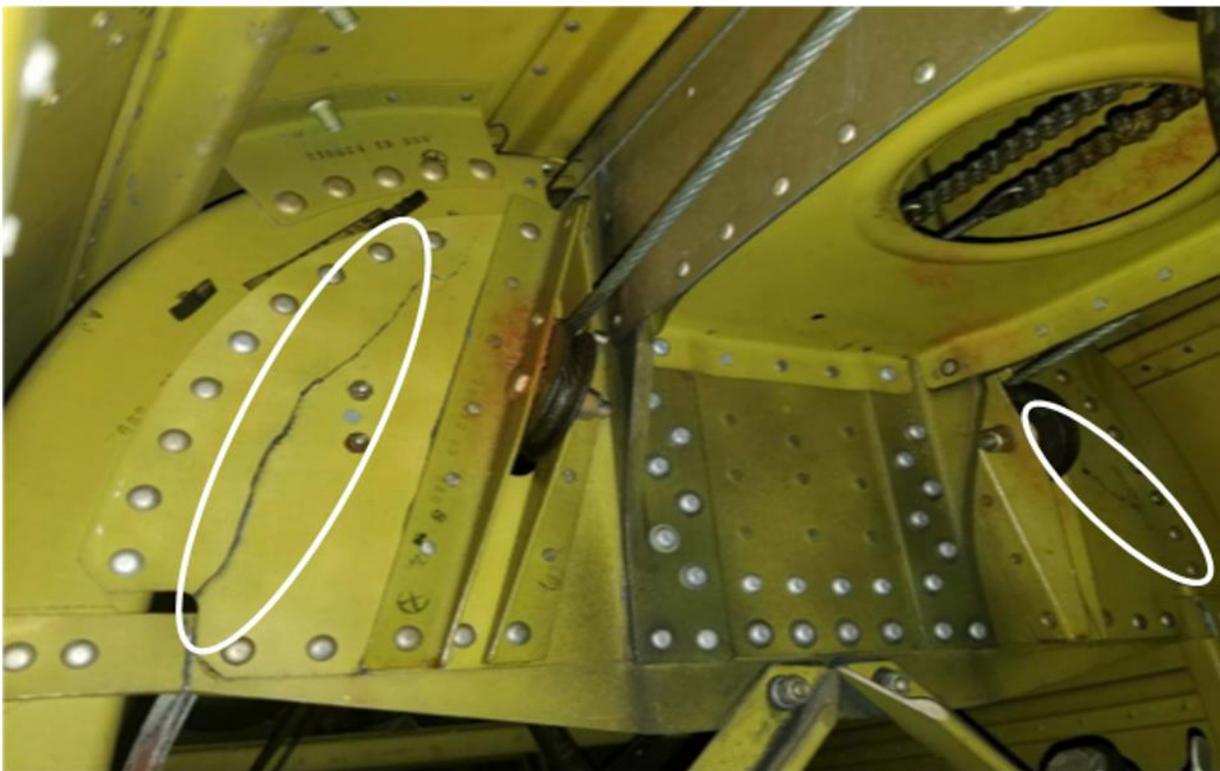
Figure 4. Cracks in aircraft bulkhead.

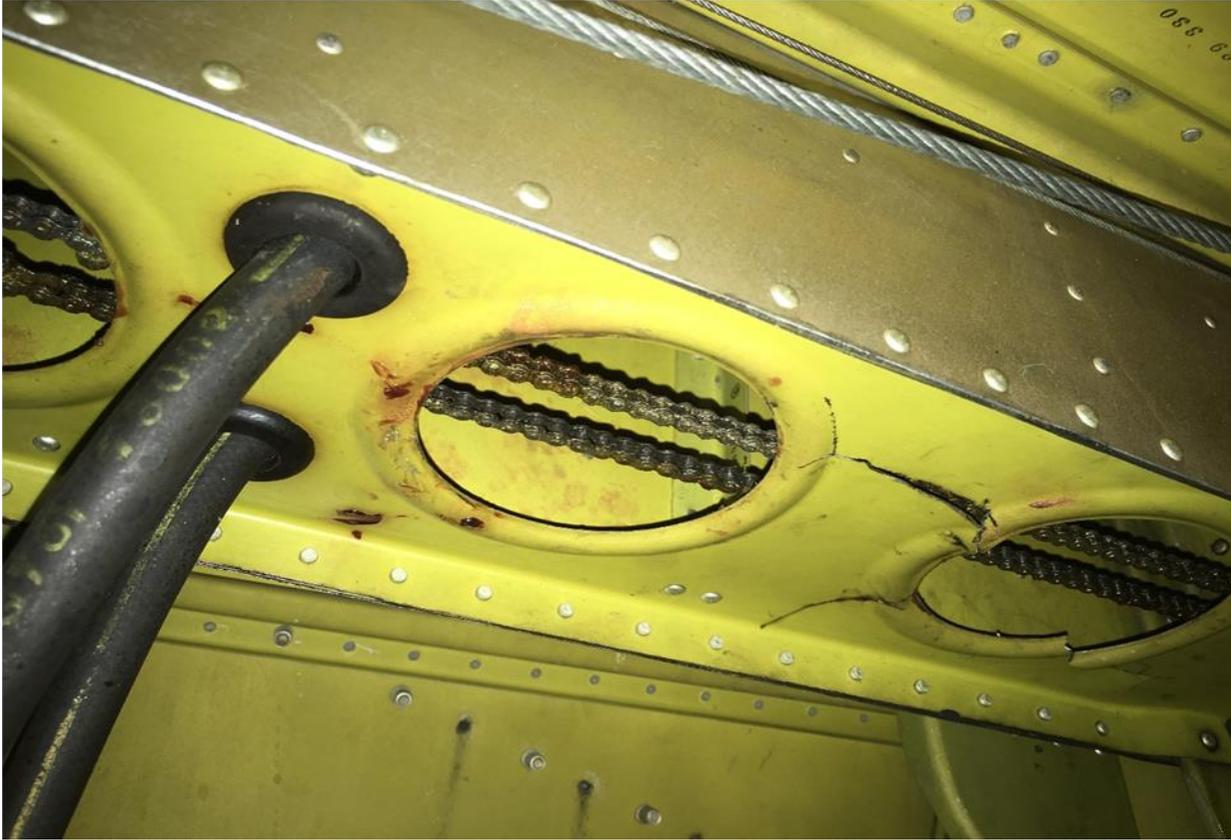
Figure 5: SB 218 includes an option to install a customer kit (CK175A) to improve the area shown here.

A Service Bulletin (SB 218) from the manufacturer for the area affected shown in Figure 5 (pg. 3) includes an option to install a customer kit (CK175A). This kit is applicable only to improve the area depicted in figure 5. Continued investigation shows areas shown in figures 1-5 are problem areas. The manufacturer has not released a SB addressing this issue.
