Department of the Interior Lessons Learned

DOI LL 19-01

Date: June 12, 2019

Subject: 3DR Solo Master Air Screw Propellers

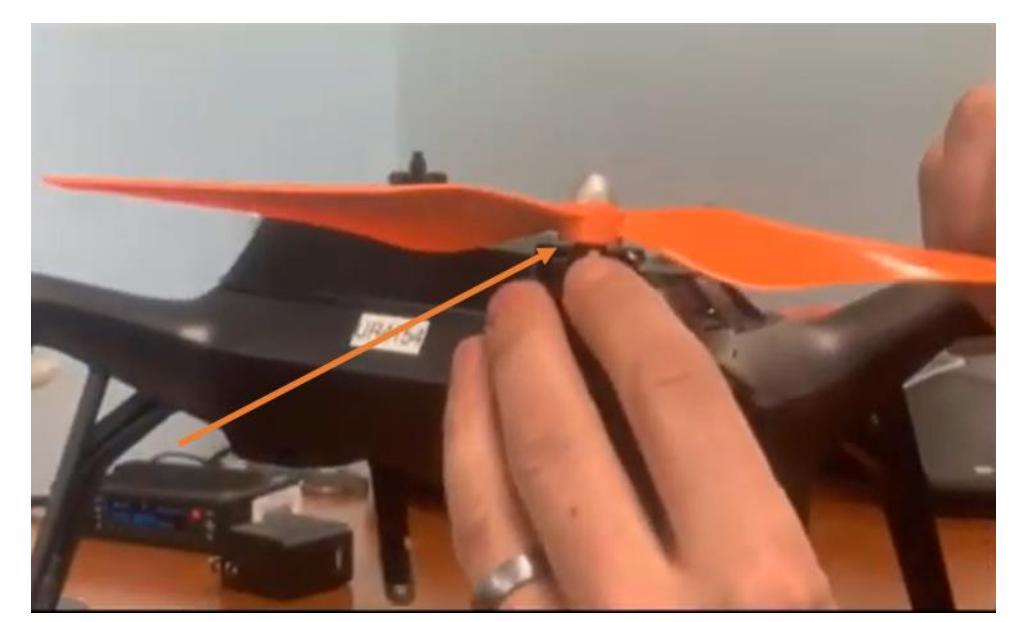
A more expansive review uncovered that the propellers were not tightened all the way to the top of the motor bell. This caused the propellers to backspin off the motor bell in turning maneuvers. Simply

After "spinning on" the propeller, there may be a noticeable gap between the propeller and the motor bell.
