Department of the Interior Lessons Learned

No. DOI LL 16-02

Subject: Aircraft Preflight and Post-Flight Responsibilities

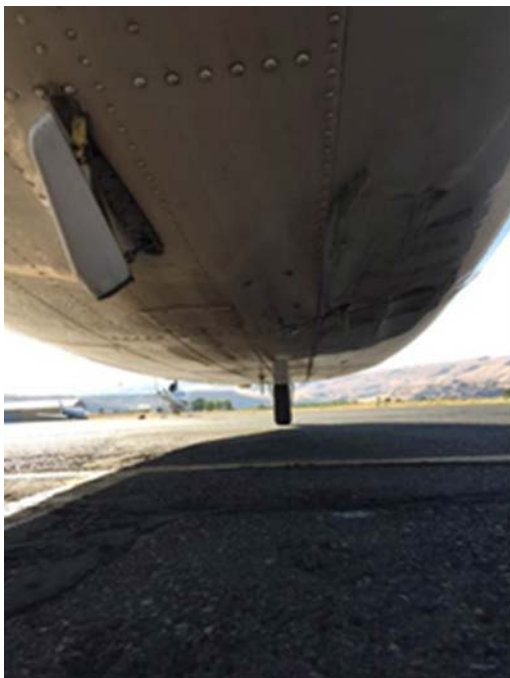
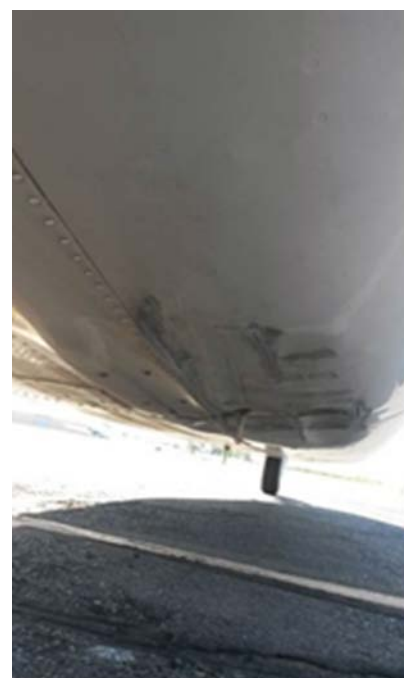
Discussion: Last year, the contract pilot of an Aero Commander inadvertently scrapped the bottom of the aircraft during takeoff for a wildland fire air attack / aerial supervision mission. The mishap occurred in response to a runway incursion by a construction truck working on the airport. Not realizing that the aircraft had been damaged, the aircrew elected to continue their mission and returned to base approximately 4.5 hours later. After landing, the pilot inspected the aircraft's wings and landing gear to see if any damage had occurred during the takeoff to which none was discovered.

Despite three post-flight inspections and two preflight inspections, the aircrew failed to discover the damage underneath the aircraft.

A relief pilot arrived two days after the mishap occurred and the damage was subsequently discovered during his preflight inspection. The NTSB determined the damage to be "substantial" under 49 CFR 830.2 and classified the event as an accident.

Lessons Learned. The Pilot-In-Command (PIC) is responsible for conducting a thorough pre and post-flight of the aircraft (351 DM 1.1E). FAR § 91.7 also states; “(a) No person may operate a civil aircraft unless it is in an airworthy condition. (b) The pilot in command of a civil aircraft is responsible for determining whether that aircraft is in condition for safe flight. The pilot in command shall discontinue the flight when unairworthy mechanical, electrical, or structural conditions occur.”

Had either a proper post-flight inspection or a preflight inspection been conducted, the damage to the aircraft would have been discovered. Unfortunately, in this instance, the aircrew was operating an unairworthy aircraft – a significant risk to which none of them were aware.

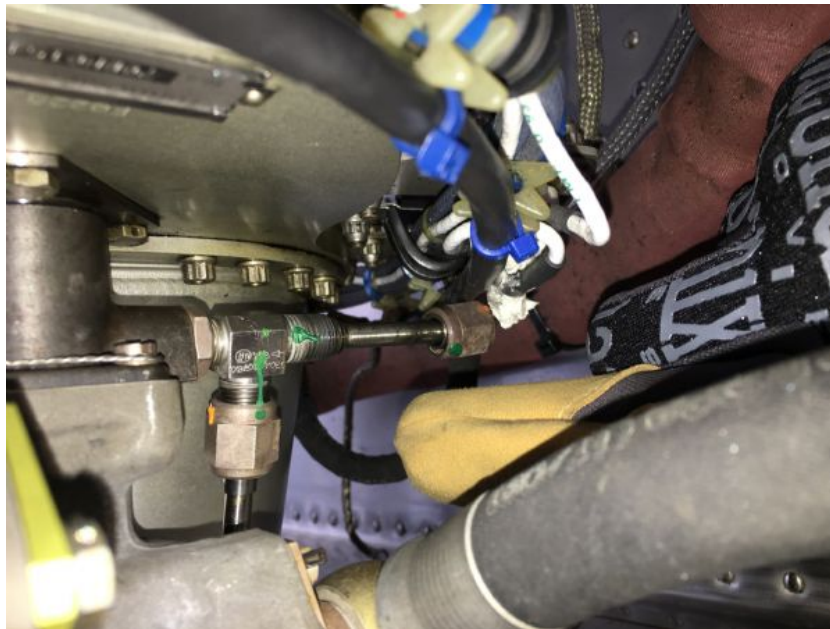
The pilot arrived in the morning and began a normal preflight of the helicopter beginning with the left side. When he opened the engine compartment, he began looking over the hydro-mechanical unit (HMU) and B-nuts to determine if the torque stripes all matched to ensure those connections were not compromised. He quickly noticed that one B-nut was completely off the threads and was dangling on the fuel line.

He informed the fleet manager who then had the mechanics check all of the B-nuts for the fuel system connecting to the engine and the HMU. This is a great example of how attention to detail during a routine inspection can prevent your flight from becoming non-routine.
