**BOUCHARD BARGE NO. 120 OIL SPILL  
BUZZARDS BAY, MASSACHUSETTS**

**PRE-ASSESSMENT DATA REPORT**

**June 7, 2005**

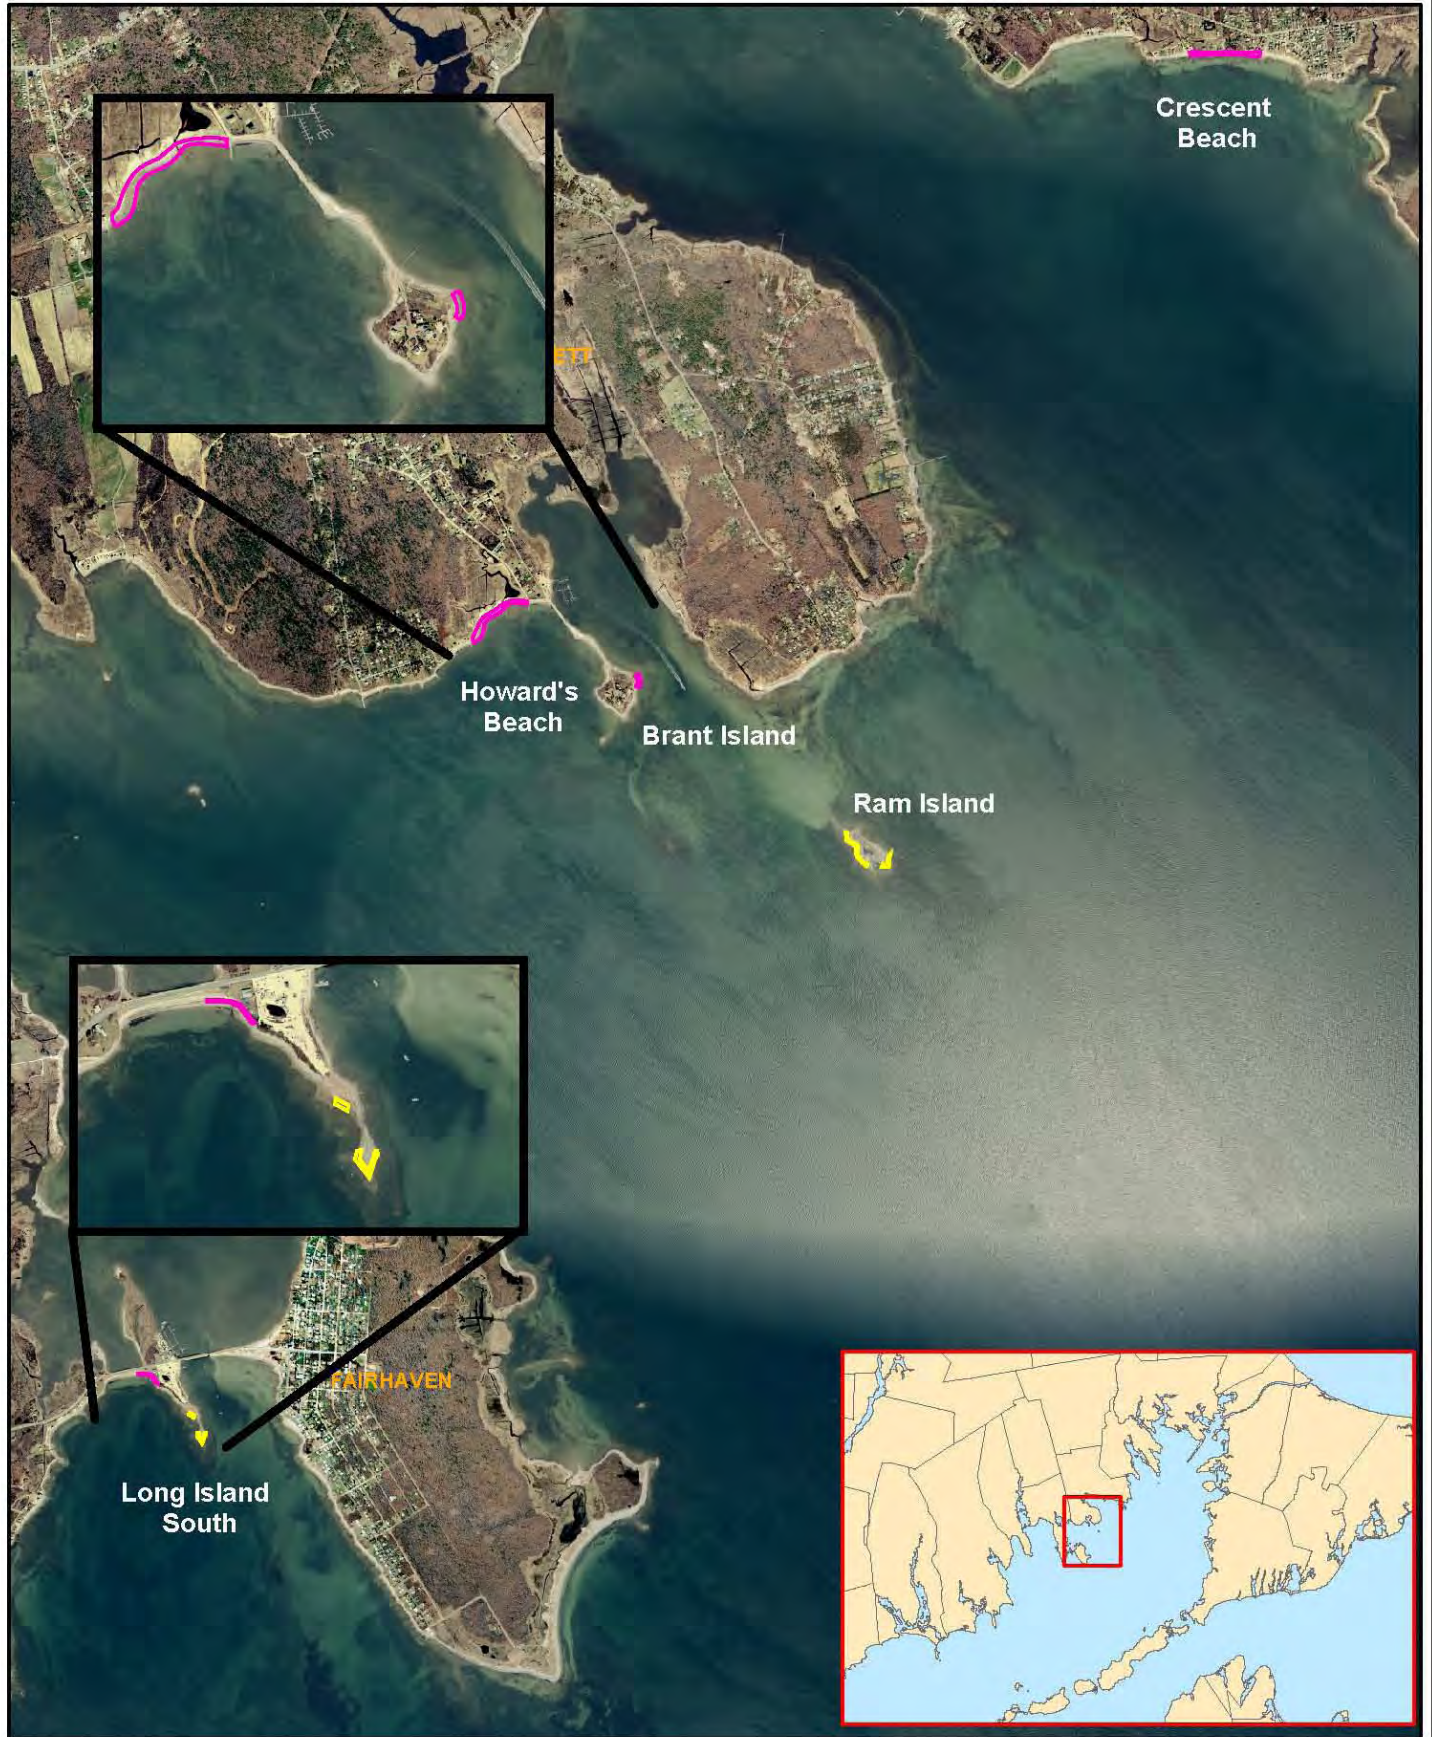
Figure 2-5  
Sediment Excavation/Replacement  
and Replant Locations  
Bouchard B No. 120 Oil Spill  
Buzzards Bay, MA

In a few heavily oiled areas, the methods discussed above were not sufficient to achieve the clean-up goal. Therefore, oiled substrate was mechanically removed with heavy equipment and replaced with natural materials of similar shape, color and size distribution. This technique was applied in areas of cobble beach where oil coated the majority of the exposed cobble surface and oil mixed with sand in the interstitial space to form hardened asphalt-like deposits. Sediment replacement was conducted at the southwest side of Long Island Point (~0.67 acres), Howard's Beach/Leisure Shores (~0.062 acres), Brandt Island (~0.33 acres) and Crescent Beach (~0.21 acres). Figure 2-5 depicts locations where sediment removal and replacement was conducted. Prior to initiating work, emergency authorizations/permits were obtained from the U.S. Army Corps of Engineers, MADEP and the local conservation commissions. At each site, pre-construction and post-construction elevation surveys were conducted to ensure that the beaches were graded appropriately. All work was performed under the supervision of the Unified Command.

Emergency restoration was conducted in a few areas of fringing salt marsh where oil deposits had hardened or where foot traffic by response personnel inhibited regrowth of *Spartina alterniflora* (smooth cordgrass). In most of these locations, the marsh surface was characterized by dense, vegetative root mat rather than loose sediments. Oil deposits up to several inches thick were manually removed from the marsh surface by scraping and/or raking using hand tools. The top layer of root mat, including the aboveground portion of the vegetation, was removed in the process of removing the hardened oil deposit. Native vegetation was replanted in these areas using bare-root seedlings of *Spartina alterniflora* obtained from a local nursery. Emergency restoration of marsh vegetation was performed at the southern tip of Long Island in Fairhaven (July 26 through 27, 2003) and at Ram Island in Mattapoisett (July 12 through 13, 2003) to supplement natural recovery/recolonization and to reduce the potential for erosion and habitat loss. Figure 2-5 depicts locations where revegetation was conducted.

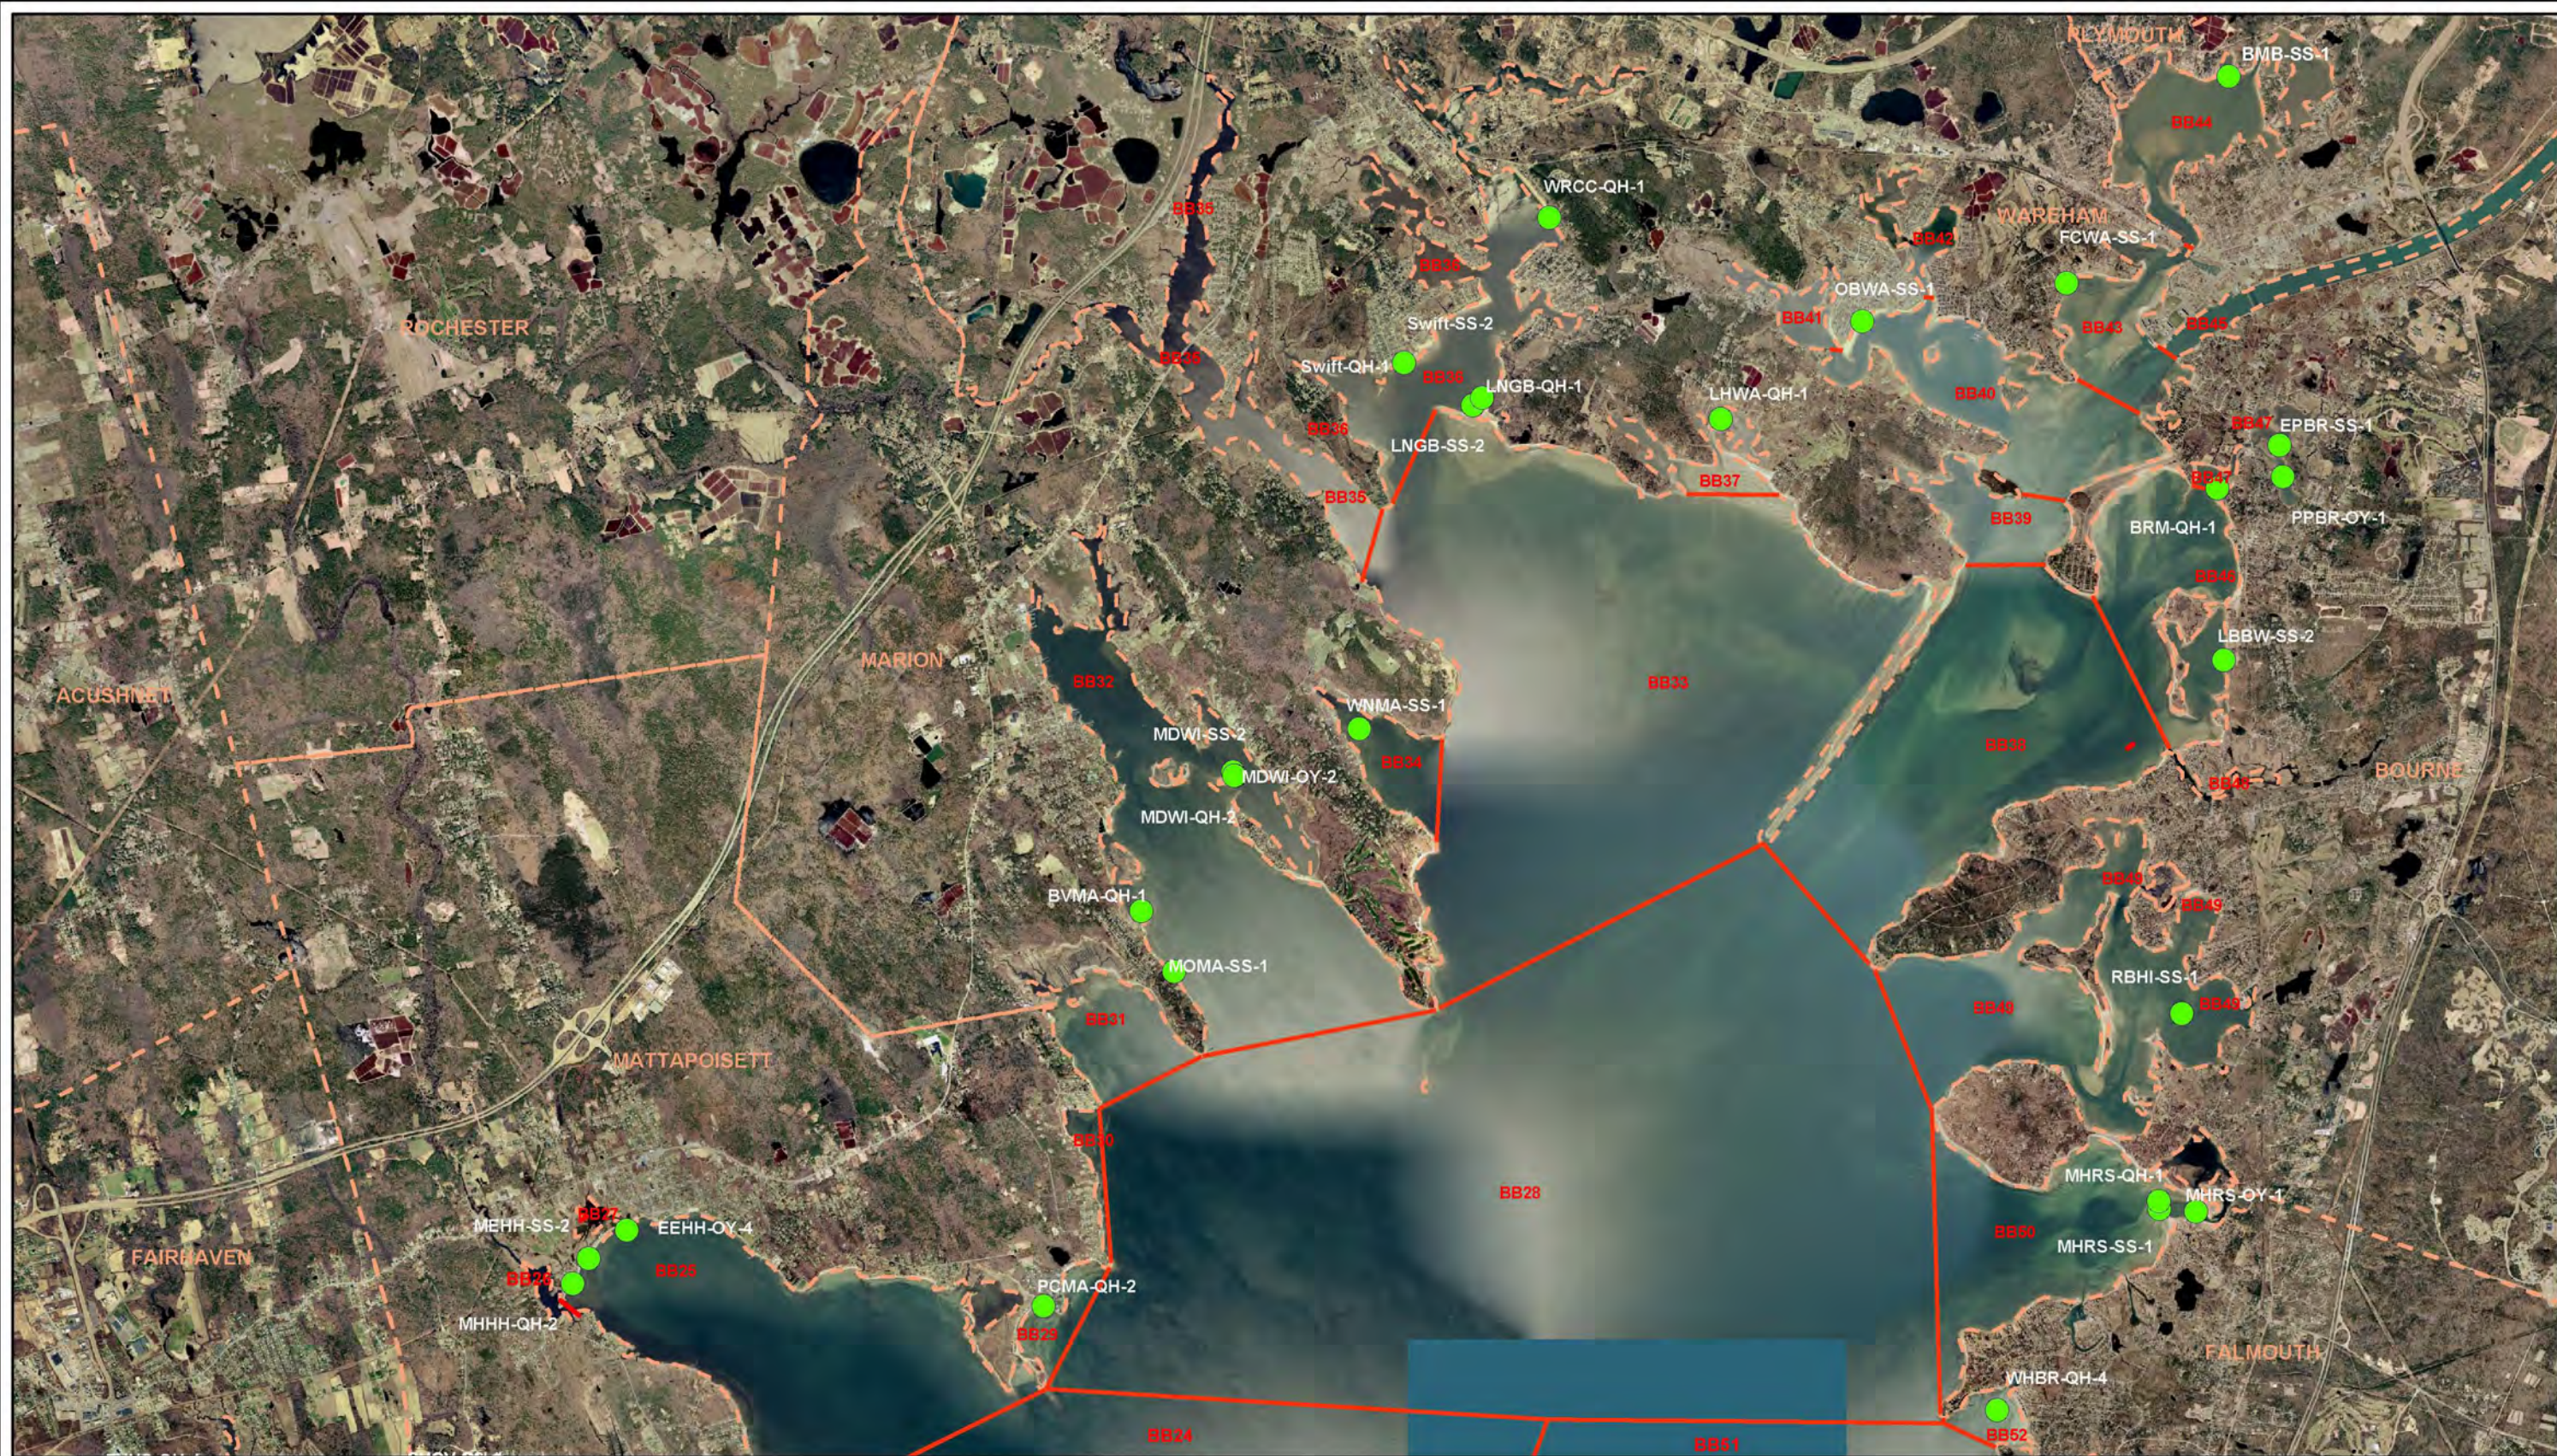
**Figure 2-8**  
**Shellfish Sampling Locations**  
**Bouchard B No. 120 Oil Spill**  
**Buzzards Bay, MA**

Total PAH concentrations measured in the shellfish tissue samples are summarized in Tables 2-3 through 2-8 by target species. Concentrations are shown in parts per billion (ppb). Shaded areas of the tables indicate that no sample was collected. Sample locations are depicted in Figures 2-8 through 2-11.

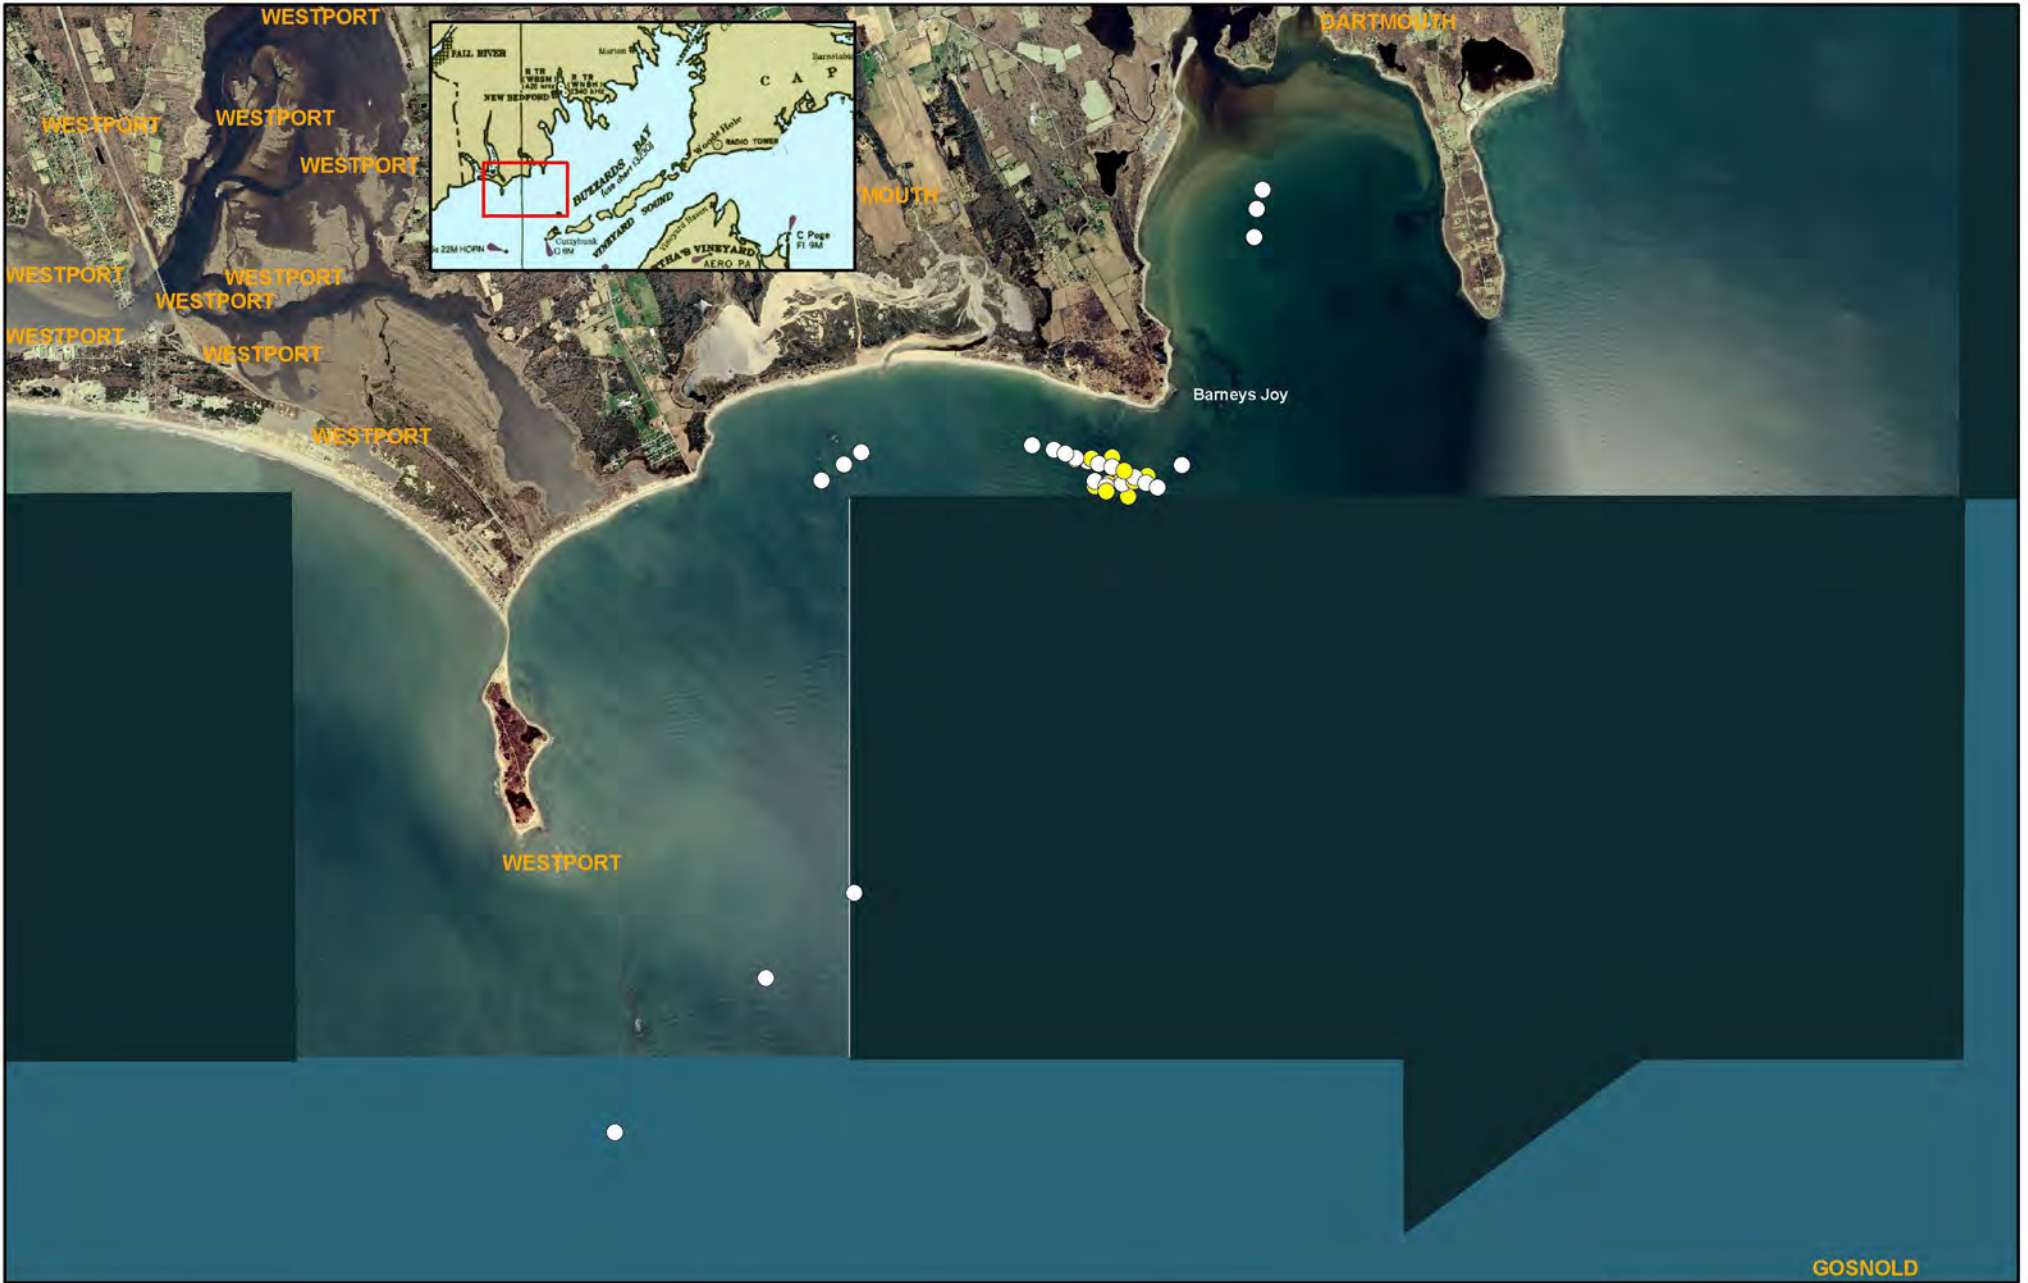
Figure 2-12  
 Lobster Pot Snare  
 Survey Locations  
 Bouchard No. 120 Oil Spill  
 Buzzards Bay, MA

Lobster pots containing snare were submerged at each survey location (Figures 2-12 and 2-13). After two to nine days, the traps were recovered and examined for the presence of oil on the pots, snare and buoys. A total of 55 pots were deployed and retrieved between May 30 and June 13, 2003. The lobster pot assessments found little to no submerged oil. Some light staining was observed on the lobster pot snare in the vicinity of Barneys Joy Point (Figure 2-14). Results of the lobster pot snare surveys are summarized in Table 2-9.

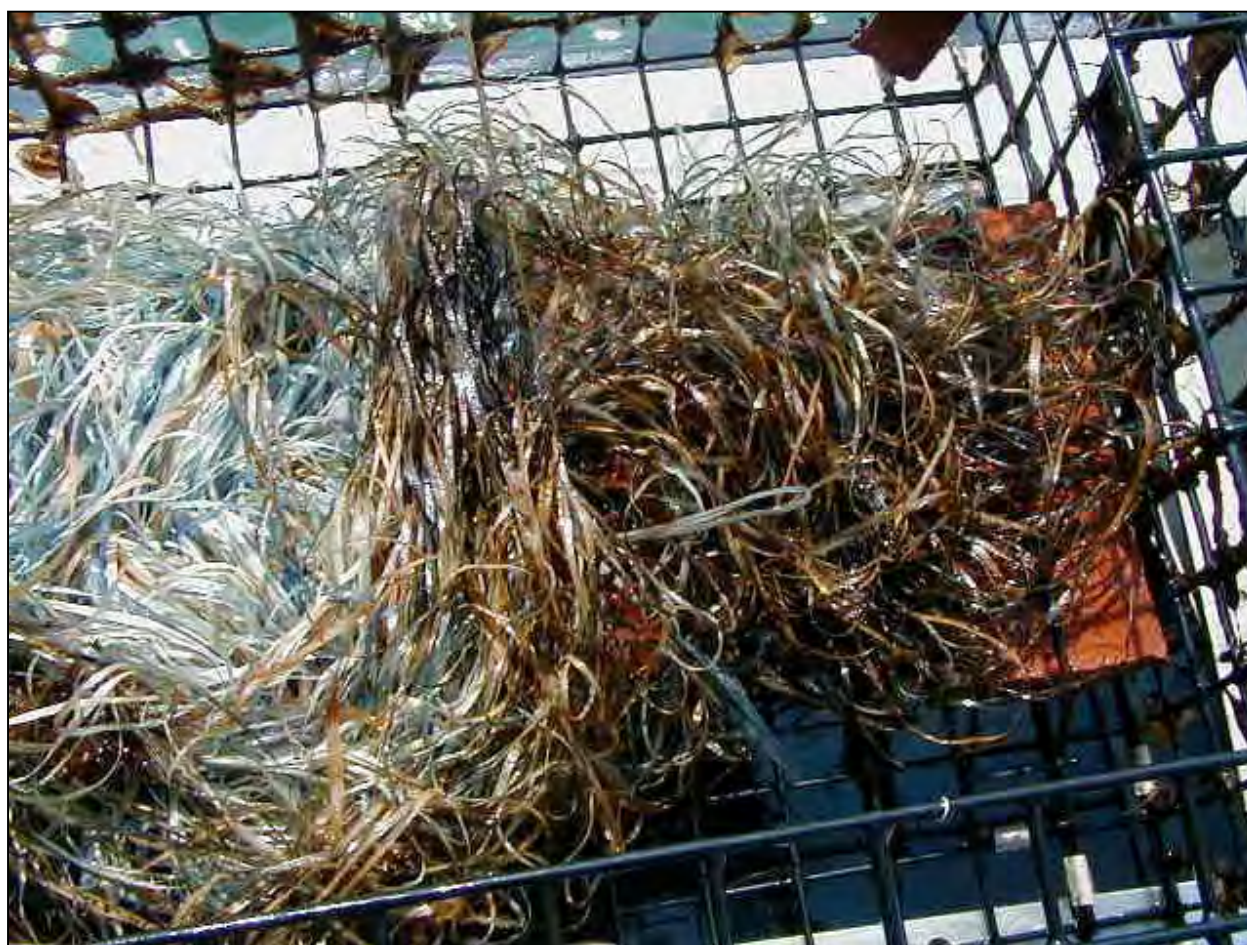
**Figure 2-14. Example of Oiled Lobster Pot Snare**

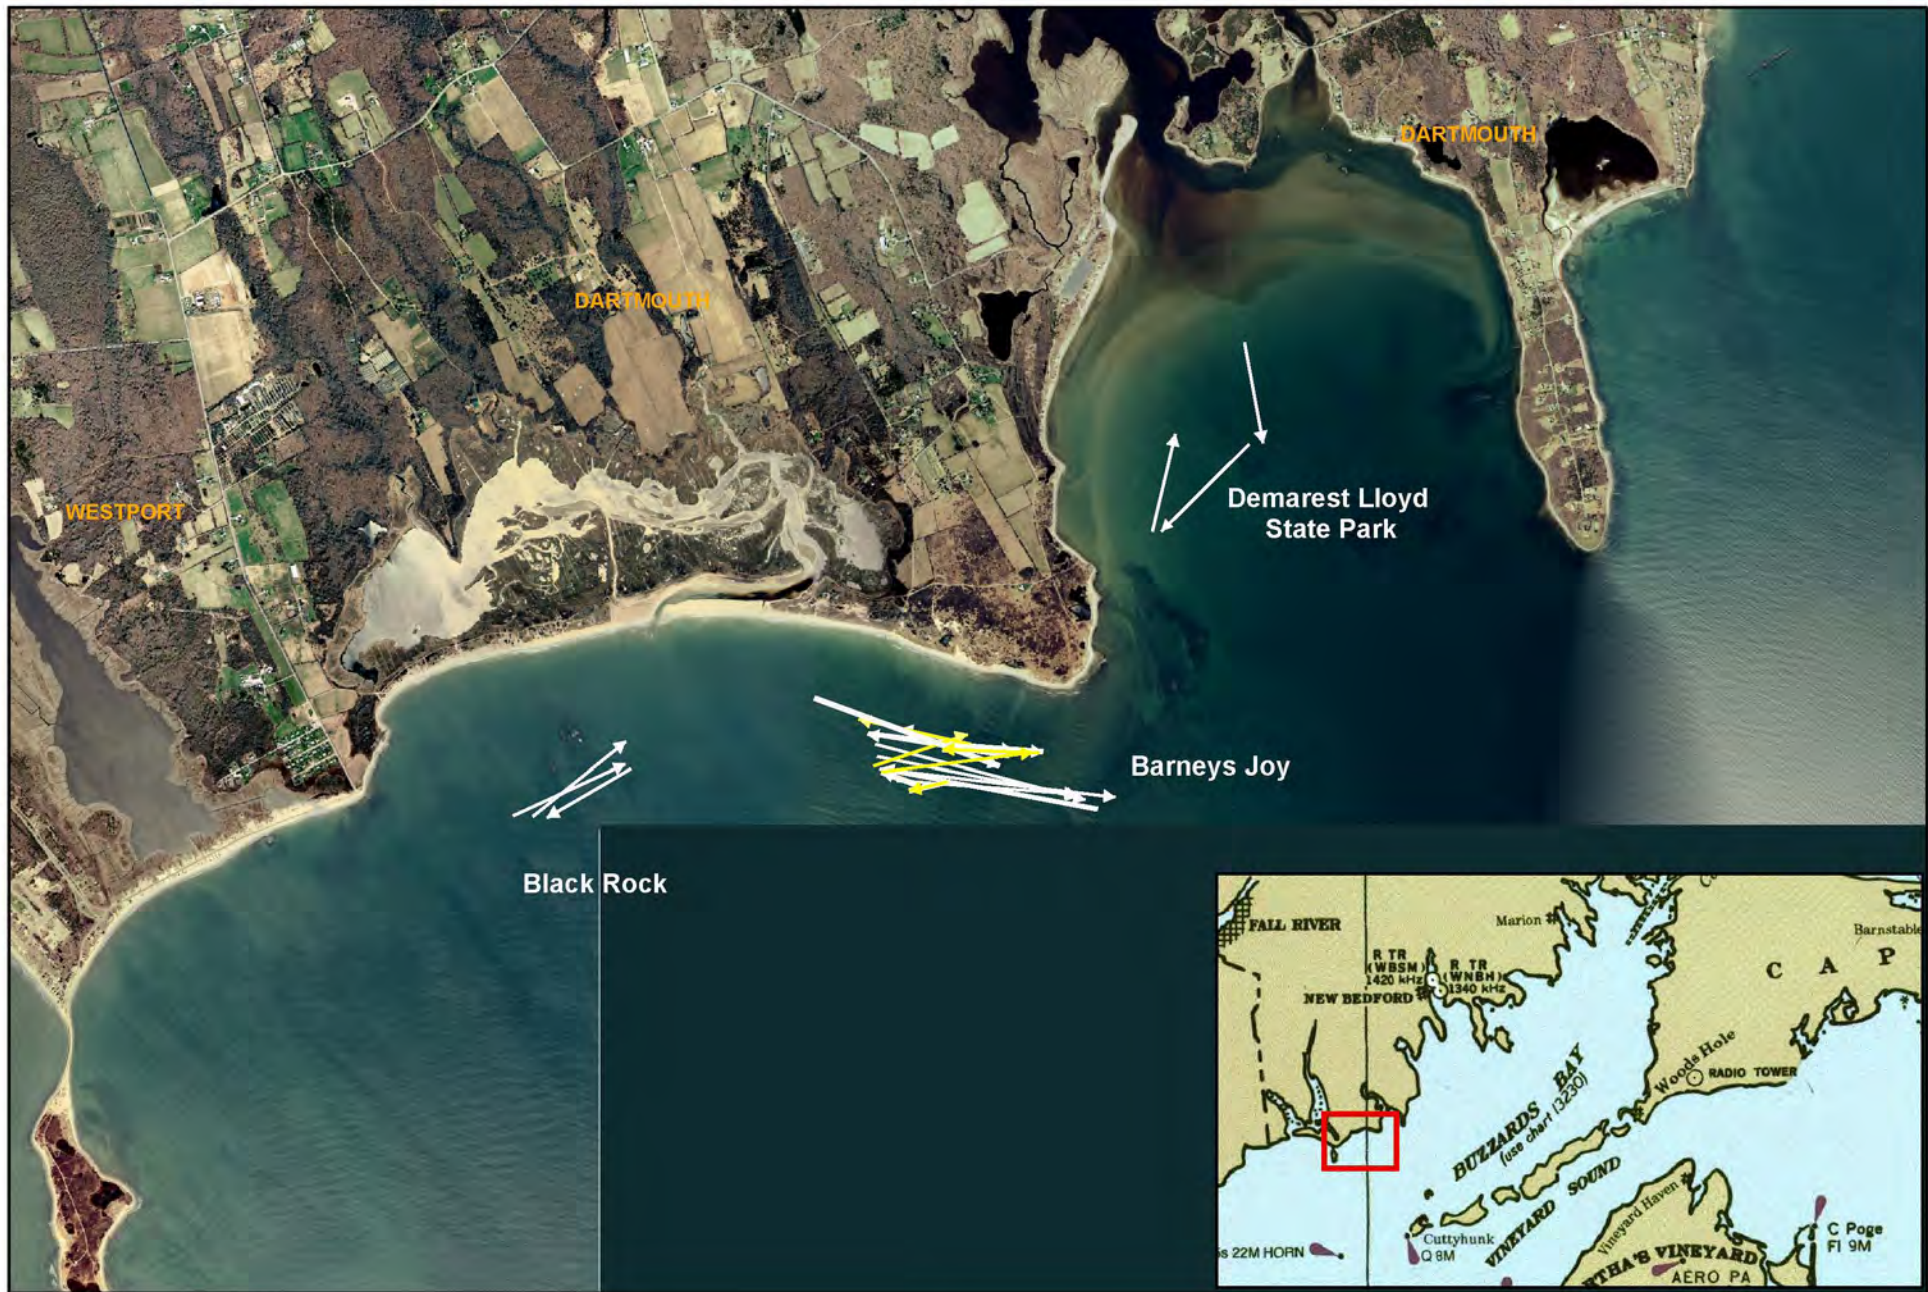
Figure 2-15  
Chain Drag Survey Locations  
Bouchard No. 120 Oil Spill  
Buzzards Bay, MA

Chains rigged with snare and weights were pulled along the seabed offshore of identified beaches (Figures 2-15 and 2-16). Three or more tows, approximately 100 meters in length each, were conducted at each site. Following each drag, the chain and snare were examined for the presence of oil. Thirty chain drags were conducted between May 30 and June 13, 2003. Little to no oil was observed during the surveys. Some light oil was observed on five of the 17 chain drags near Barneys Joy Point during the first few surveys. Figure 2-17 illustrates evidence of oiled chain drag equipment. Results of the chain drag assessments are summarized in Table 2-10.

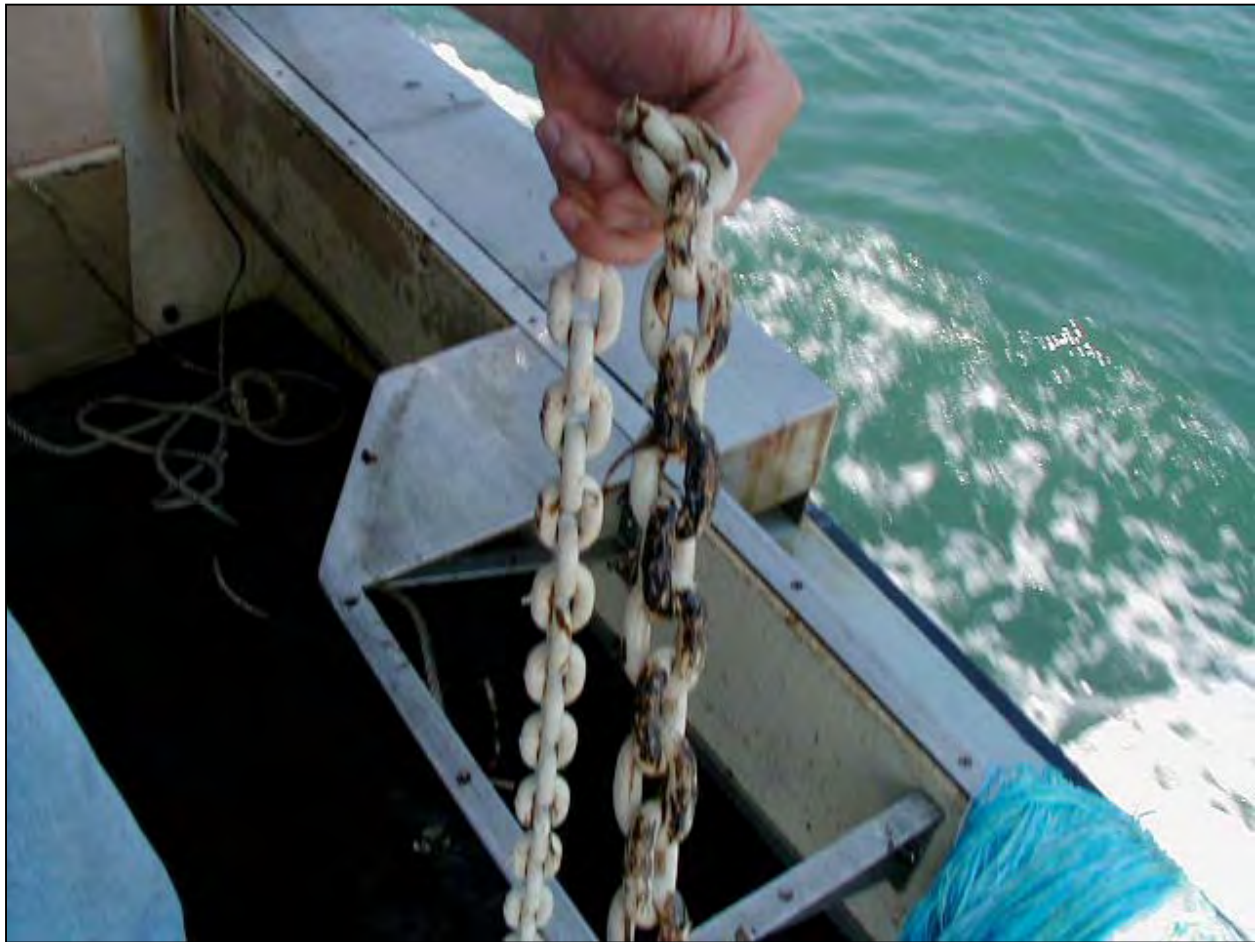
**Figure 2-17. Oiled Chain Drag Equipment**

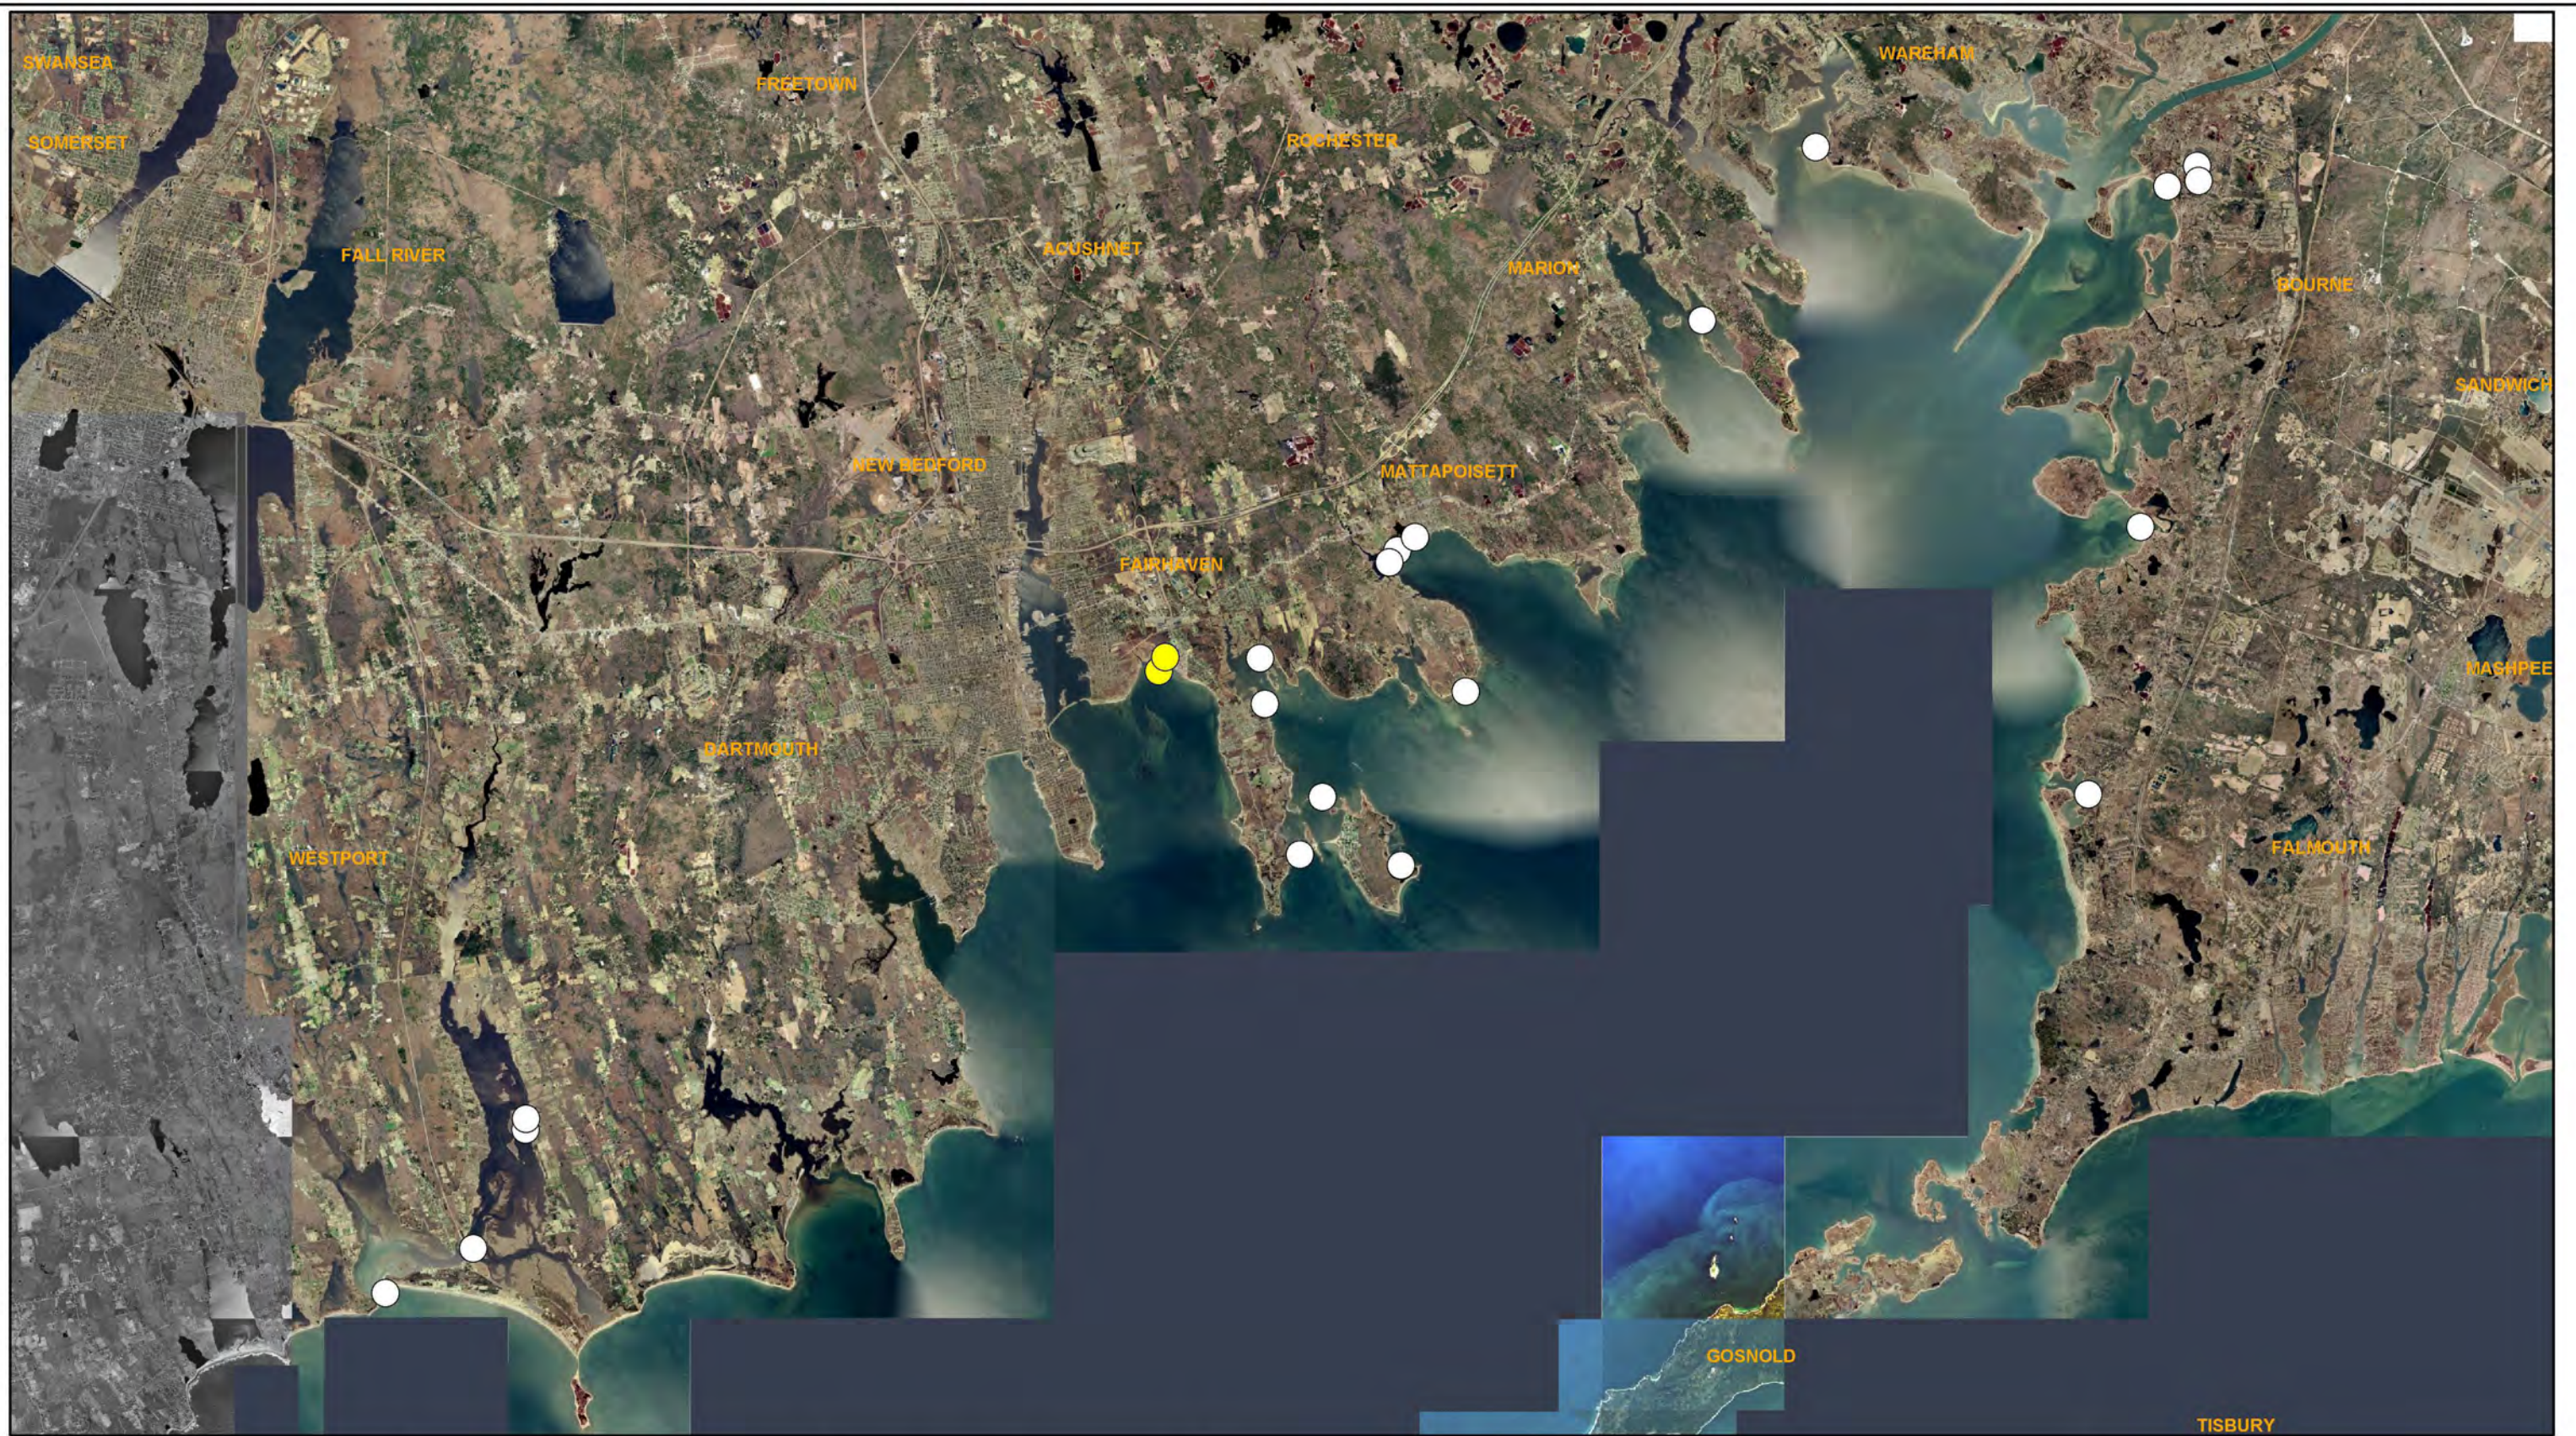
**Figure 2-18**  
**Absorbent Pad Survey Locations**  
**Bouchard B No. 120 Oil Spill**  
**Buzzards Bay, MA**

Absorbent pad swipe surveys were conducted between May 5 and June 10, 2003 at shellfish sampling stations during low tide (Figure 2-18). At each intertidal station, absorbent pads were swabbed along the exposed surface of a 20-foot diameter area in the intertidal zone. The presence/absence of oiling on the pads was noted. At subtidal beds, absorbent pads were individually wrapped around the heads of clam rakes and secured with tape. The pad was then submerged and swabbed along the bottom in a 20-foot diameter area. The pad was brought to the surface and observations of oiling were recorded. The used absorbent pads were placed in labeled plastic bags for future reference. Oil was observed on two absorbent pads collected at the Fairhaven Hacker Street and Sconticut Neck shellfish sample locations. No oil was observed on any of the other swipes. A photo documenting evidence of oil on absorbent pads is included in Figure 2-19. Results of the absorbent pad swipe surveys are summarized in Table 2-11.
