Interagency Aviation Lessons Learned

No. IALL 10-01

Subject: Aircraft Lessons Learned - Aircraft Pre and Post Flight

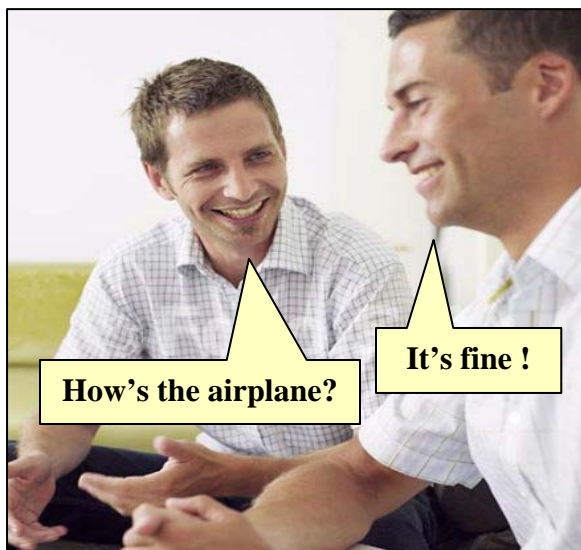
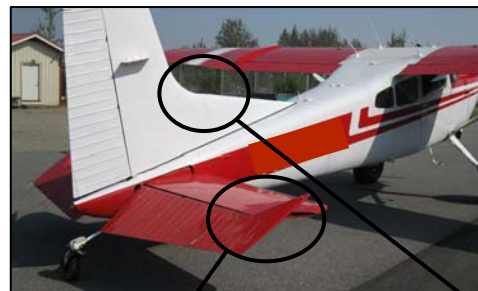
The landing gear box was cracked in the lower forward corner. The outboard hinge and spar of each elevator was cracked, compromising the structural integrity of the flight control, and the rudder fairing skin was cracked and buckled. The pilot said that he did notice the damage to the rudder fairing (oil canning) but didn't report it because he didn't think it was significant since it wasn't unusual if the aircraft was moved improperly. But he certainly didn't know how the other damage occurred.

Proper mission preparation and effective crew resource management (CRM) includes a preflight and post-flight of the aircraft by the pilot and a “look over” by all personnel involved in the flight. A pilot should never assume that a previous pilot did a thorough post-flight inspection. Ample time should be planned prior to the flight to conduct a thorough preflight. It is the responsibility of the Pilot-In-Command (PIC) to conduct a thorough pre and post-flight of the aircraft (351 DM 1.1E) and to ensure that all maintenance issues are brought to the attention of appropriate personnel. It is a violation of FAA policy to knowingly pilot an un-airworthy aircraft (FAR Part 91.7).

Had a proper post-flight inspection and a proper pre-flight inspection been conducted, damage to the one aircraft would have been found. Instead, lives were put at risk by flying in an un-airworthy aircraft. For additional information, see Interagency Safety Alert 06-03 “Duties Requiring Additional Attention to Detail.”
