# Interagency Aviation Accident Prevention Bulletin

No. IA APB 23-04

**Subject:** Freely Alta X Landing Gear Separations During Flight

**Area of Concern:** Uncrewed Aircraft Systems (UAS) Operations

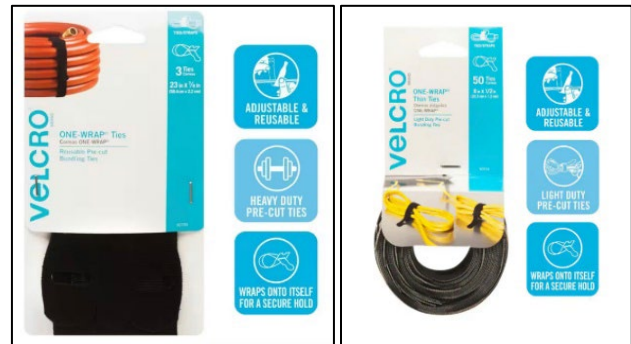
- After each flight, the remote pilot in command must check the landing gear to ensure proper assembly to the aircraft.
- This check requires lifting the aircraft and preventing the weight of the UAS from tensioning the screw.
- Verify that the screw is fully seated. This applies to the skid screw, tension nuts, and screw that attaches to the frame of the UAS.

1. Take the Velcro strap and locate the end with the upper and lower pins. (Figure 1 & 4)
2. Insert the upper pin through one end of the Velcro strap, ensuring it goes all the way through. (Figure 1 & 4)
3. Insert the lower pin through the same end of the Velcro strap, making sure it aligns with the upper pin. (Figure 2)

4. Pull both pins through until they are securely held by the Velcro strap. (Figure 1 & 4)
5. Repeat steps 2-4 for the other end of the Velcro strap.
6. Now that both ends of the Velcro strap have the upper and lower pins inserted, position the strap around the brackets you want to secure. (Figure 2 & 3)
