Interagency Aviation Lessons Learned

No. IA LL 21-03

Subject: Single Engine Air Tanker Operations

Area of Focus: Mission Profile

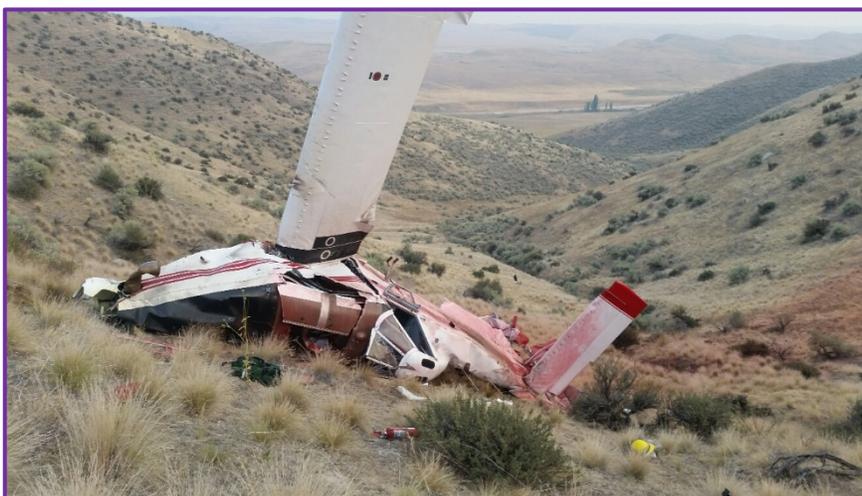
Drop Profile: The investigation benefited from eyewitness accounts and their cell phone video along with the aircraft Automatic Dependent Surveillance-Broadcast (ADS-B) data. The ADS-B data enabled a drone flight simulation covering the route of flight. On the accident drop, the video showed a clear view of the aircraft descending well below the tops of the ridges into the draw. The pilot was on the correct line and had called “gate armed.” The pilot crossed the target ridge at approximately 15 feet above the top, continued to descend into the draw, and past the target area where the drop should have been initiated. For some unknown reason, the pilot never released any retardant. The aircraft was unable to meet the performance requirements and could not clear the ridge due to the delayed climb and the additional weight of retardant that remained on board.

It is conceivable that the pilot intended to make the drop well inside the draw at low altitude due to his deliberate descent into the draw. The arming switch for the gate was found in the “off” position. Although it is possible (but unlikely) that the switch was moved during the impact sequence, failing to arm the gate could have inhibited the pilot’s ability to release his load with the pilot-controlled drop switch on the flight controls. All pilots should never place their aircraft in a position that depends on the

release of aerial delivered suppressants to clear terrain. It is also important for pilots to jettison their load whenever safety of flight is an issue. Careful planning of the aircraft's approach, speed, height, horizontal separations, and exit are essential – especially when operating in austere conditions.
