Interagency Aviation SAFETY ALERT

No. IASA 21-01

Subject: Unmanned Aircraft Systems (UAS) DJI M600 Mishaps

Area of Concern: Airworthiness Inspection.

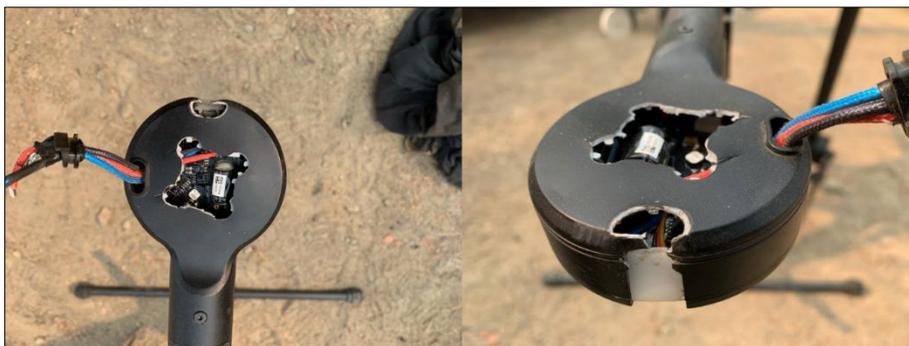
Figure 2: Motor mount after departure of motor.

Initial post-crash inspection revealed that both aircraft were missing one of the motors at the 9 o'clock position. After an extensive search, neither motor was located. Additional evidence of small fractures on one of the motor housings strongly suggests that the motor broke free of the motor housing during flight. It is

It is suspected that metal fatigue played an integral role as the small fractures propagated over time until the motor finally broke free. Both mishap aircraft had experienced extensive use over the past two years.

All Department of Interior/US Forest Service (DOI/USFS) remote pilots are required to inspect the motor housing of all DJI M600 aircraft for any evidence of cracking around the four mount attachment points. If any cracks are discovered, the aircraft is grounded until a replacement mount can be installed. These cracks are most probable on aircraft that have experienced extensive use and/or been carrying heavy payloads.

maintenance measures. The inspection procedures for the DJI M600 are outlined below. Any cracks should be reported to OAS and your respective National Aviation Office/Manager.

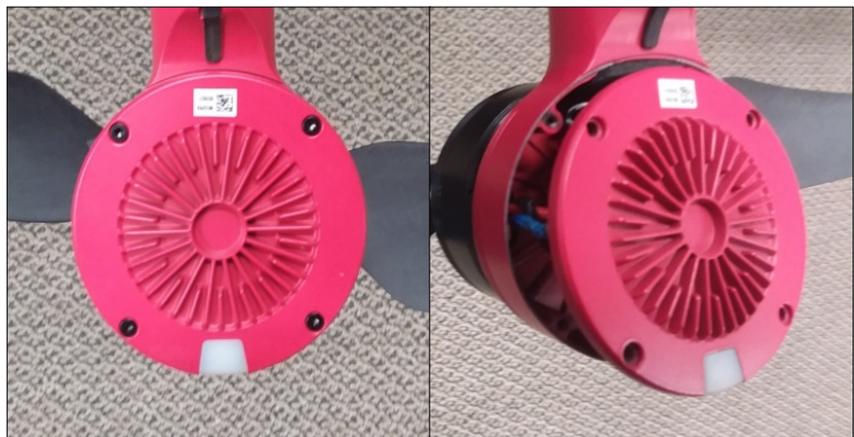
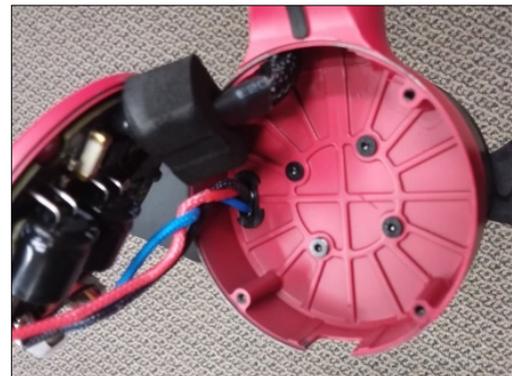
4. Locate **the foam plug and** gently pull the cable through. This will expose four screws that go in to the motor base. With a magnifying glass and light, inspect the area around each bolt head for signs of cracks or defects.

5. With the assistance of another person, inspect the exterior of the motor mount around each bolt looking for cracks. As one person is inspecting the exterior, the other person should carefully apply torque to the props. This is done in accordance with the training received in A-454, *Small UAS Operator Add-On Course*, in which you are testing that the motor is firmly mounted. If cracked, this action should reveal defects.
