Interagency Aviation TECH BULLETIN

No. IATB 18-01

SUBJECT: NAS1211B20 Ring and Stud Failure, Rappel Spotter Tether Attachment System

DISTRIBUTION: All Rappel Type II Helicopter Operators

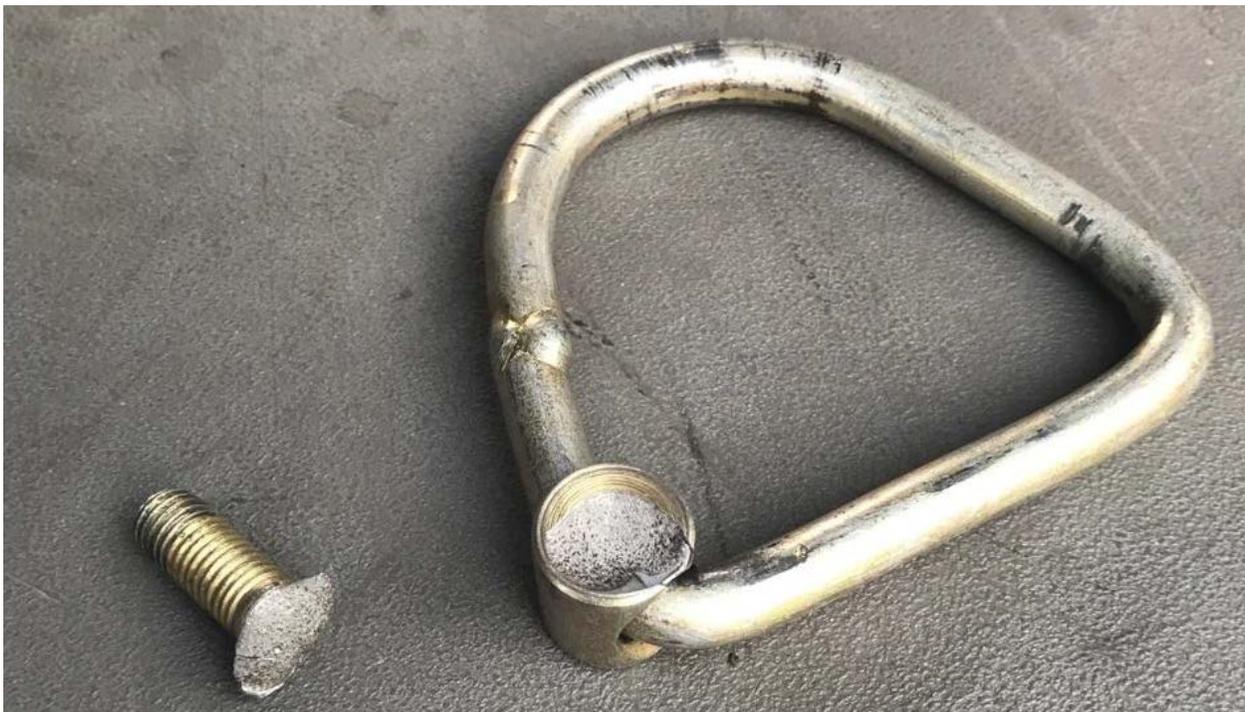
Figure 1 – Failed NAS1211B20 Ring and Stud Fitting

ISSUE: On August 19, 2017 a Type II rappel helicopter responded to an initial attack rappel fire on the Sierra N.F. in Region 5. The rappel spotter deployed four rappellers and two loads of cargo on the incident. After the second load of cargo the spotter stated that it felt like their tether was hung up on something then freed itself. Upon further inspection it was evident that one NAS1211B20 ring and stud fittings had failed. The Air Rescue Systems (ARS) spotter anchor attaches to the LH and RH transmission wall via two NAS1211B20 ring and stud fittings.

The failed NAS1211B20 was recovered and sent to an independent lab for analysis. Hydrogen embrittlement caused the fitting failure. At this time the failure appears to be an isolated case.

The documentation from the helicopter contractor showed the failed ring and stud had been procured from Heli-Tech approximately 7 years ago. The USFS contacted Dart Aerospace (who now own Heli-Tech) to alert them of the matter. In response Dart is working toward issuing a recall on NAS1211B20 ring and stud fittings sold in kits to install STC No. SH261WE by Heli-Tech. Please contact Dart Aerospace for further information on the replacement NAS1211B20 hardware if the installed items are believed to have come from Heli-Tech.

As with all "Standard Parts" a Certificate of Conformity (C of C) should be provided by the producer of the standard part and be sold with that part.

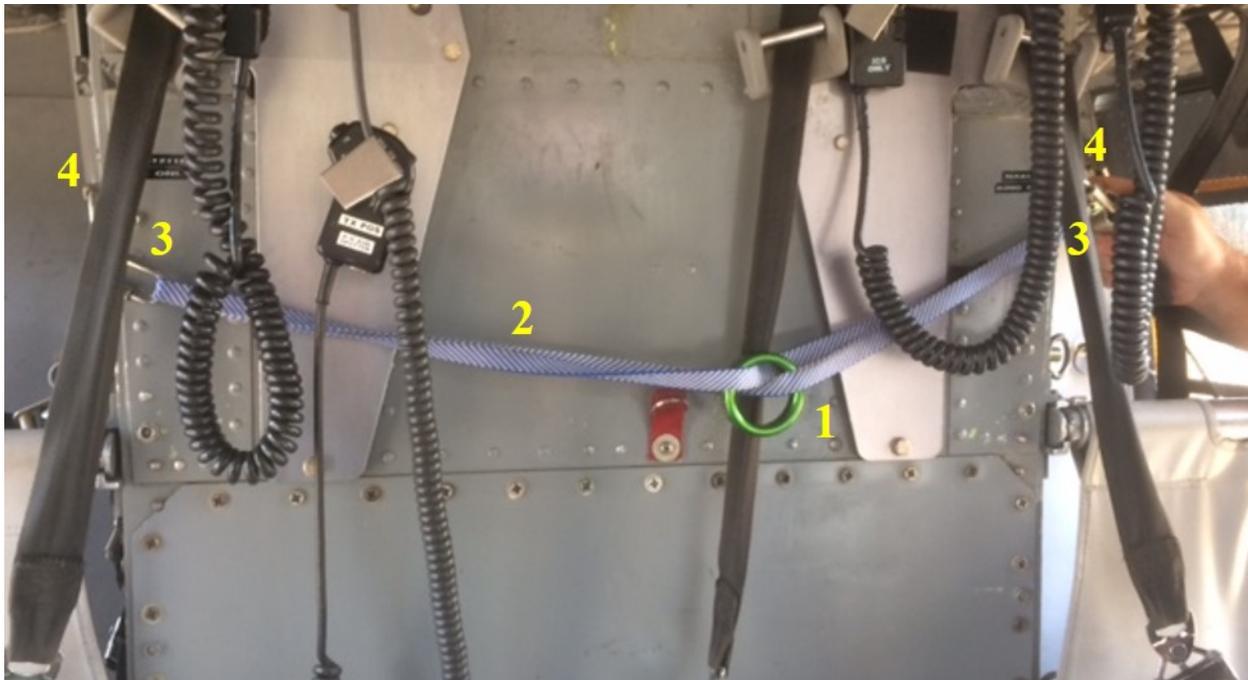
Figure 2 – ARS Spotter Anchor and Attach Points

DISCUSSION: The ARS Spotter Anchor is attached at two locations to a NAS1211B20 ring and stud fitting on the transmission wall. The ARS Spotter Anchor did not fail. Each attach point is able to carry the ultimate load. If one of the NAS1211B20 ring and stud fittings fail the second fitting will pick up the ultimate load. Figures 2 and 3 below illustrates components of the spotter tether system.

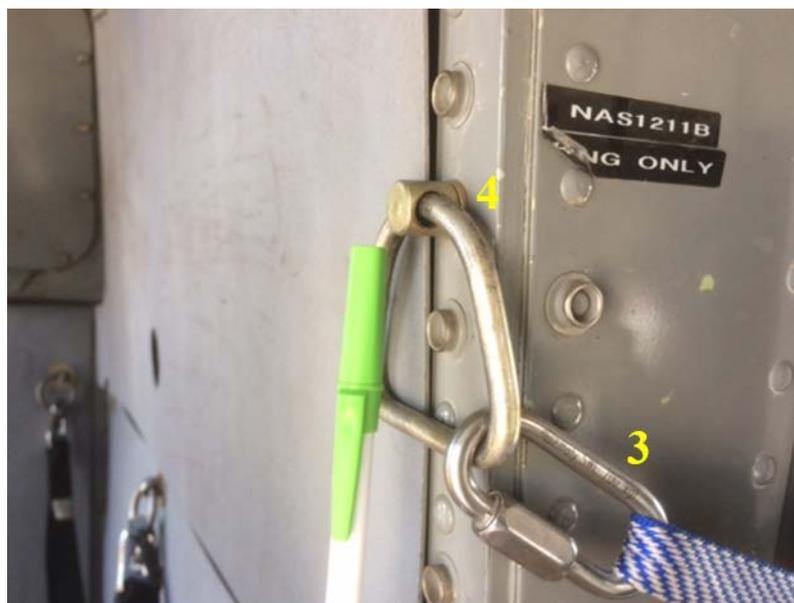
Figure 3 – NAS1211B20 and Kong Quick Link

1.	ARS Ring	30 kN	6,744 lbs
2.	ARS Webbing	30 kN	6,744 lbs
3.	Kong Quick Link	40 kN	8,992 lbs
4.	NAS1211B20		2,500 lbs
5.	Transmission Wall Structure		1,650 lbs

The weakest link in the system is the structure the NAS1211B20 is mounted to. The tether system is designed for a 300 lb working load. A safety factor of 3.5 is applied to the working load and then multiplied by 1.5 for the ultimate load.
