Interagency Aviation Lessons Learned

No. IA LL 14-02 July 7, 2014 Page 1 of 2

Subject: Eurocopter AS350/AS355 Sliding Doors

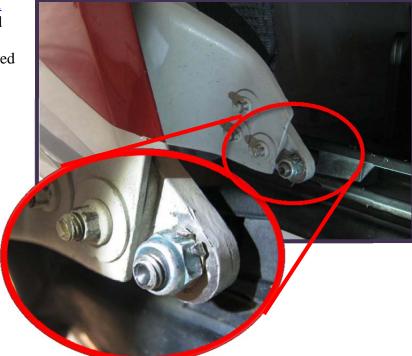
Figure 1 Right Hand Door Lower retention nut and lock-washer

The design of the lower attachment point on this helicopter door depends on one bolt and nut. The removal of this single nut will allow the entire door to come off. Maintainers must install and tighten the nut in accordance with the manufacturer's guidelines using the proper torque value. This nut is visible when the sliding door is open and it should be checked on daily and periodic inspections to ensure that it remains secure.

Maintainers should only reuse nuts in accordance with the manufacturer's guidelines. Locking nuts that can be threaded on by hand should be discarded and replaced with new ones. The manufacturer specifies a minimum thread protrusion on the bolt to ensure the nut is capable of locking. This also provides an additional method of visual inspection.
