Interagency Aviation Safety Alert

No. IA 09-04

Subject: External Load and Short Haul Operations

Area of Concern: Inadvertent Cargo Hook Releases and Cable Adjustment

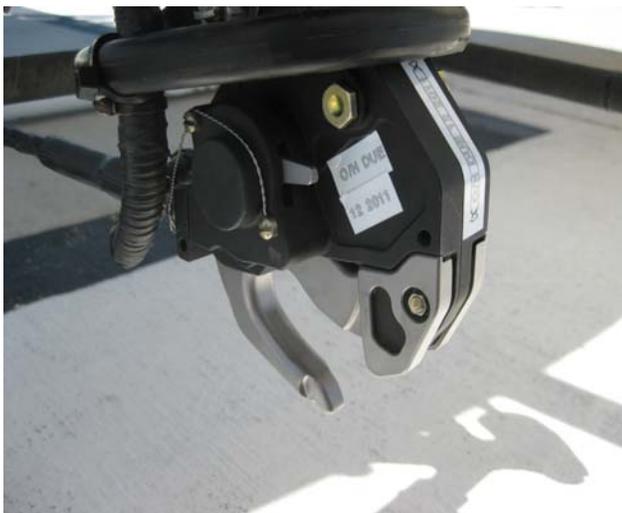
Figure 1 Cargo Hook

The helicopter was a Eurocopter AS 350, configured with a Talon Keeperless Cargo Hook from Onboard Systems as the primary anchor (figure 1). The manual release mechanism for the cargo hook is shown in figure 2.

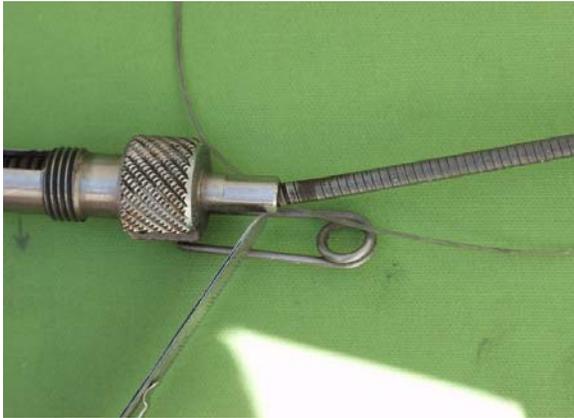
Figure 3 Damage to manual release cable

An aviation safety team from the Bureau and NBC-AMD was dispatched to investigate the inadvertent release. The investigation revealed several items that, when combined, resulted in this incident. Damage was noted on the outer sheath of the manual release cable (figure 3). With the manual release mechanism cover removed (figure 4), the rigging of the fore and aft cables could be measured.

1. Clearance between the attach end of the inner cable and the end of the outer sheath
2. Clearance between the guide on the forward cable and the end of the aft cable
3. General cleanliness and condition of the release cable.

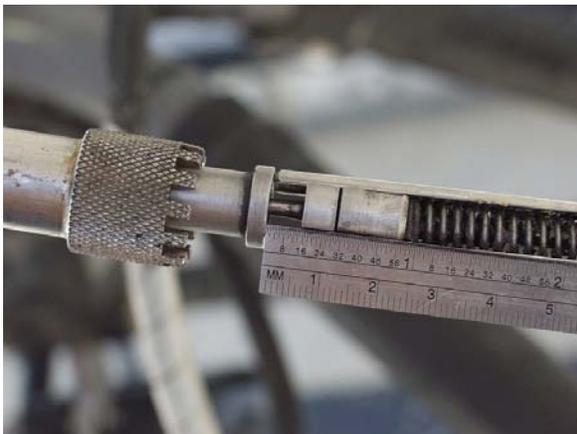
Figure 5 Rigged cables pre-loaded for release

With the cables rigged together, the aft cable is pulled approximately 5/8" toward the release position (figure 5). Another helicopter rigged with the same cargo hook was examined to see if there were any differences in rigging. The comparison showed that when rigged together, the aft cable on the second helicopter was not pulled toward the release position, but had approximately 1/8" free play (figure 6).

The examination and comparison of the manual release cable rigging showed that the manual release cable in the incident aircraft had approximately 1/4" of the movement necessary to effect a mechanical release when connected. Any bending of the forward cable, such as when the collective is raised, causes an effective "shortening" of the inner cable relative to the sheath due to the changing radius of the bend.

Proper rigging is critical. It is recommended that all A Star helicopters with manual cargo release cables be checked for:

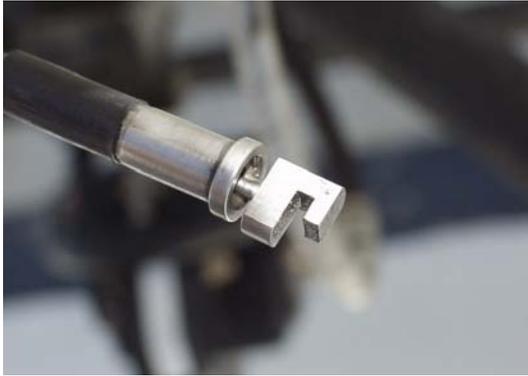
Figure 7 Gap with cable disconnected

When the aft cable is disconnected from the forward cable, both aircraft showed a similar amount of exposed cable (figures 7 and 8).
