BIOLOGICAL ASSESSMENT

**Pensacola Fish Hatchery Site
NRDA ERP Project
City of Pensacola, FL**

**Wetland Sciences, Inc.
1829 Bainbridge Avenue
Pensacola, FL 32507**

August 19, 2013

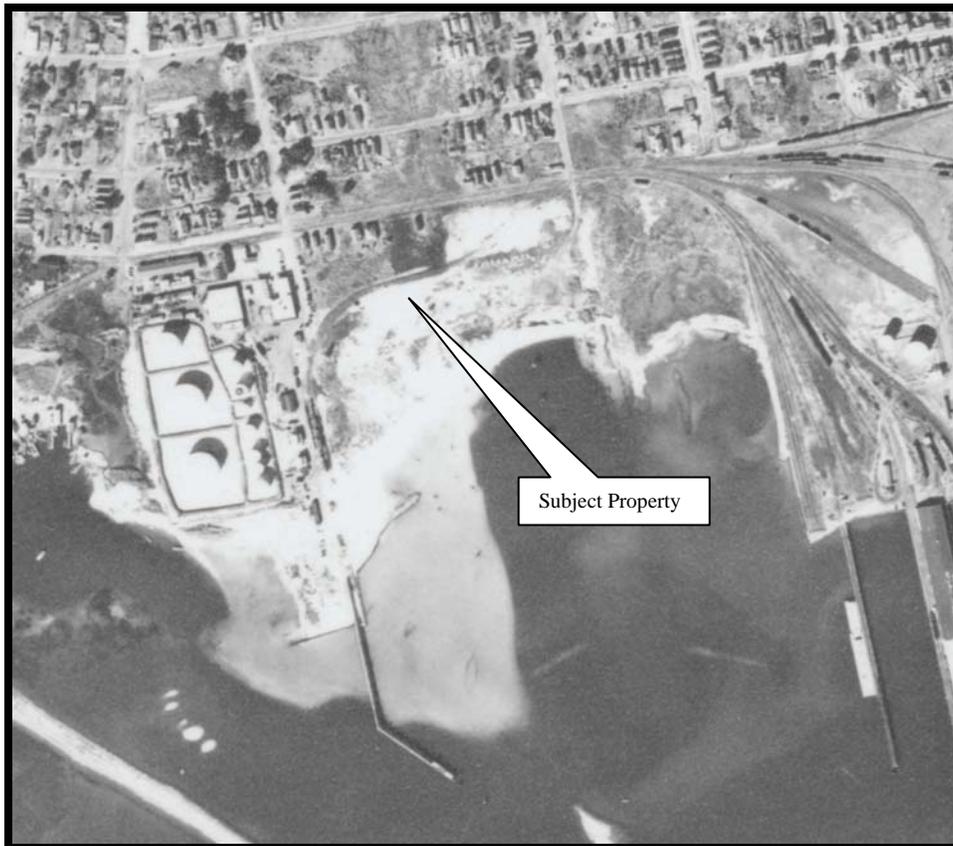
Historical records suggest the property is man-made land, created in the early 1900's by filling in a portion of Pensacola Bay. Documented industrial activities have been ongoing on this property since 1910 (Figure 1).

Figure 1. Circa 1951 aerial of the subject property.

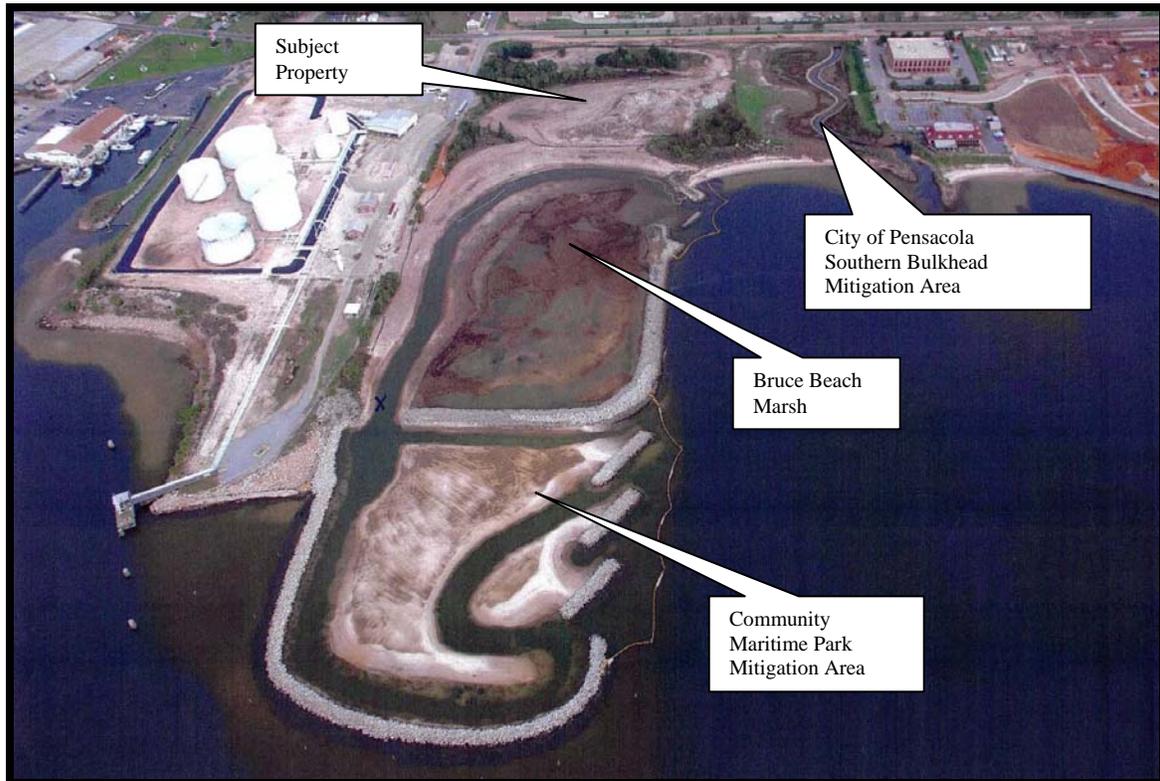
There are three areas immediately adjacent and within the subject property that have been developed as wetland mitigation areas (Figure 2 & plan view drawing attached in Appendix B).

Figure 2. Ca. 2012 Oblique view of the subject property and areas immediately surrounding.

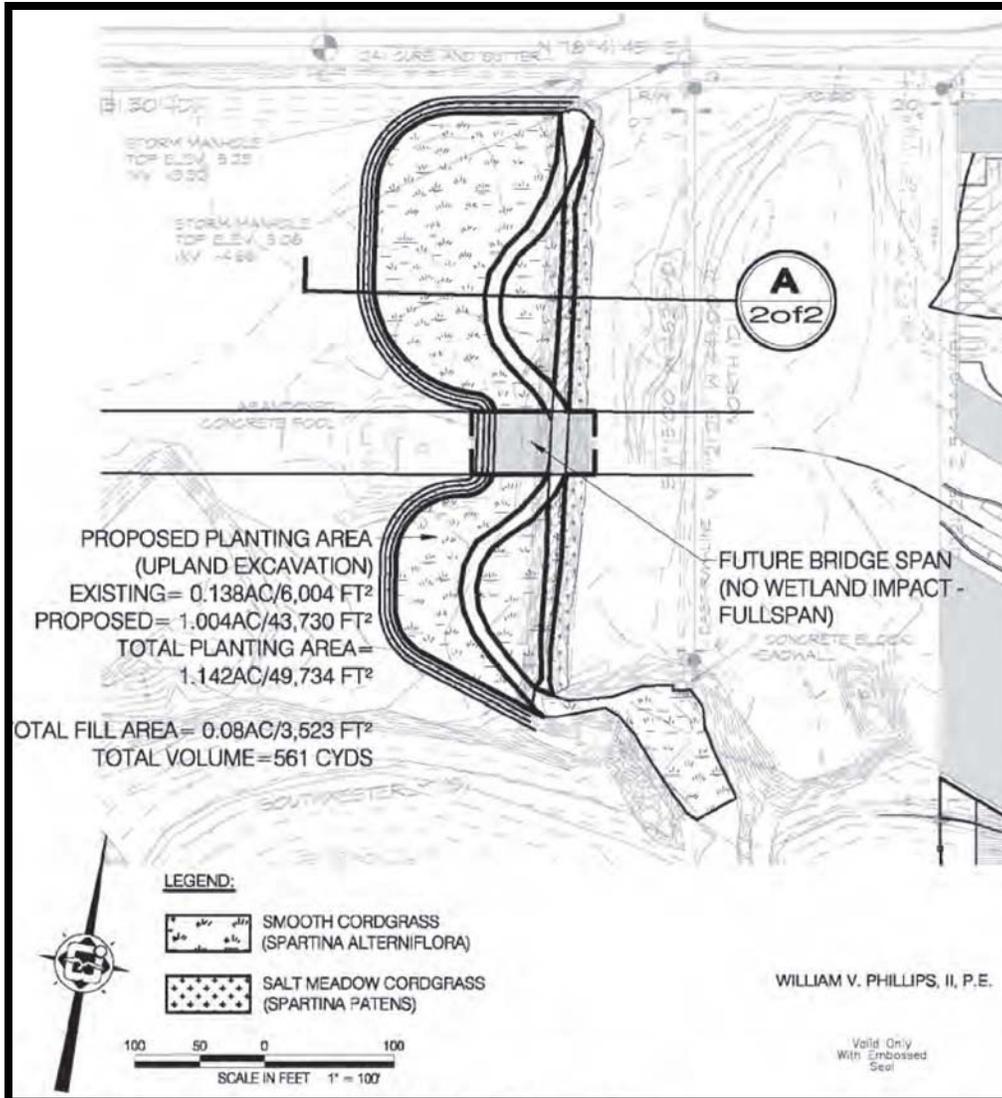
The southern bulkhead mitigation site is a mitigation area that was designed to compensate for wetland losses incurred with the construction of the southern bulkhead along the waterfront of what is now the Community Maritime Park. This mitigation site was once a channelized canal formerly used to discharge treated effluent from a now decommissioned wastewater treatment plant. The mitigation site is comprised of a meandering tidal channel and low/high marsh areas planted with smooth cordgrass (*Spartina alterniflora*) and marsh hay (*Spartina patens*) (Figure 3).

Figure 3. Plan view of southern bulkhead mitigation site.

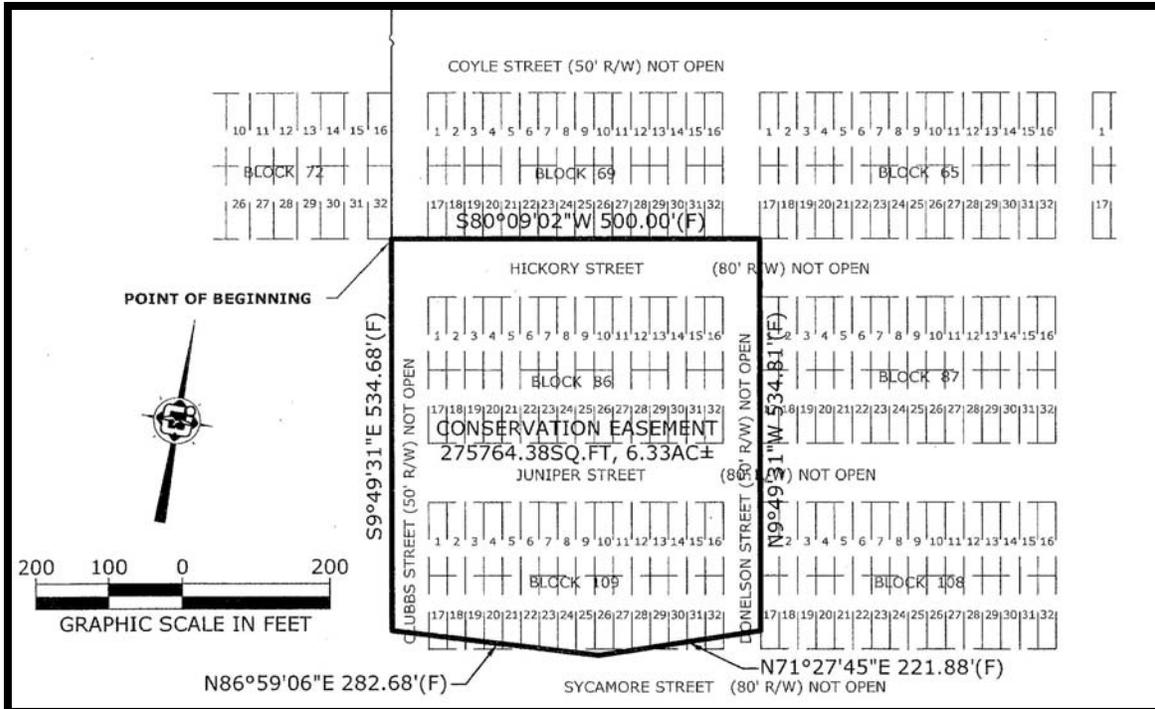
The Community Maritime Park (CMP) wetland mitigation area was established in 2012 to compensate for loss of wetland functions that were eliminated by the construction of the Pensacola Community Maritime Park. The wetland mitigation plan included the creation of a salt marsh consisting of 0.86 acres of oyster reef habitat/breakwaters, 1.96 acres of planted salt marsh, and 1.72 acres of tidal creeks and pools which serve as a waterward extension of the existing Bruce Beach mitigation area. The mitigation plan also included modifications to the existing Bruce Beach Mitigation Area. These modifications included the re-grading of adjacent uplands to intertidal elevations for additional marsh creation and opening the southern end of the site to enhance tidal exchange between Bruce Beach and the CMP mitigation areas. This mitigation site is protected via a conservation easement recorded in OR Book 6417 Pages 1666-1680 in the official records of Escambia County (Figure 4).

Figure 4. Plan view of conservation easement area associated with the CMP wetland mitigation site.

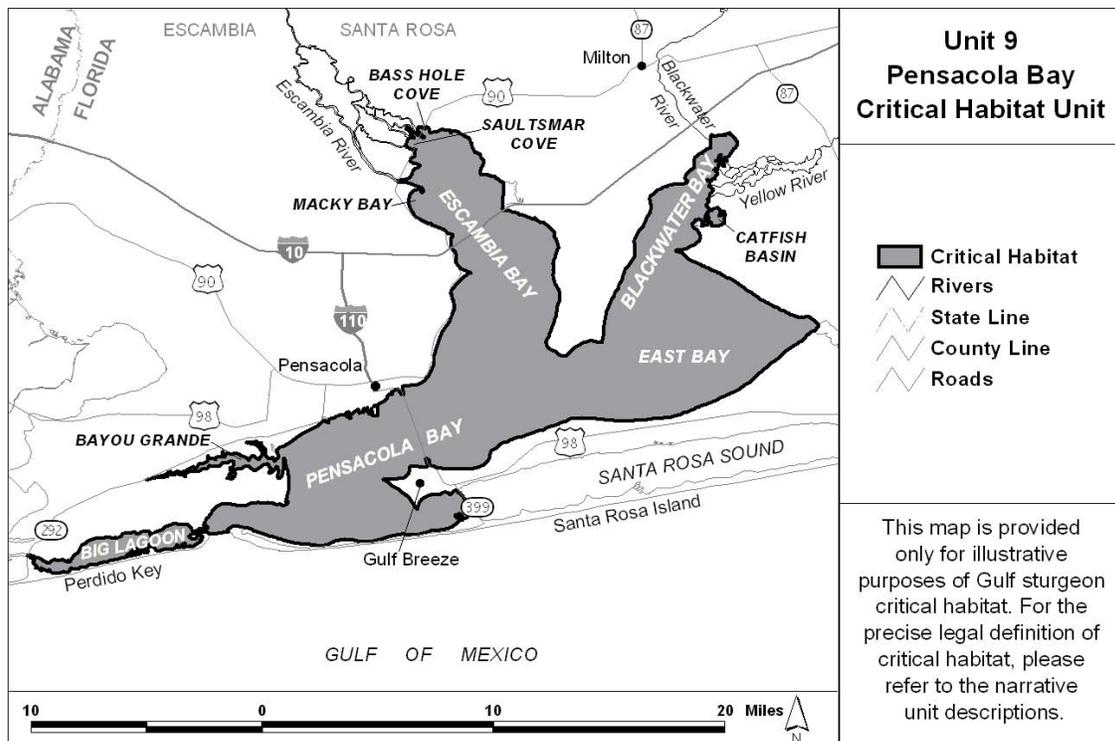
The waters of Pensacola Bay lying adjacent to the subject property are designated as critical habitat of Gulf Sturgeon. Gulf Sturgeon (*Acipenser oxyrinchus desotoi*) is a federally listed species (threatened) and a state species of special concern. Gulf sturgeon critical habitat is composed of 14 geographic areas, or units. The units collectively encompass almost 2,800 river kilometers and over 6,000 square kilometers of estuarine and marine habitat. The subject property is adjacent to Unit 9, the Pensacola Bay Critical Habitat Unit (Figure 5).

Unit 9 includes Big Lagoon, Bayou Grande, Macky Bay, Bass Hole Cove, Saultsmar Cove, Catfish Basin, Pensacola Bay, Escambia Bay, Blackwater Bay, and East Bay. The Federal Register, 2003 defines the western boundary of Unit 9 as the Florida State Highway 292 Bridge crossing Big Lagoon to Perdido Key. The southern boundary is the 72 COLREGS line between Perdido Key and Santa Rosa Island [(defined at 33 CFR 80.810 (g)]. The eastern boundary is the Florida State Highway 399 Bridge at Gulf Breeze, Florida. The lateral extent of Unit 9 is the mean high water (MHW) line on each shoreline of the included waterbodies (Federal Register, 2003).

Figure 5. Unit 9, Pensacola Bay Critical Habitat Unit for Gulf Sturgeon.

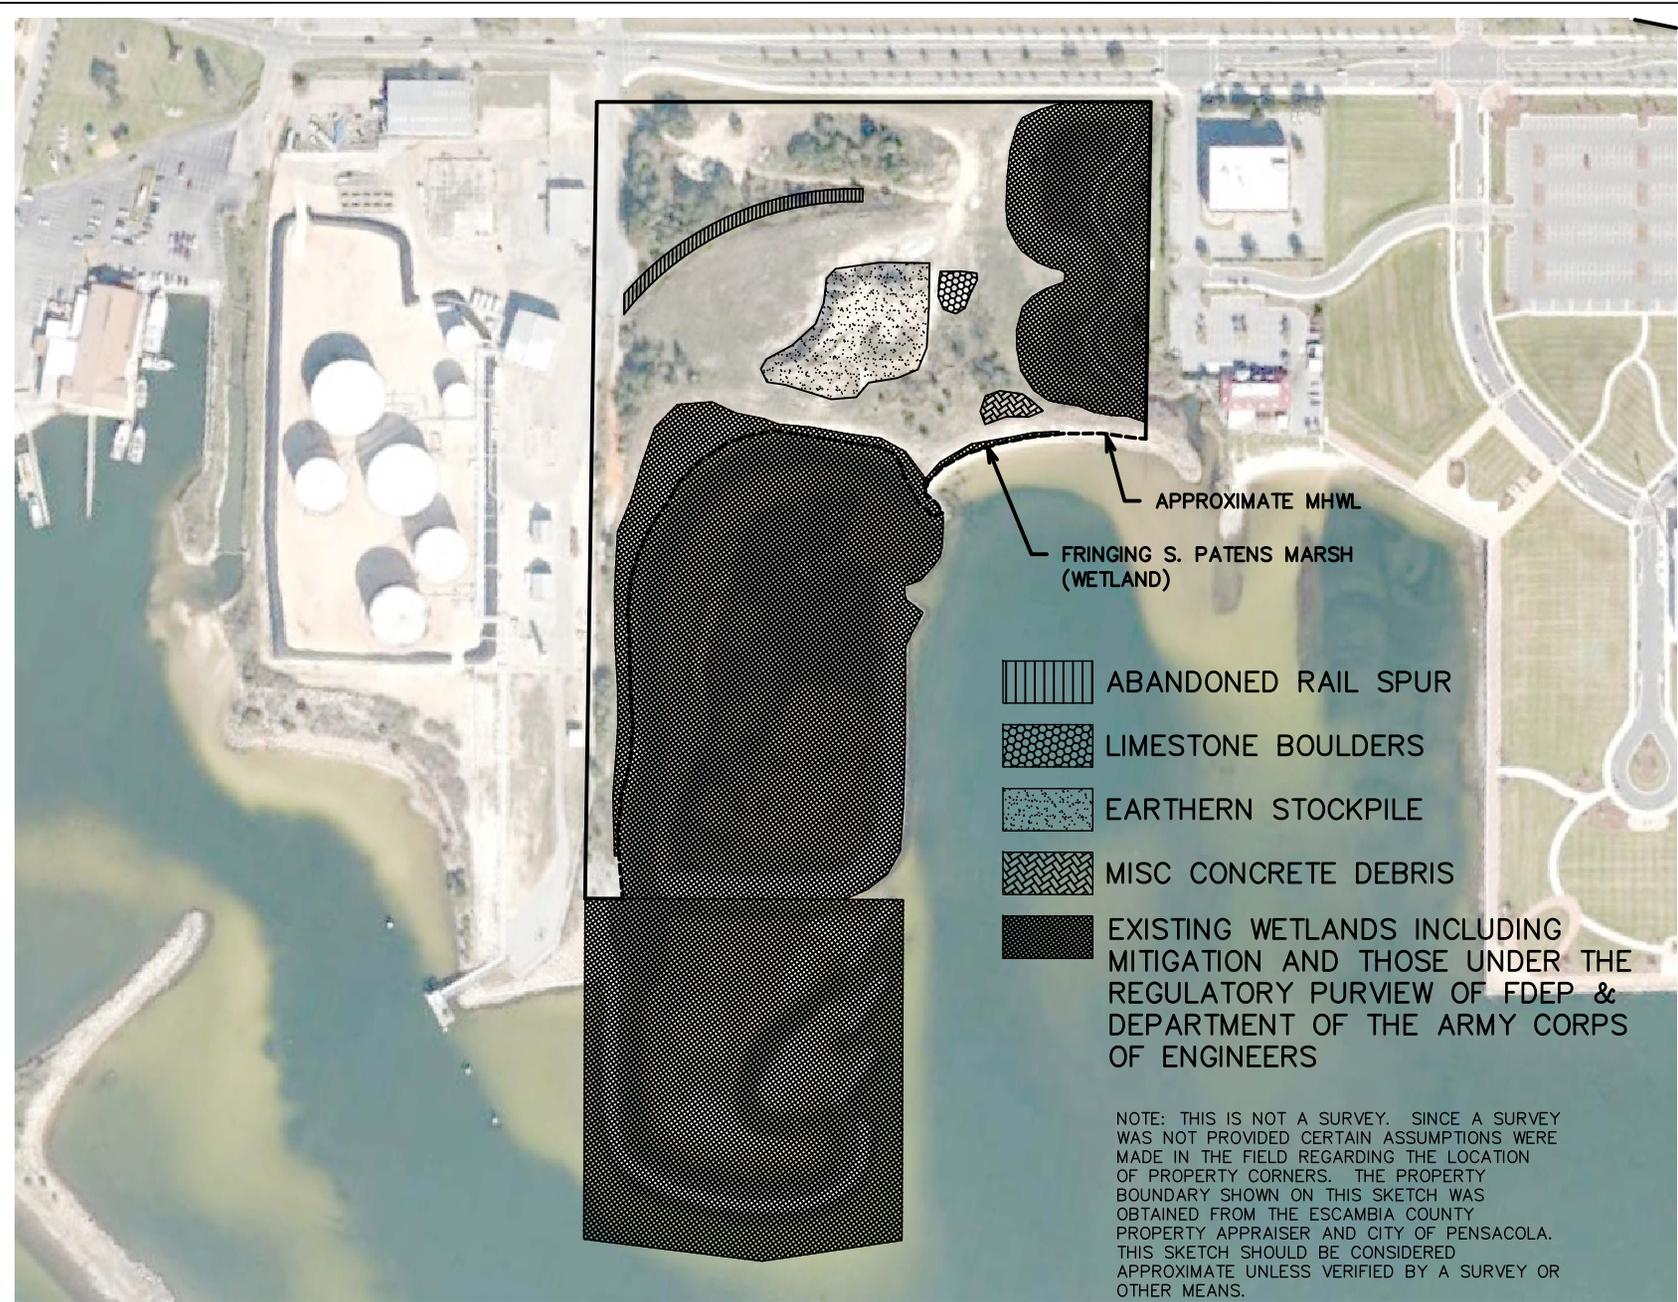
Remnant Construction Debris & Historic Features Noted

The subject property is highly disturbed. Excess material including earth fill and limestone rip rap are stockpiled within the subject property. Additionally, the site is strewn with other historic debris from previous industrial land uses including creosote treated timbers, concrete pilings, concrete culverts, bricks, abandoned rail spur, etc. These surface features noted during our site inspection are depicted on the plan view drawing attached in Appendix C. Please note additional material not evident during our site inspection may be present within the subject property.

Finally, the site does contain a small fringing marsh along the waterfront of the subject property that is located just south of the southern bulkhead mitigation site and east of Bruce Beach Marsh. This fringing marsh is largely comprised of a monoculture of marsh hay (*Spartina patens*) which forms a narrow band of vegetation just landward of the mean high water line. This feature is depicted on the plan view drawing contained in Appendix C & D.

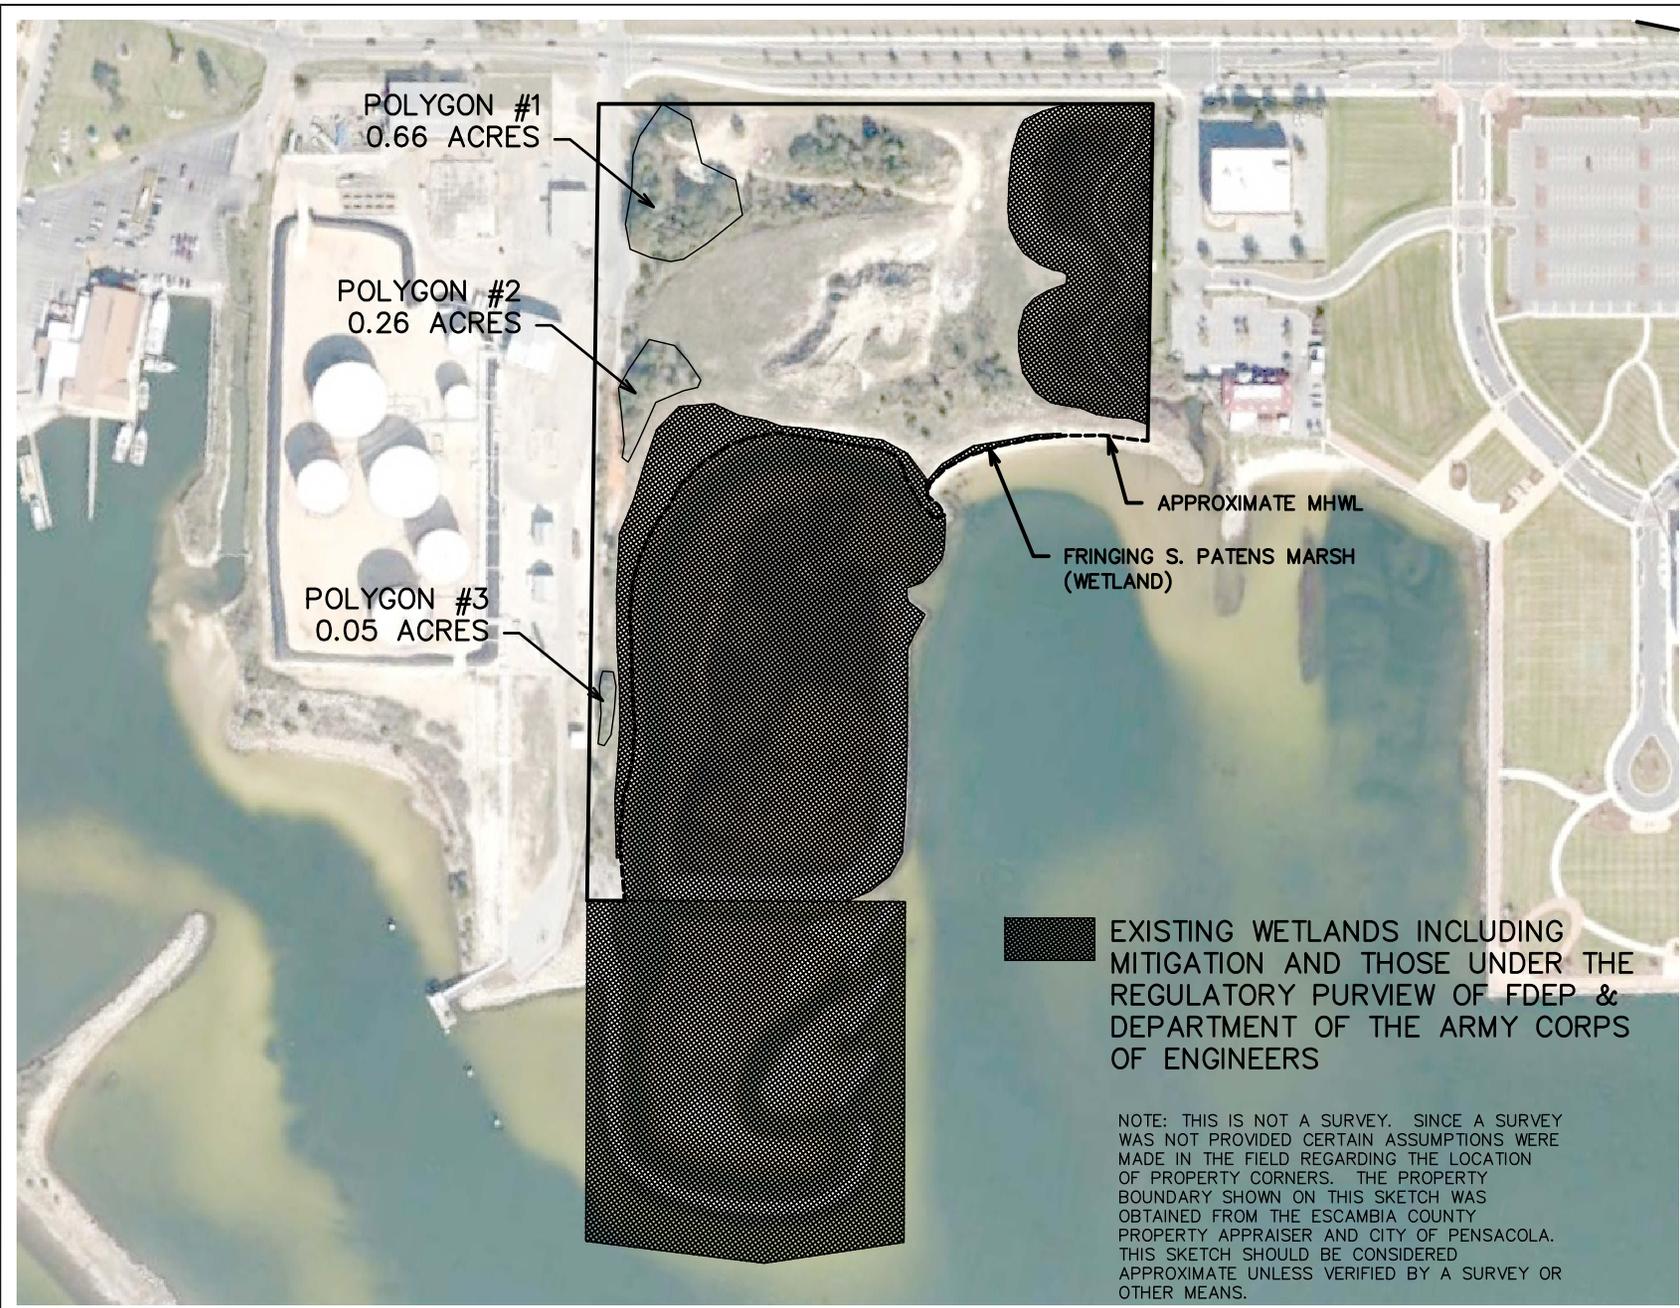
Natural Plant Communities

With the exception of the existing wetland mitigation sites, there are only three areas located in the uplands that maintain any resemblance of an intact plant community. These areas are depicted on the plan view drawing attached in Appendix D.

For discussion purposes these three areas were identified as Polygon 1, 2, & 3. Polygon #1 is located in the northwest corner of the subject property and consisted of 0.66 acre. The canopy is largely dominated by live oak (*Quercus virginiana*) with approximately 30-35% coverage and cabbage palm (*Sabal palmetto*) at 15%. Section 12-6-1 of the City of Pensacola Land Development Code does afford protection to live oaks greater than 6-inches in diameter measured at breast height (dbh). Most of the live oaks within this polygon will be protected. Additionally, some of the live oaks may be considered heritage trees defined (>34-inches dbh) in Section 12-6-2(D) of the same code. There are two pecan trees (*Carya illinoensis*) located near the northeastern boundary of the polygon just north of a small unimproved road. Like the live oak these trees are afforded protection under the City's Land Development Code. The subcanopy was dominated by laurel oak (*Quercus laurifolia*) at 10% and live oak (*Quercus virginiana*) at 5%. Shrub species consisted of cherry laurel (*Prunus caroliniana*), tung oil tree (*Aleurites fordii*), Chinese tallow (*Triadica sebifera*), and common lantana (*Lantana camara*). Each shrub species comprised less than 1% of total cover. The herbaceous stratum was generally lacking given the dense coverage of the canopy and subcanopy but when present consisted of pinebarren goldenrod (*Solidago fistulosa*), American pokeweed (*Phytolacca Americana*), and trumpet vine (*Campsis radicans*).

Polygon #2 is located just landward and northwest of the existing Bruce Beach marsh. This polygon consists of a small cluster of live oak (*Quercus virginiana*) with total coverage at 30%. Again the live oaks found within this polygon may be afforded protection via City of Pensacola Land Development Code. Chinaberry (*Melia azedarach*) and live oak comprise the subcanopy. Coverage by both species is less than 10%. Shrub canopy was comprised of yaupon holly (*Ilex vomitoria*), cabbage palm (*Sabal palmetto*), wax myrtle (*Myrica cerifera*), and red cedar (*Juniperus virginiana*). Each shrub canopy species represented less than 2% total coverage.

Polygon #3 is located within a narrow spit of land in between the Bruce Beach marsh and the western property line. This polygon consists of 0.05 acre. This polygon is lacking a canopy. The subcanopy is dominated by laurel oak (*Quercus laurifolia*) at 20% coverage. The subcanopy is also comprised of china berry (*Melia azedarach*) at 15%, cherry laurel (*Prunus caroliniana*) at 10%, and cabbage palm (*Sabal palmetto*) at 5%. Herbaceous plants were lacking due to dense coverage of subcanopy species.

Some of the relic plant communities identified by Wetland Sciences, Inc. do contain tree species that will be afforded protection by City of Pensacola's Land Development Code. I would recommend the site be subject to a tree survey to identify and locate these protected trees.

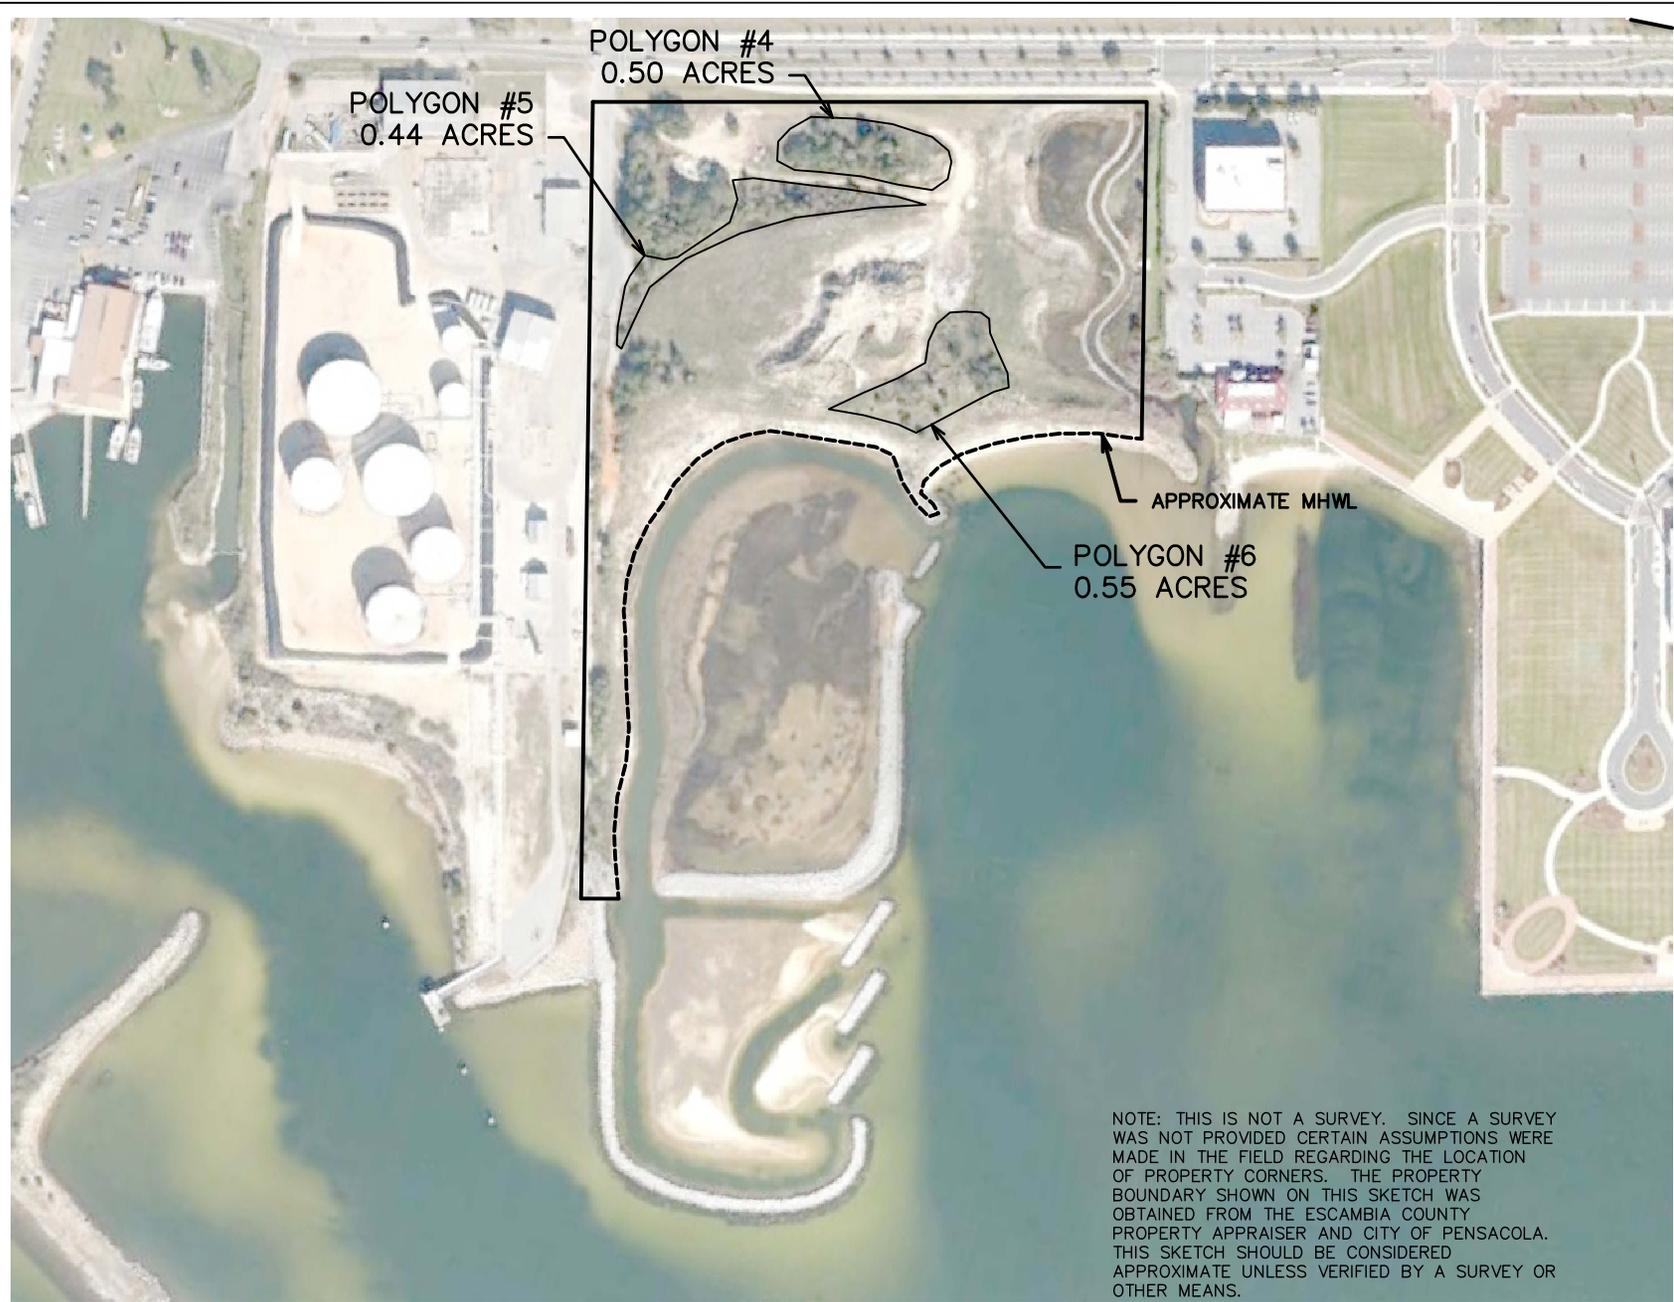
Ruderal & Invasive Plant Communities

There are three other polygons within the subject property that contain a myriad of invasive & ruderal plant species. For discussion purposes, I have identified the polygons as #4, 5, & 6. These polygons are depicted in the plan view drawing attached in Appendix E.

Polygon #4 is located in the north central portion of the property and comprised of 0.50 acres. This polygon is largely dominated by Chinaberry at 35% coverage. Chinaberry is listed as Category II exotic species. This polygon also contains 3-4% coverage by small Chinese tallow saplings. Chinese tallow is a Category I exotic species. This polygon also contains 5-10% coverage by live oak and 5% coverage by cabbage palm.

Polygon #5 is located immediately south of #4 and comprised of 0.44 acre. This polygon is very similar in composition to #4 with China berry at 30% coverage and Chinese tallow at 3%. Additionally this polygon contains 10% coverage by live oak and 5% coverage by cabbage palm.

Polygon #6 is located near the southeastern shoreline of the subject property in between the southern bulkhead mitigation site and Bruce Beach marsh. It is approximately 0.55 acres in size. The canopy within this polygon is largely lacking with only a few cabbage palms at 5% coverage. Subcanopy is largely dominated by Chinaberry (Category II exotic specie) at 25% and cherry laurel tree at 2%. Herbaceous stratum is largely dominated by wetland nightshade (*Solanum tampicense*) at 30-40% coverage. Lantana (*Lantana camara*) is also found in the groundcover at 1% coverage. Both lantana and wetland nightshade are listed as Category I exotic species. The herbaceous stratum was also comprised of tall morning glory (*Ipomea purpurea*) at 15% with the following species all less than 5% total coverage each: cowpea (*Vigna unguiculata*), hemp sesbania (*Sesbania herbacea*), florida beggarweed (*Desmodium tortuosum*), painted poinsettia (*Euphorbia cyanthophora*), various species of ragweed (*Ambrosia* spp.), and trumpet vine (*Campsis radicans*).

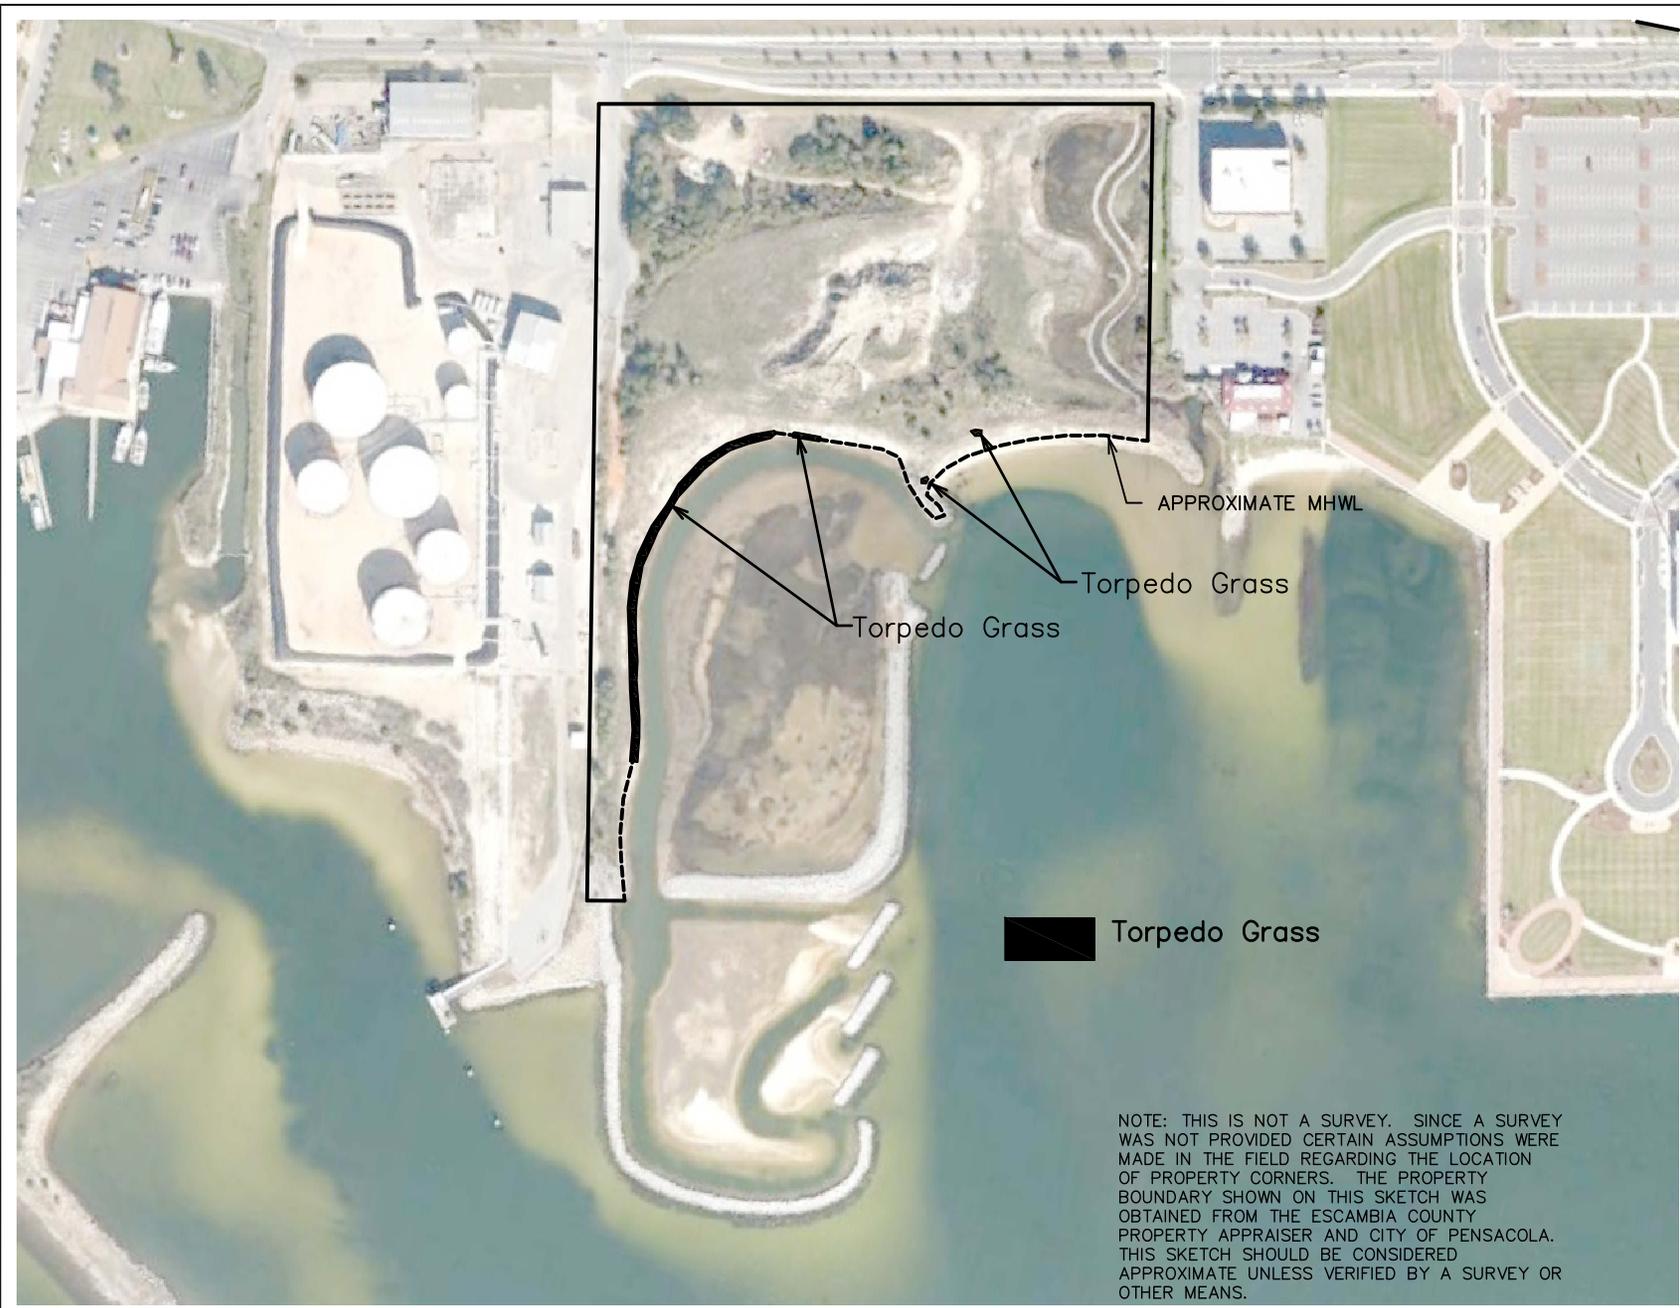
Torpedo Grass Locations

Finally, there are monoculture stands of torpedo grass (*Panicum repens*) located at various points along the shoreline. These stands are depicted in the plan view drawing attached in Appendix F. Torpedo grass is listed as a Category I exotic species.
