**Genesis Crude Oil L.P. Oil Spill,
Soso, Mississippi**

Final Restoration Plan

**Mississippi Department of Environmental Quality
and
the United States Department of the Interior
through the United States Fish and Wildlife
Service**

**Conceptual Restoration Plan
For
Unnamed Tributary to Leaf River, Collins MS.**

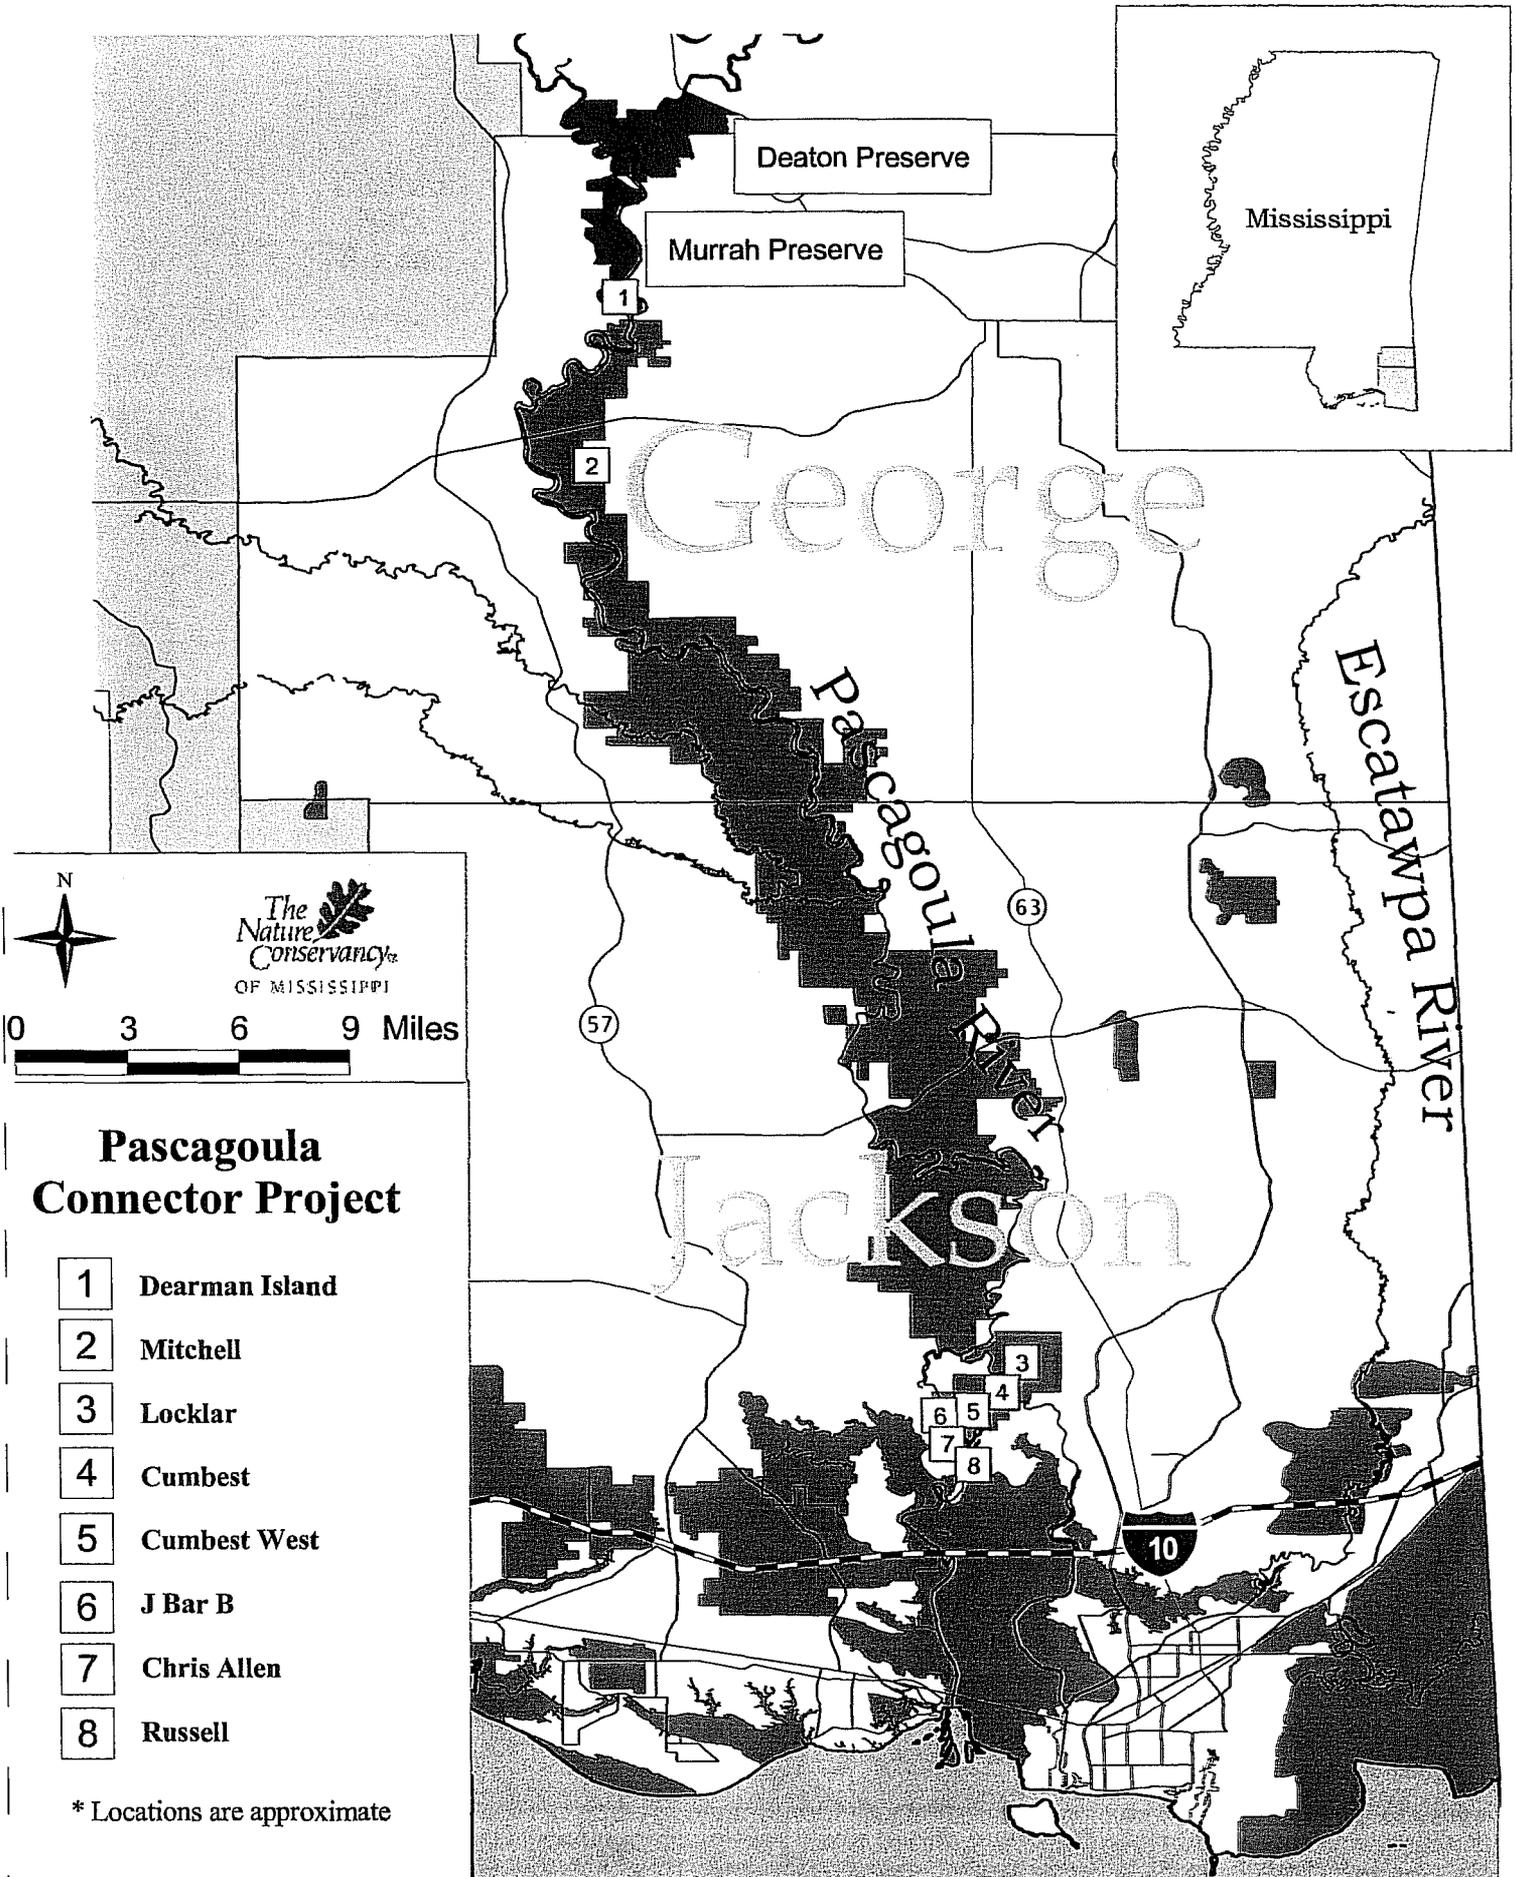
Figure 2. The Deaton Preserve, the Murrah Preserve and the Upper Pascagoula Connector Project

The restoration alternatives considered include natural recovery and restoration of the unnamed tributary affected by the incident (to include channel stabilization, re-establishment of the riparian zone with species with high wildlife value, and introduction of natural habitat types to replace that removed by the clean-up activities). Also considered were the conversion of the stream mileage affected to wetland acreage and enhancement with subsequent purchase of additional wetland acreage from The Nature Conservancy's Murrah Preserve (Figure 2); funding of a stream related project or projects on The Nature Conservancy's Murrah Preserve (alone or in conjunction with installation of some grade control structures on the unnamed tributary affected by the incident); and/or purchase of a tract or tracts of land as part of The Nature Conservancy's Upper Pascagoula Connector Project that would connect the Pascagoula Wildlife Management Area to the Leaf River Wildlife Management Area (alone or in conjunction with installation of some grade control structures on the unnamed tributary affected by the incident) (See Figure 2).

The Trustees believe that the conversion of stream mileage to wetland acreage and enhancement through purchase of acreage at The Nature Conservancy's Murrah Preserve (Figure 2) does not represent direct replacement of lost resources and resource services, i.e., this "replaces apples with oranges." The derivation or development of a "conversion factor" further confounds this option that would allow for the conversion of stream miles to wetland acres. Searching scientific literature provided no sound basis for the conversion of stream miles into wetland acres for this case.

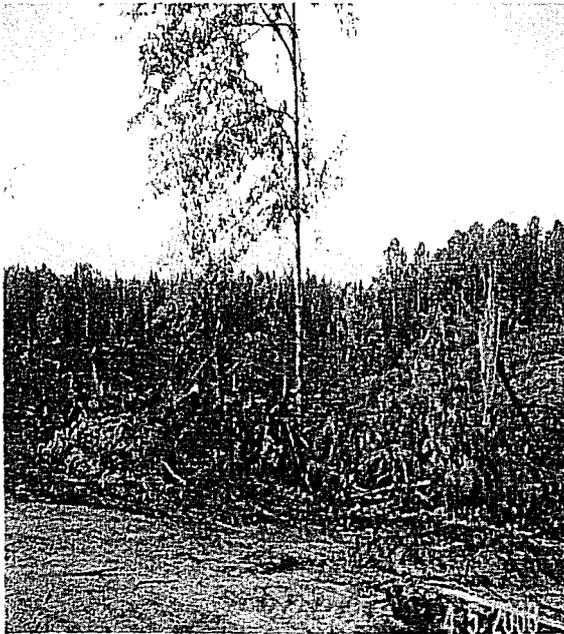
Figure 1.1.a

The existing condition of the subject watershed was determined by aerial photo analysis and field visits to the subject site during 2002. The dominant land-use within the subject watershed is Loblolly Pine plantations with a high-intensity rotational harvest / replant cycle. This type of forest management most often causes excessive erosion in moderately steep channels and floodplains, due mainly to changes in the hydrologic regime, changes in sediment discharge, and the amount of coarse organic (woody) debris entering the channel. The second most prevalent land-use that occurs within the subject watershed is petroleum exploration and production. The scale of this land-use can swing wildly with market fluctuations and could become a potential source for future development pressure (land clearing and increased runoff). The subject watershed is entirely in private land ownership and thusly enjoys no restrictive covenants or conservation easements to date. This may greatly reduce the chance for the stream channel to reach a stable (dynamic equilibrium) state for its desired future condition (DFC).

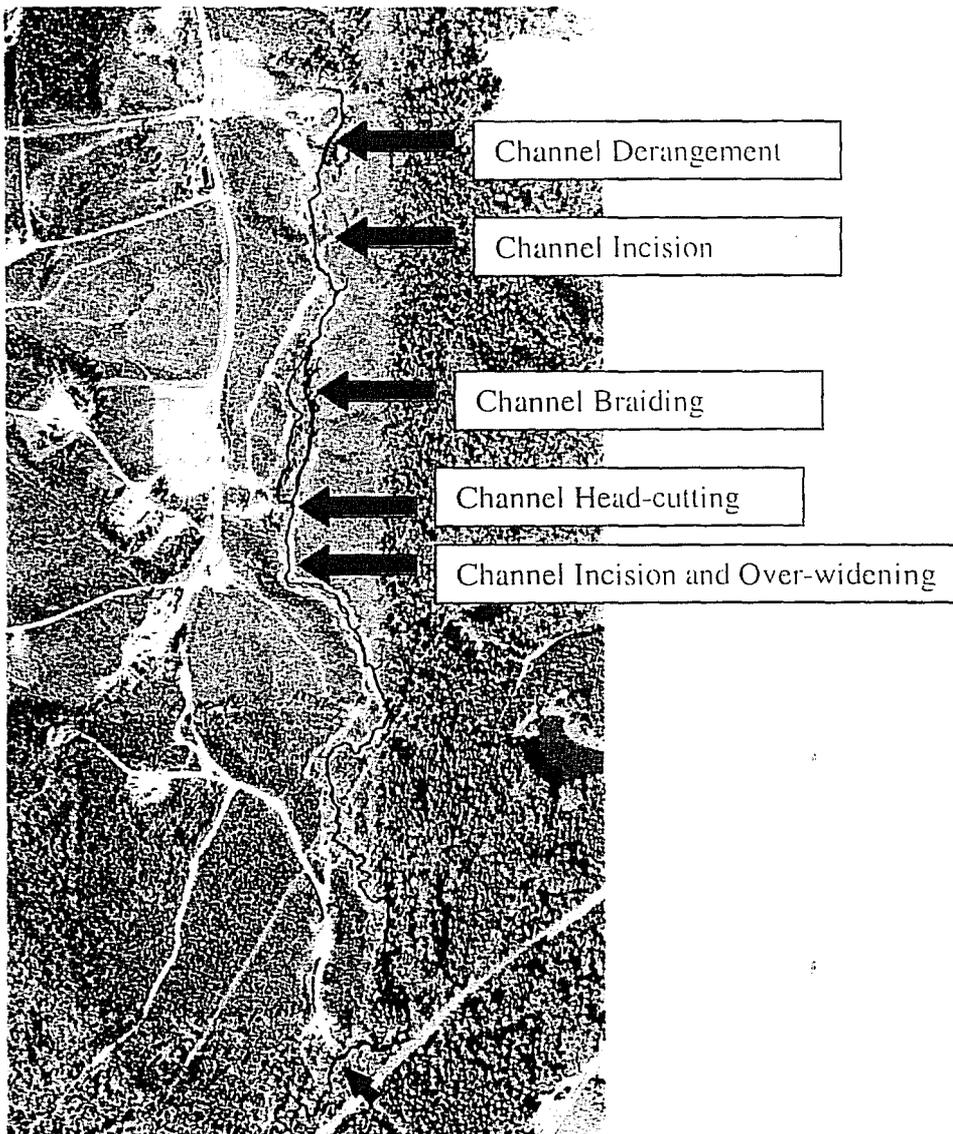
Figure x

The existing condition of the subject channel reach was determined by site visits and a pedestrian survey of the entire channel length during 2002. While conducting the pedestrian survey we performed a coarse scale assessment of the subject channel's geomorphic stability. We found the subject stream channel to be in very unstable condition. We recognized the following five major exhibitions of geomorphic instability: 1.) Channel derangement, 2.) Channel braiding, 3.) Channel incision, 4.) Rotational bank failure, 5.) Head-cut migration. The most severe perturbation to the subject channel within our study reach is the head-cut migration. We surveyed the entire channel from the headwater area down to the subject channel's confluence with the Leaf River. We observed many head-cutting knick-points that are eroding headward (in the upstream direction) as the subject stream works to flatten its gradient (slope along the longitudinal profile). Please refer to attached Power Point Slides for additional site photographs.

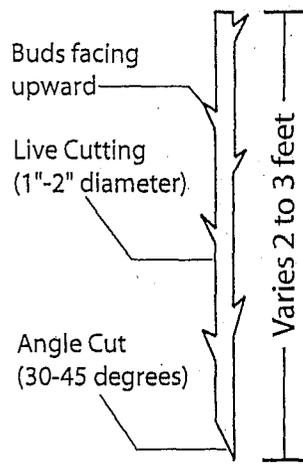
LIVE STAKE

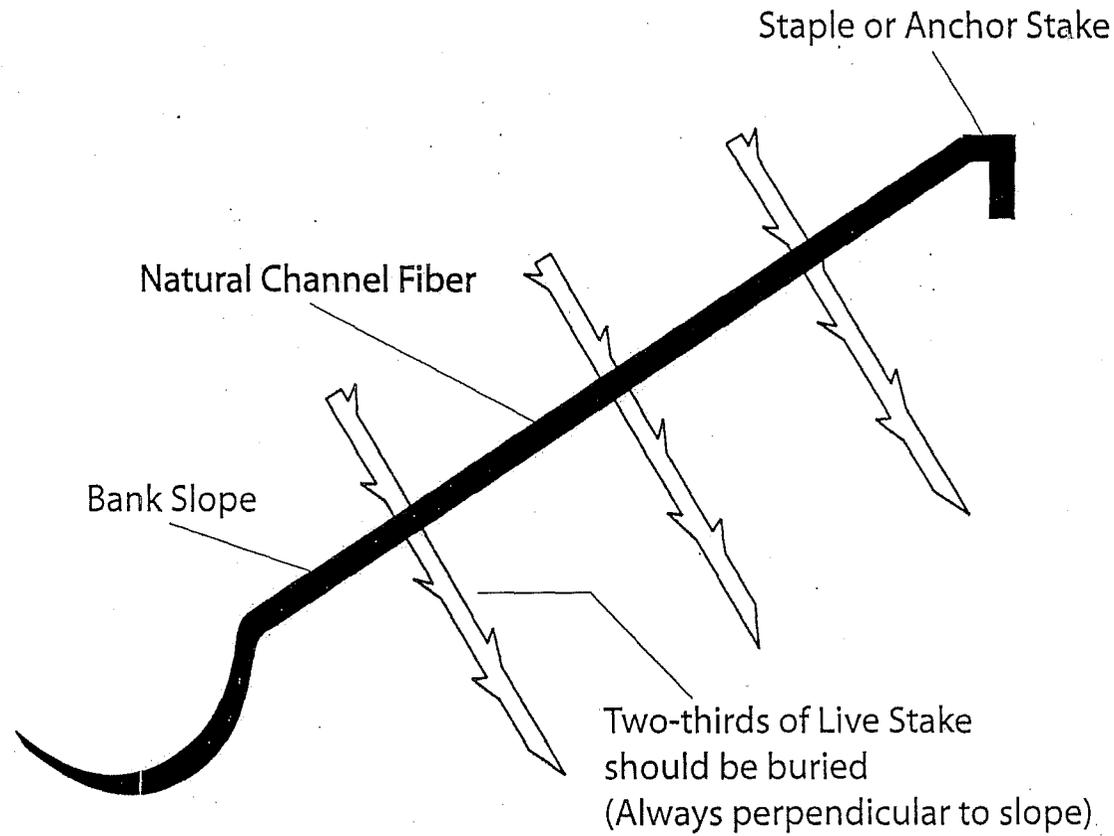
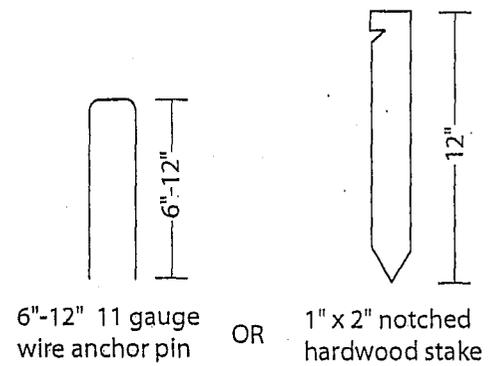
Anchoring

LIVE STAKES

Scale: N.T.S.

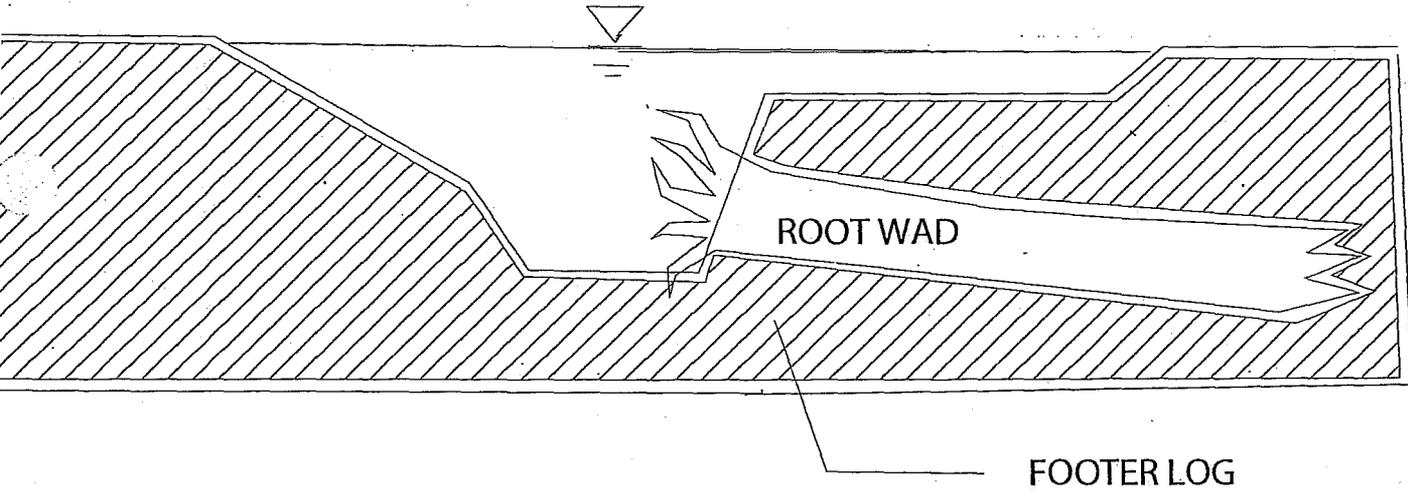
CROSS SECTION VIEW OF ROOT WAD WITHOUT FOOTER LOG

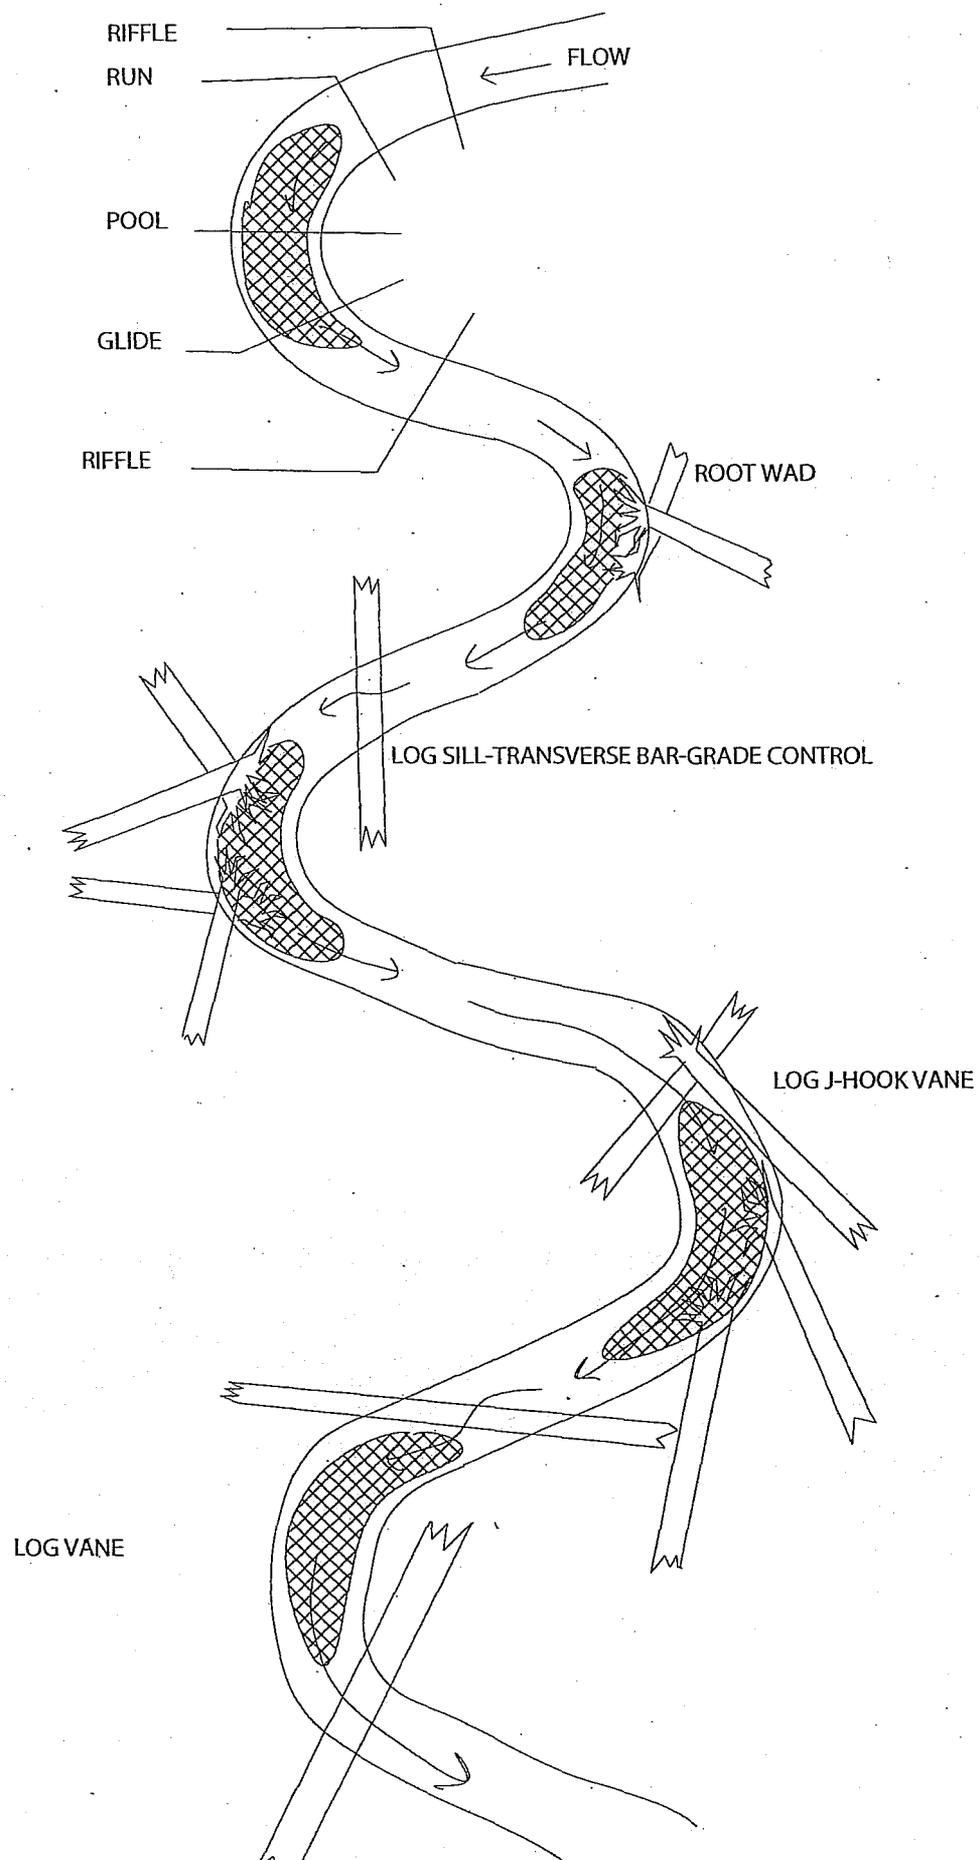
PLAN VIEW OF RESTORATION STRUCTURES

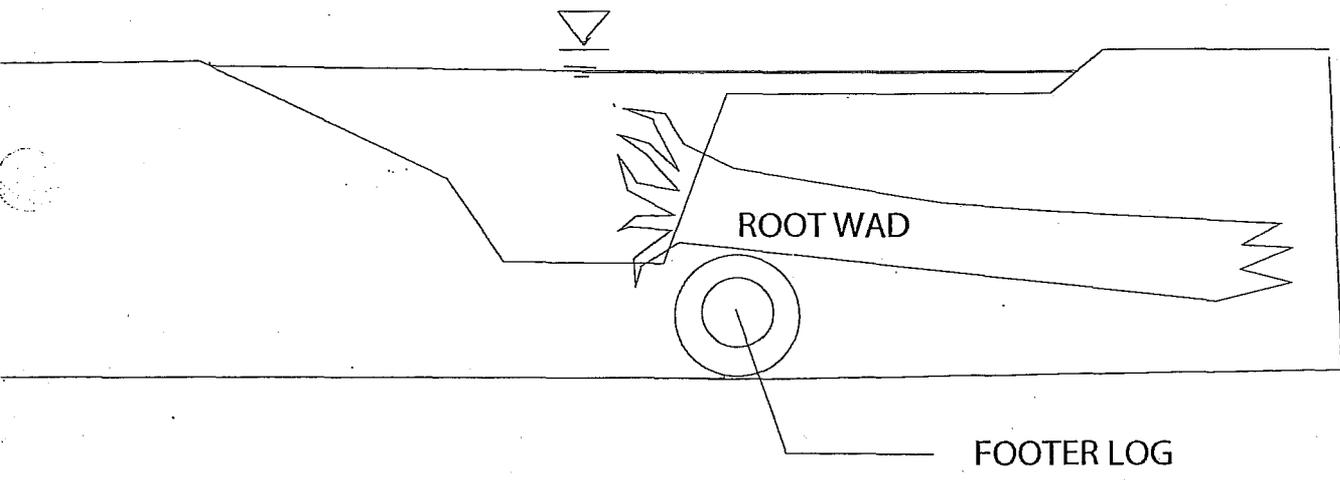
CROSS SECTION VIEW OF ROOT WAD WITH FOOTER LOG

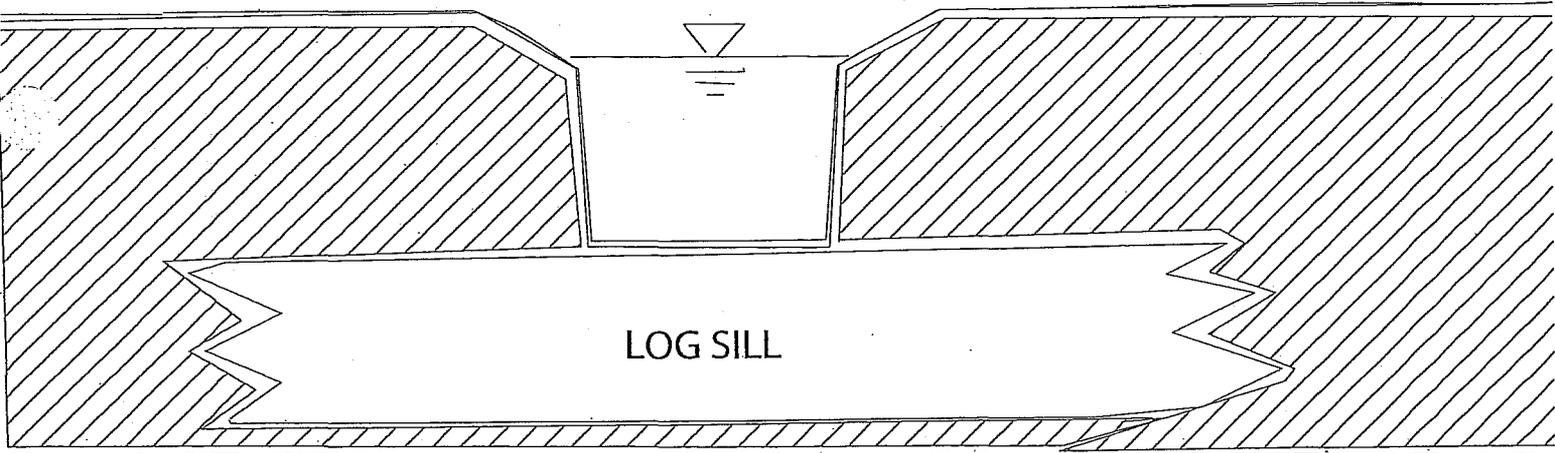
CROSS SECTION TYPICAL FOR LOG SILL

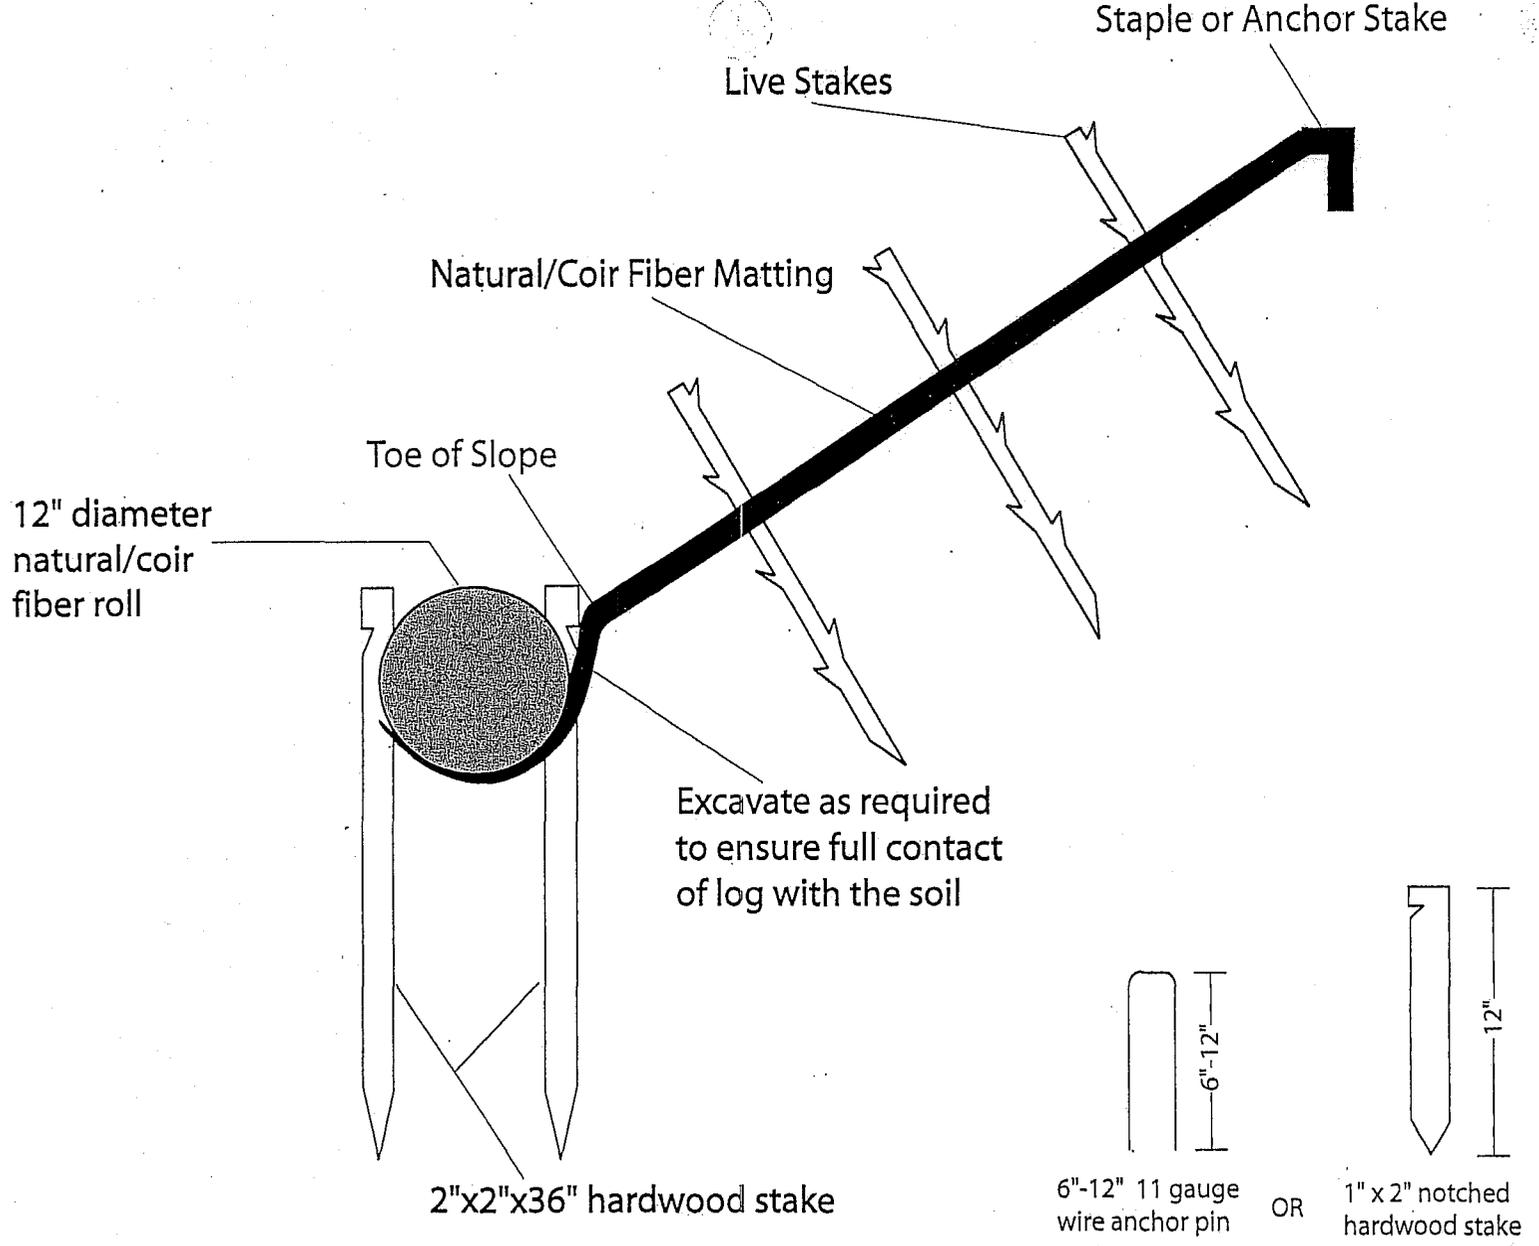
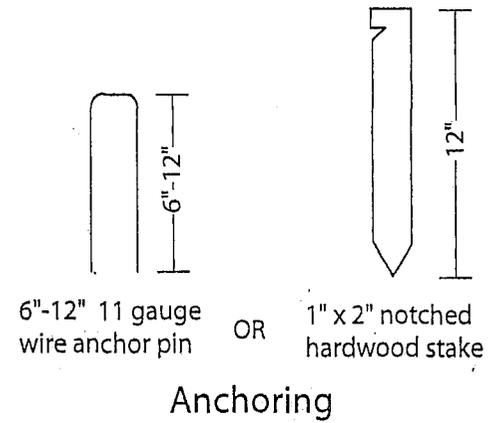
1. Stakes should be evenly spaced throughout length of the log 2 feet apart.
2. Stakes shall be driven flush with the fiber roll.

NATURAL/COIR FIBER ROLL
 Scale: N.T.S.

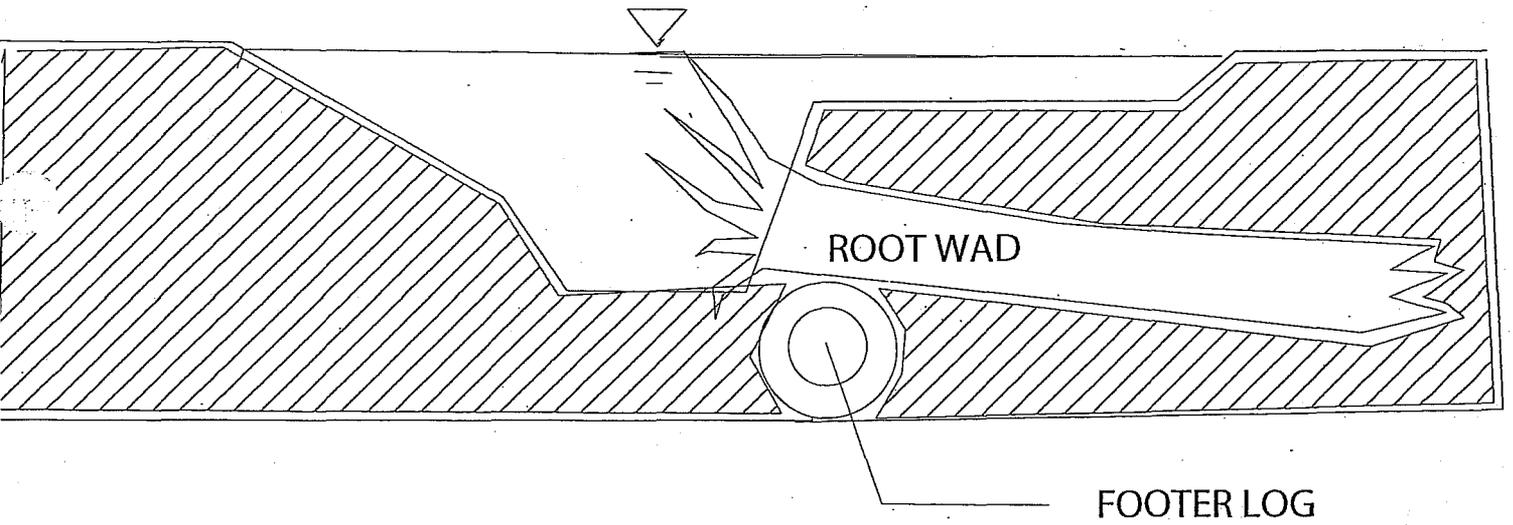
CROSS SECTION VIEW OF ROOT WAD WITH FOOTER LOG

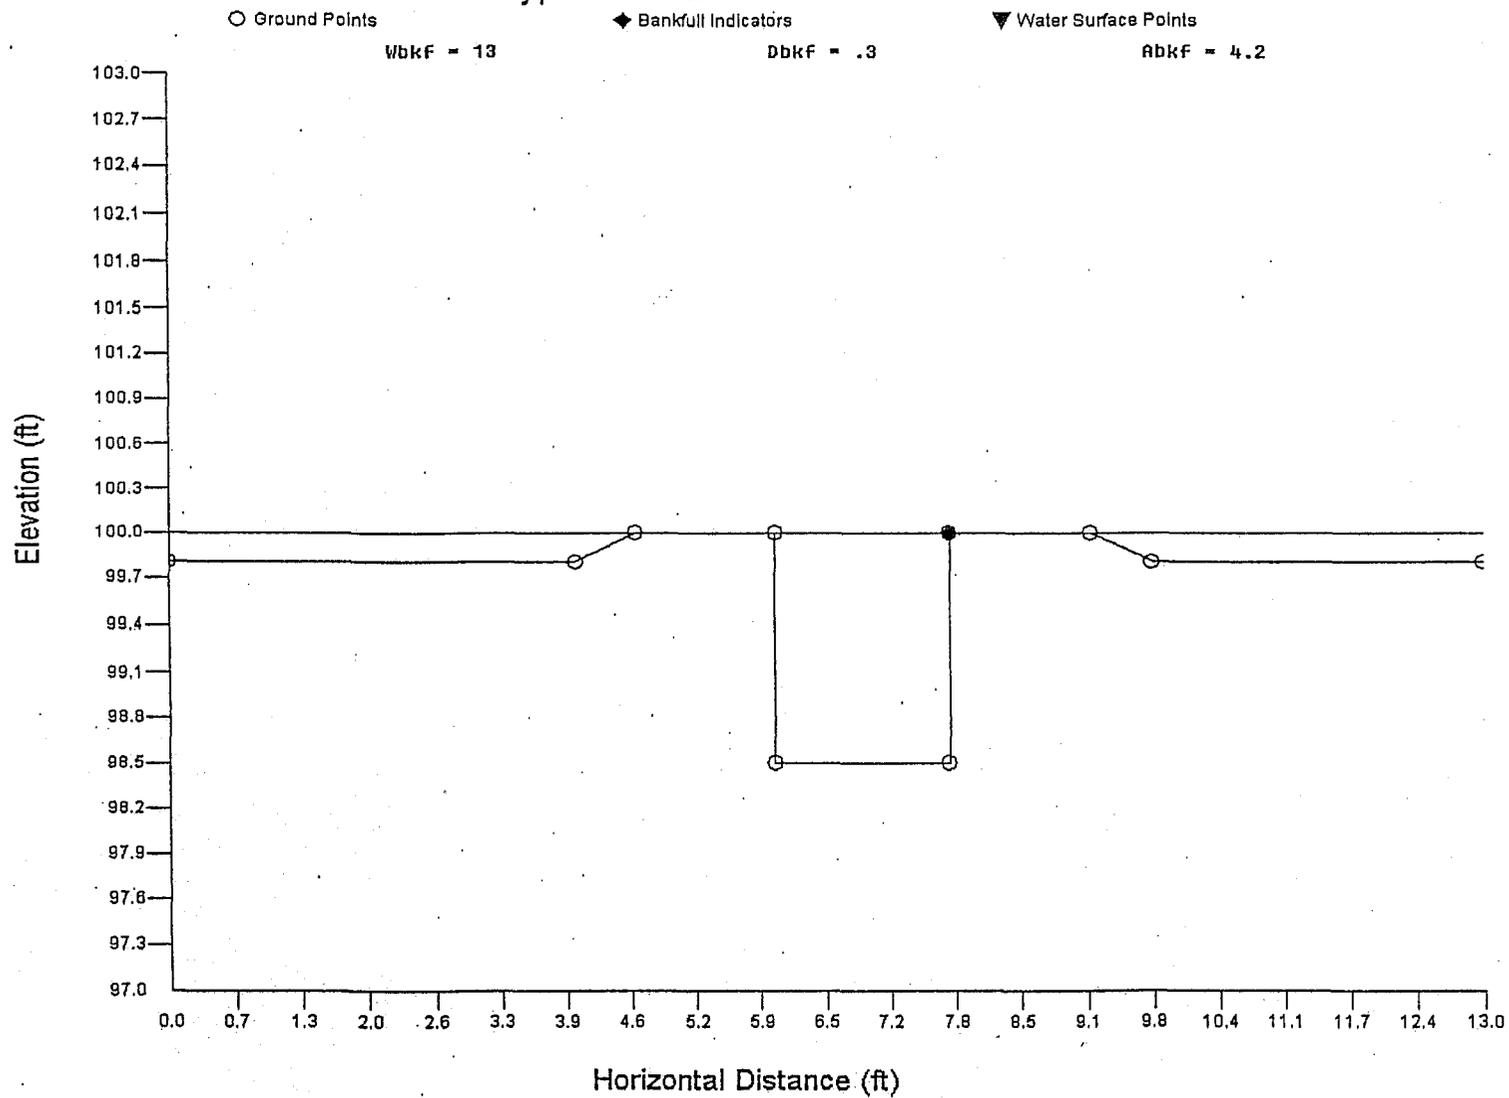
Corresponds to Monitoring Cross
Section : Riffle XS 4
See Map

Typical E Riffle -xs area = 1

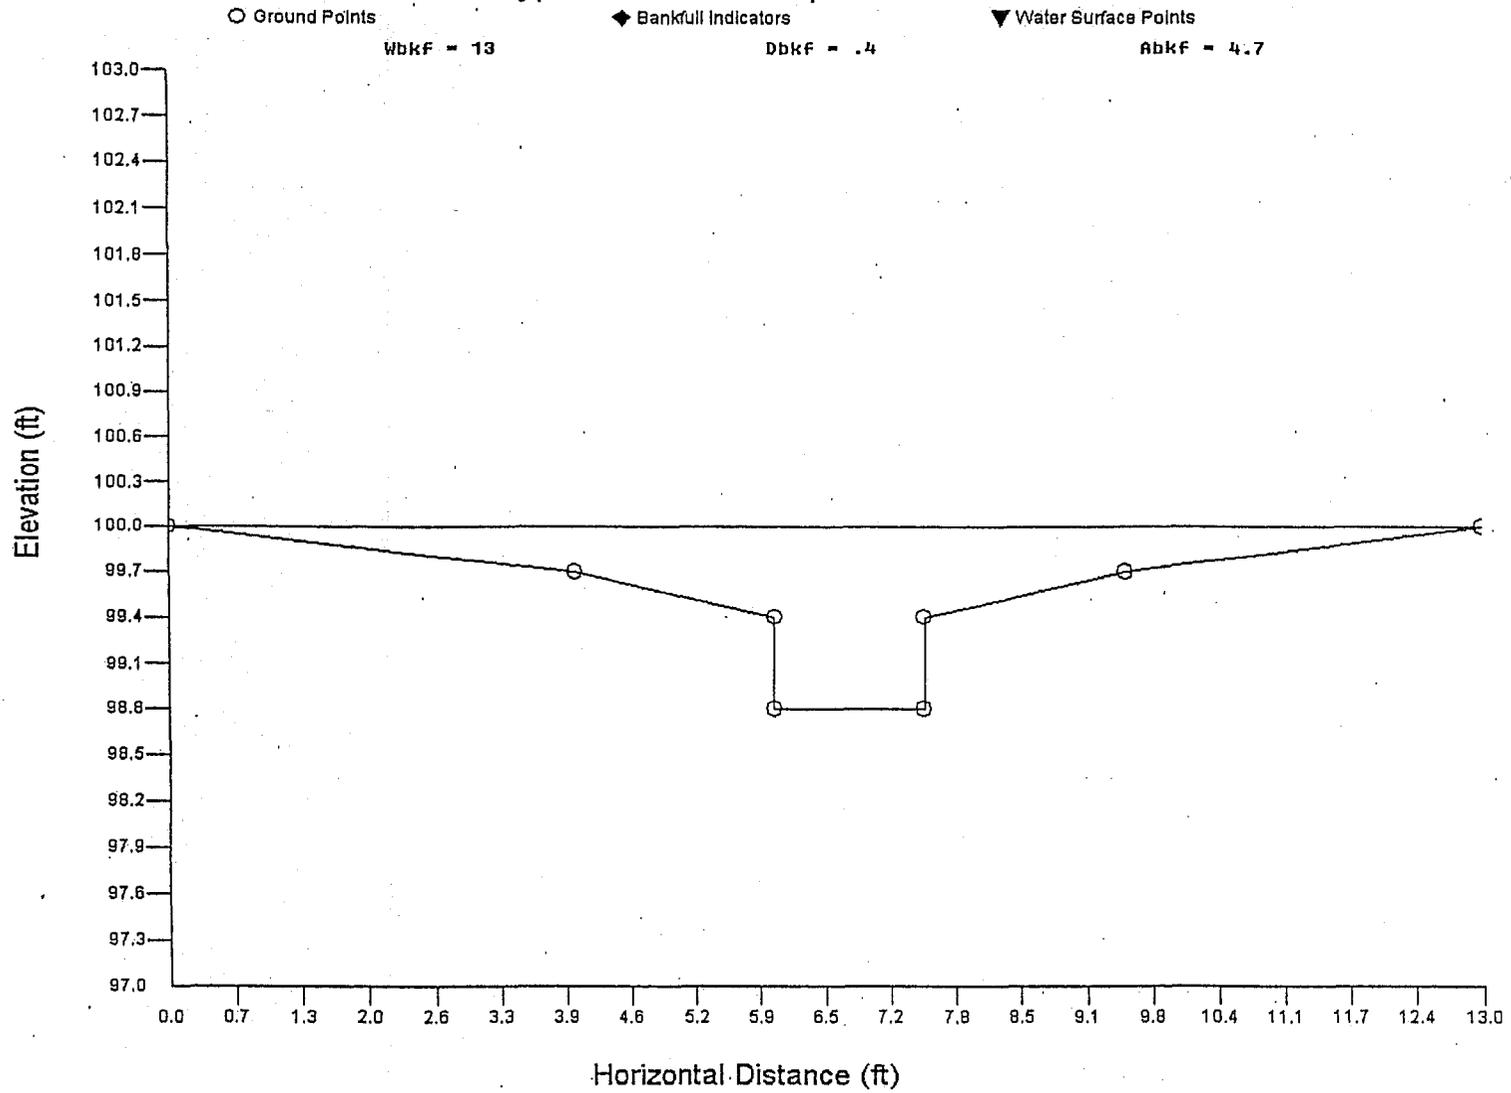
Corresponds to Monitoring Cross
Section : Pool XS 4
See Map

Typical E Pool -depth 1.3 ft.

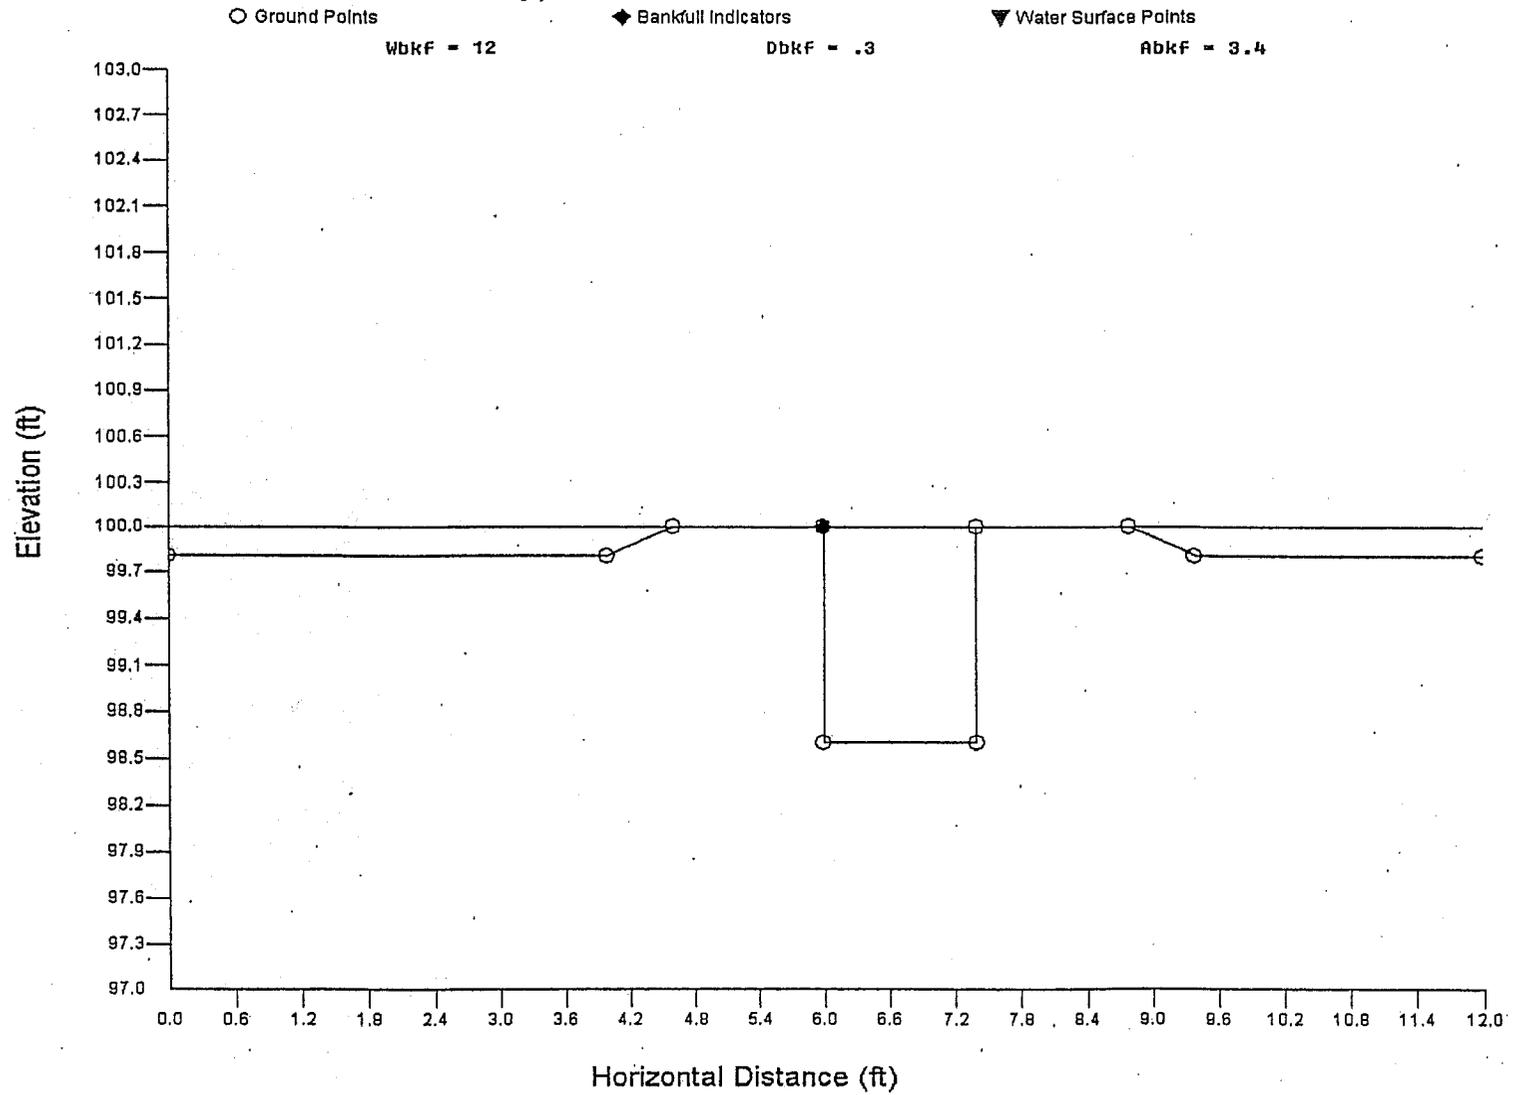
Corresponds to Monitoring Cross
Section : Riffle.XS 1
See Map

Typical E Riffle -xs area = 2

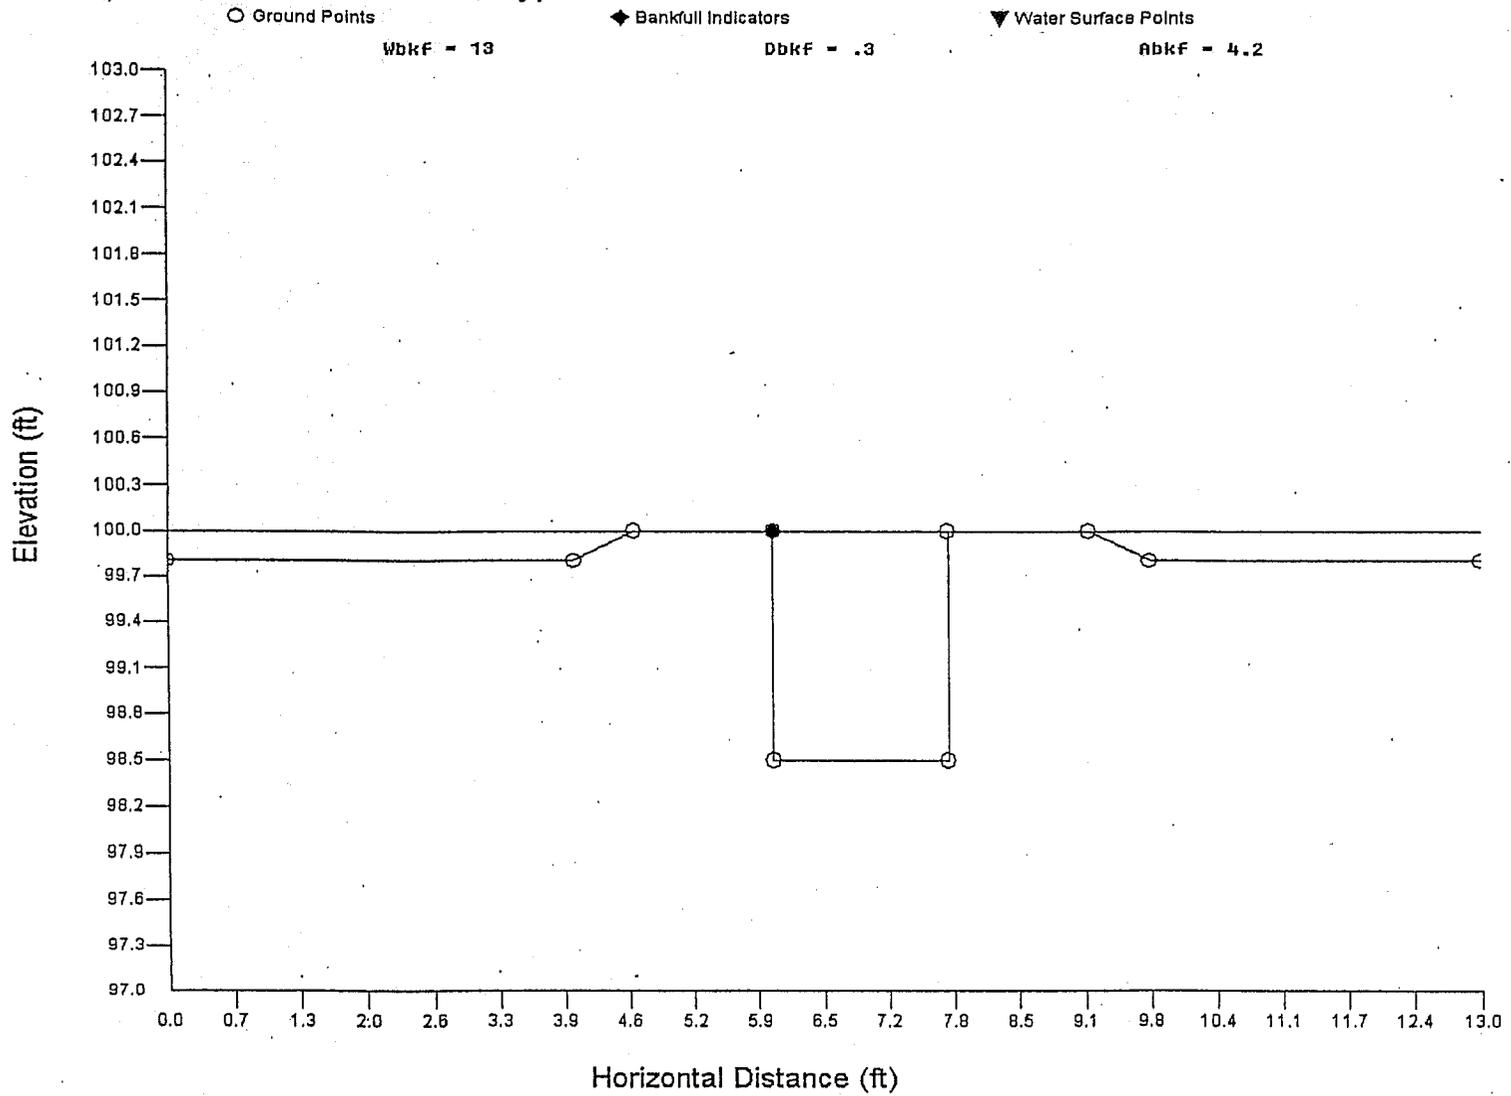
Corresponds to Monitoring Cross
Section : Riffle XS 3
See Map

Typical E Riffle -xs area = 3

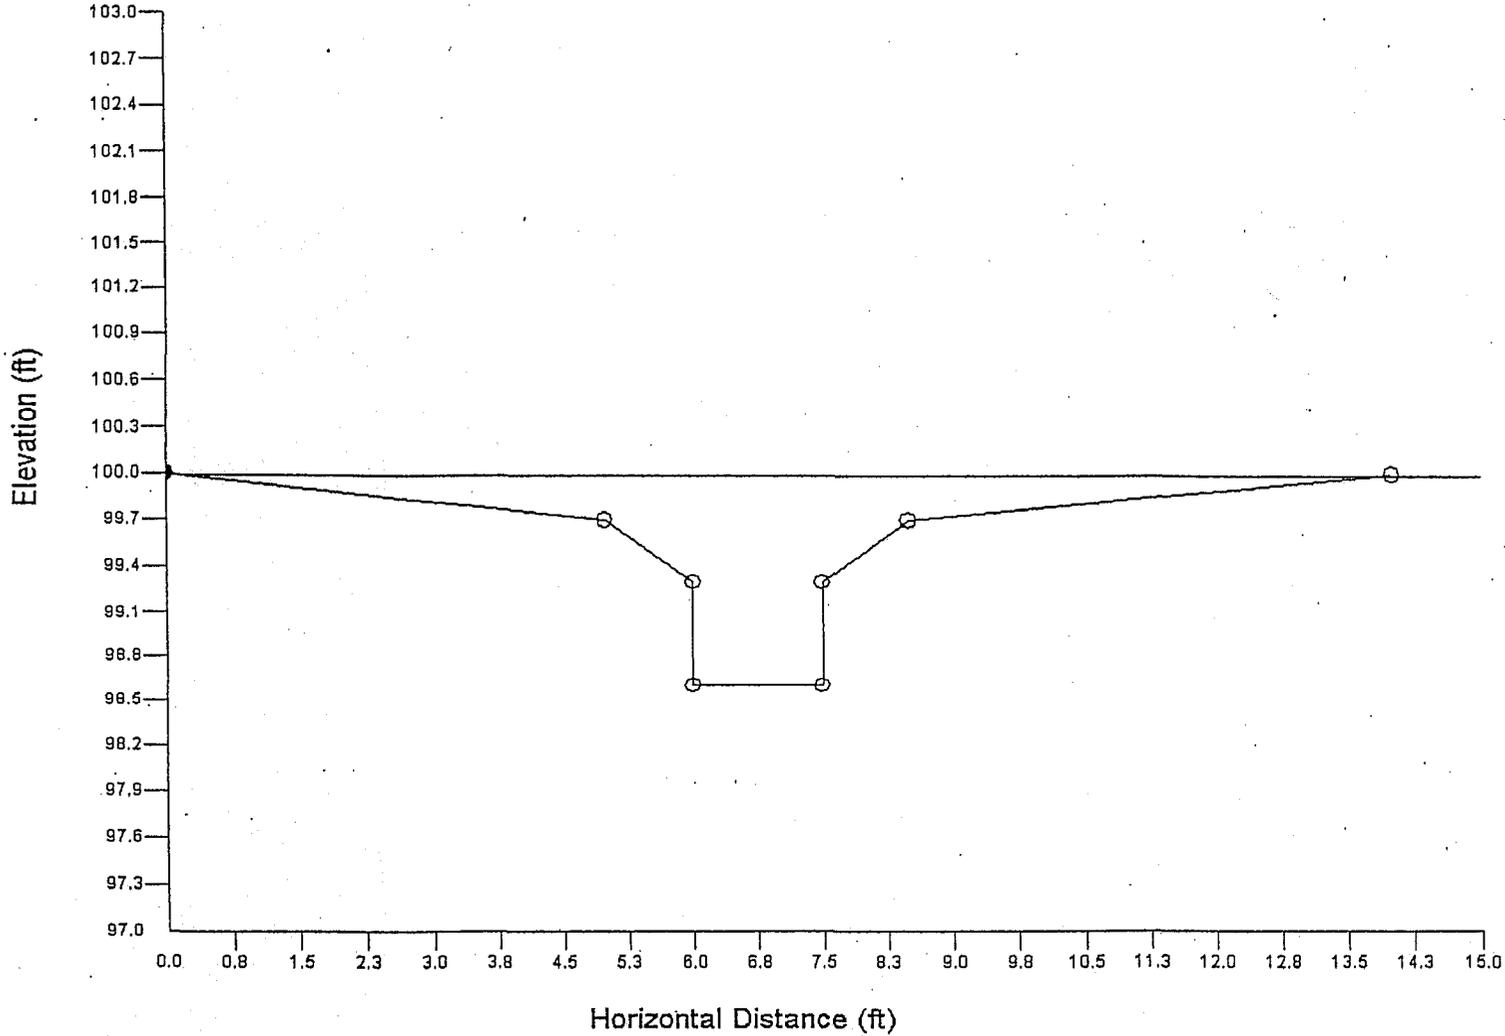
Typical E Pool - max depth 1.5 ft.

○ Ground Points ◆ Bankfull Indicators ▼ Water Surface Points
Wbkf = 13.6 Dbkf = .3 Abkf = 4.5
