**Genesis Crude Oil L.P. Oil Spill,
Soso, Mississippi**

Final Restoration Plan

**Mississippi Department of Environmental Quality
and
the United States Department of the Interior
through the United States Fish and Wildlife
Service**

**Conceptual Restoration Plan
For
Unnamed Tributary to Leaf River, Collins MS.**

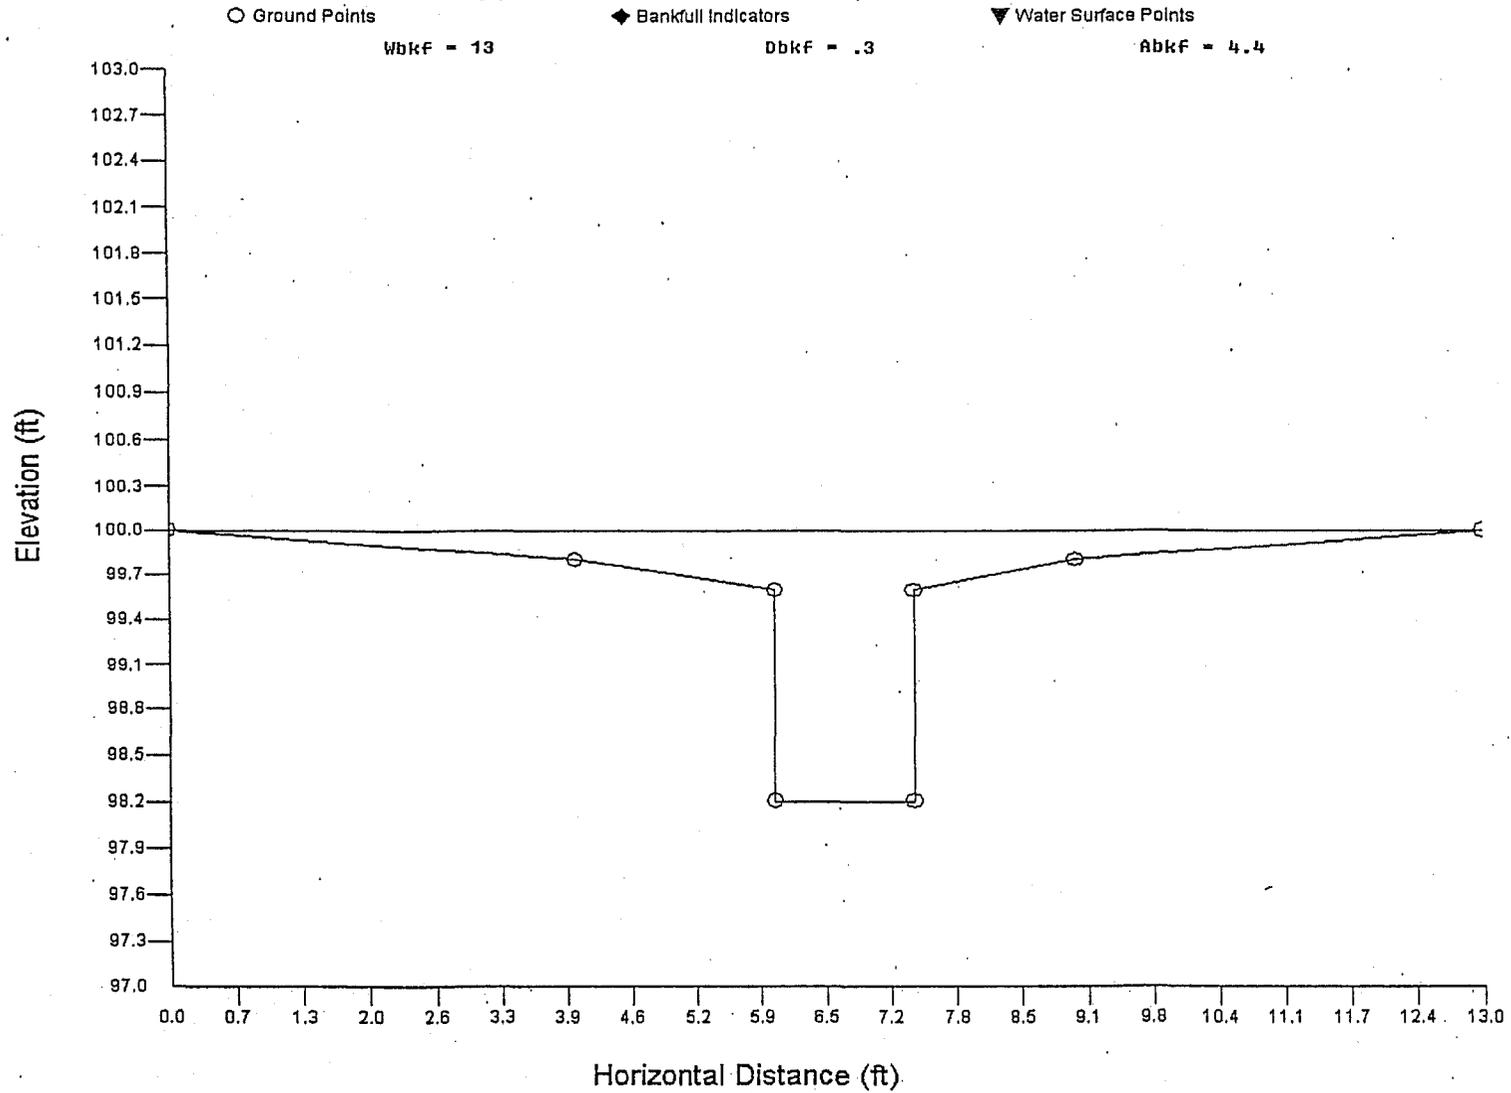
Corresponds to Monitoring Cross
Section : Pool XS 2
See Map

Typical E Pool -max depth 1.8 ft.

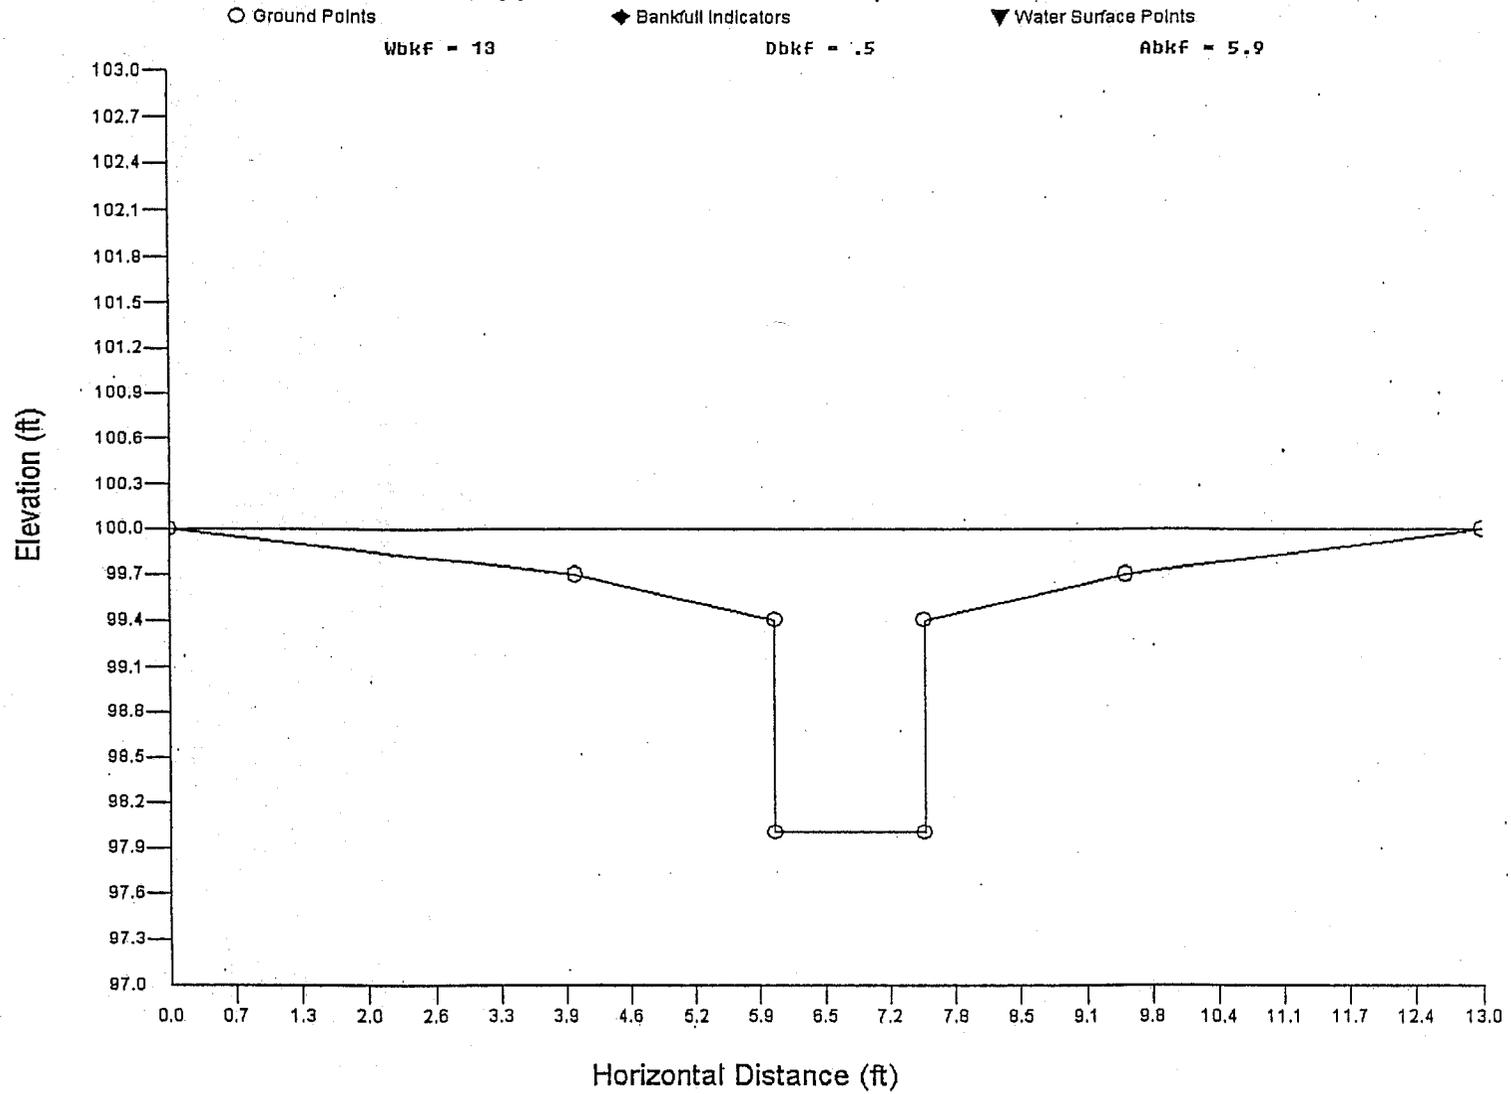
Typical E Pool -max depth 2 ft

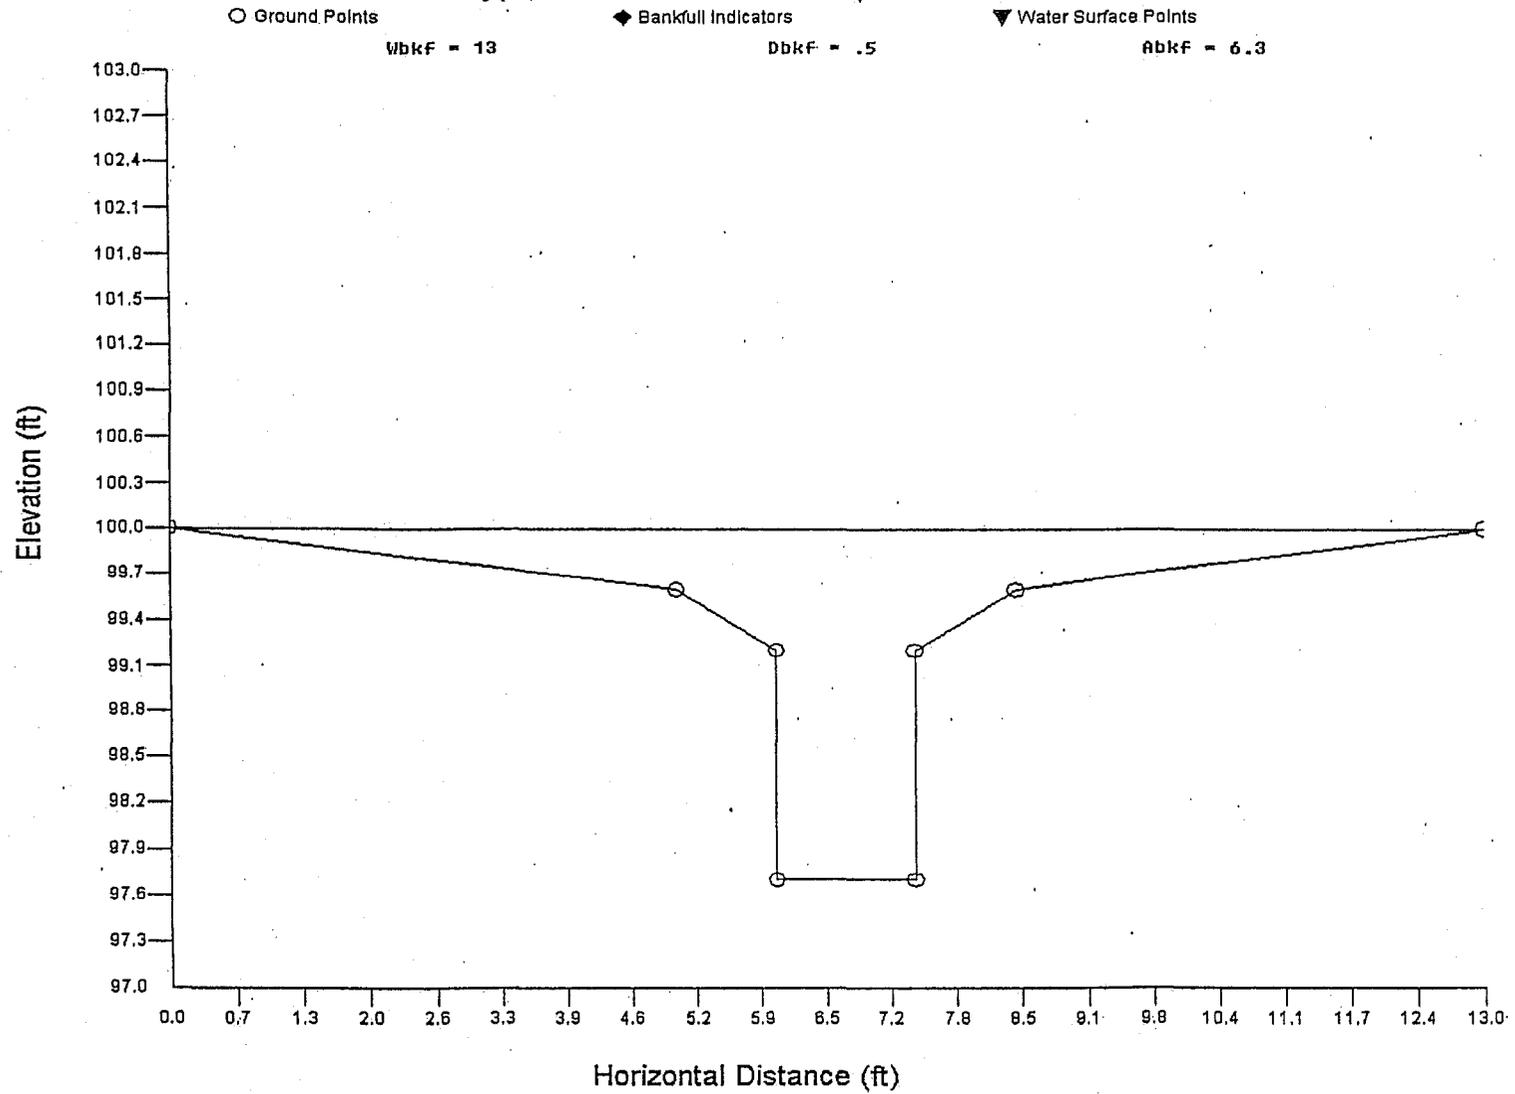
Corresponds to Monitoring Cross
Section : Pool XS 3
See Map

Typical E Pool -max depth 2.3 ft.

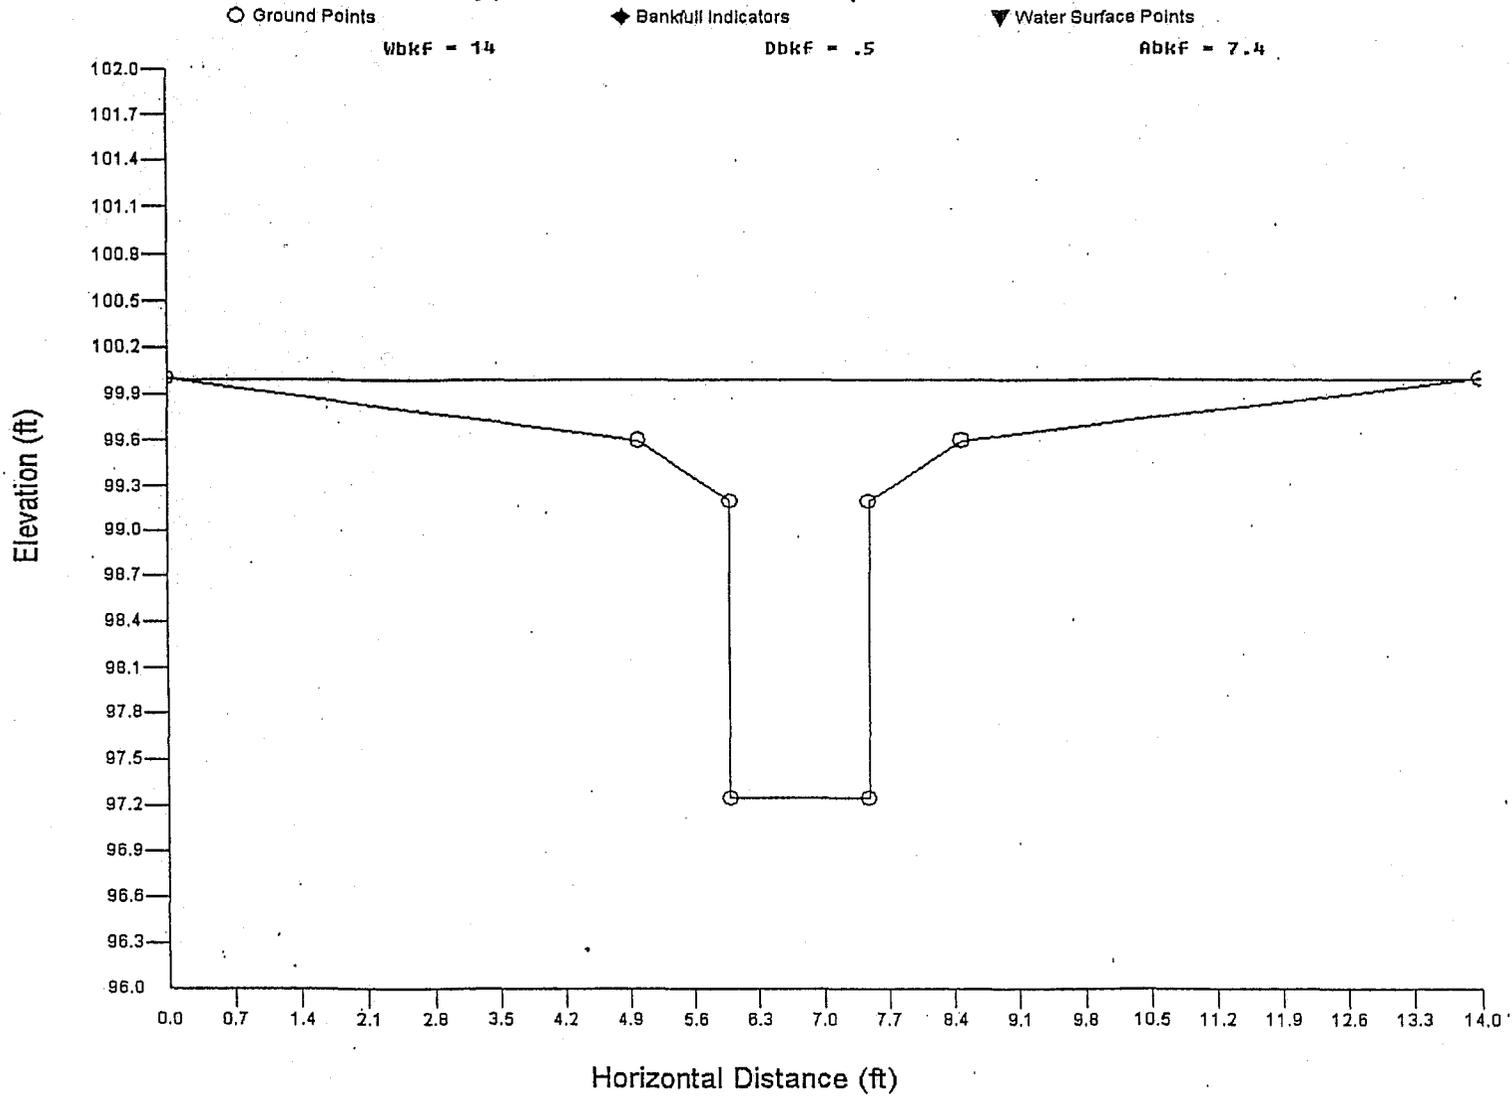
Typical E Pool -max depth 2.75 ft

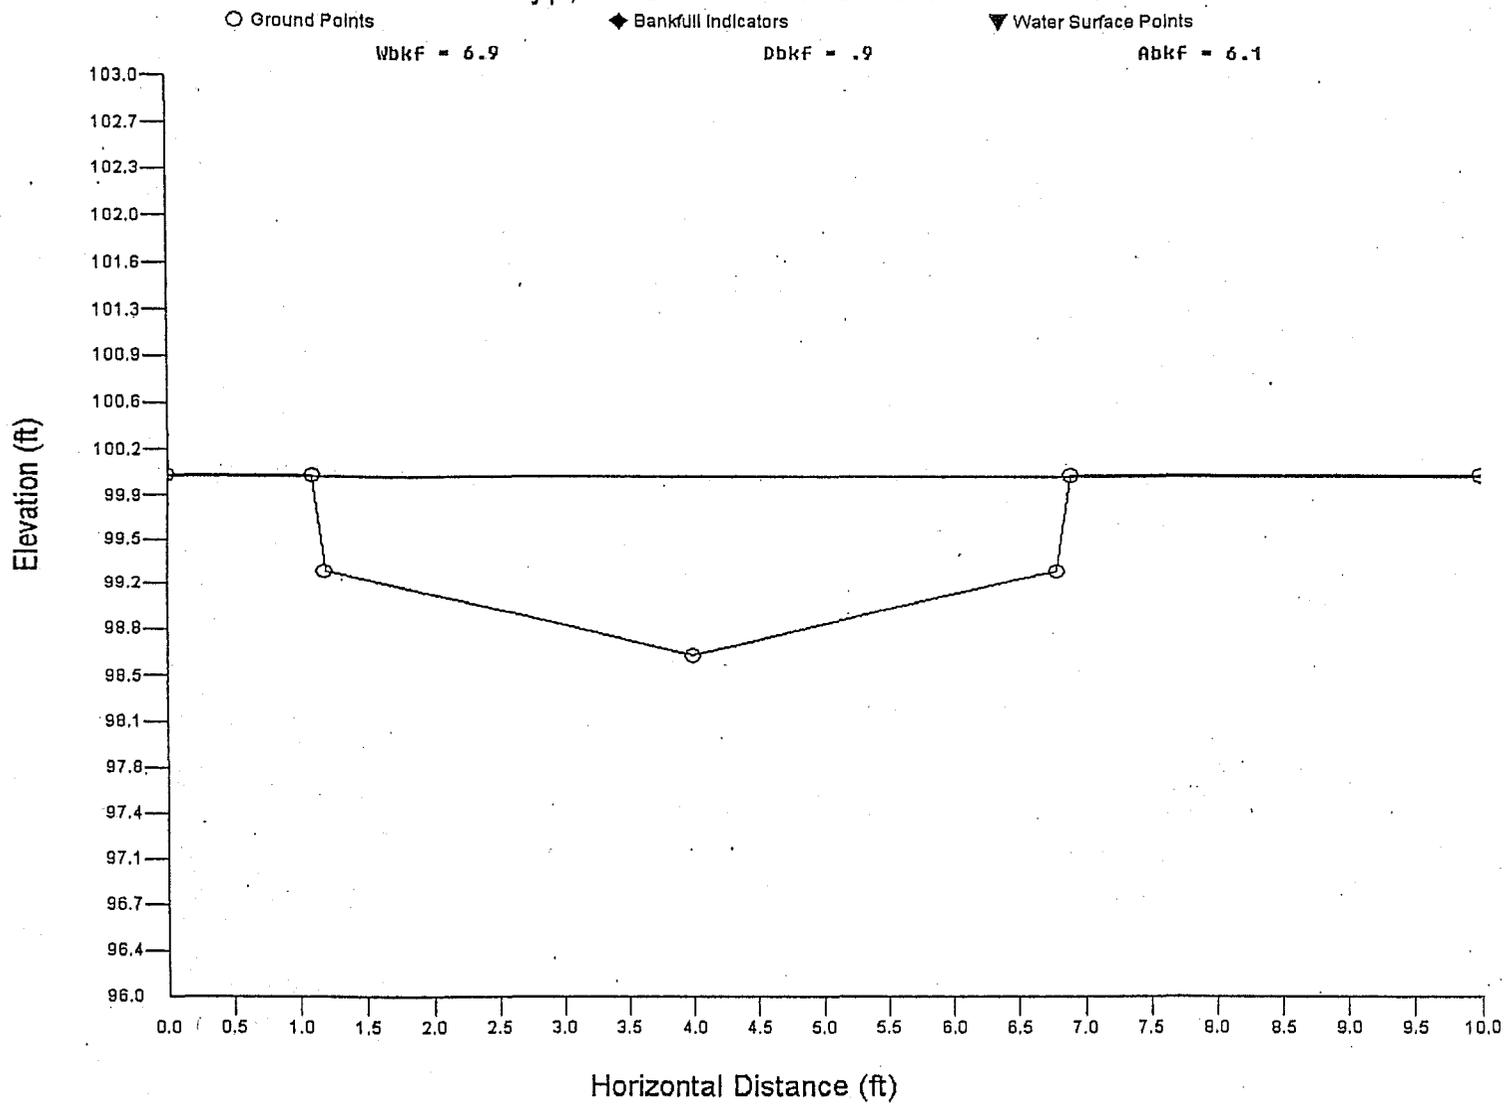
Corresponds to Monitoring Cross
Section : Riffle XS 5
See Map

Typical B Riffle -xs area 7

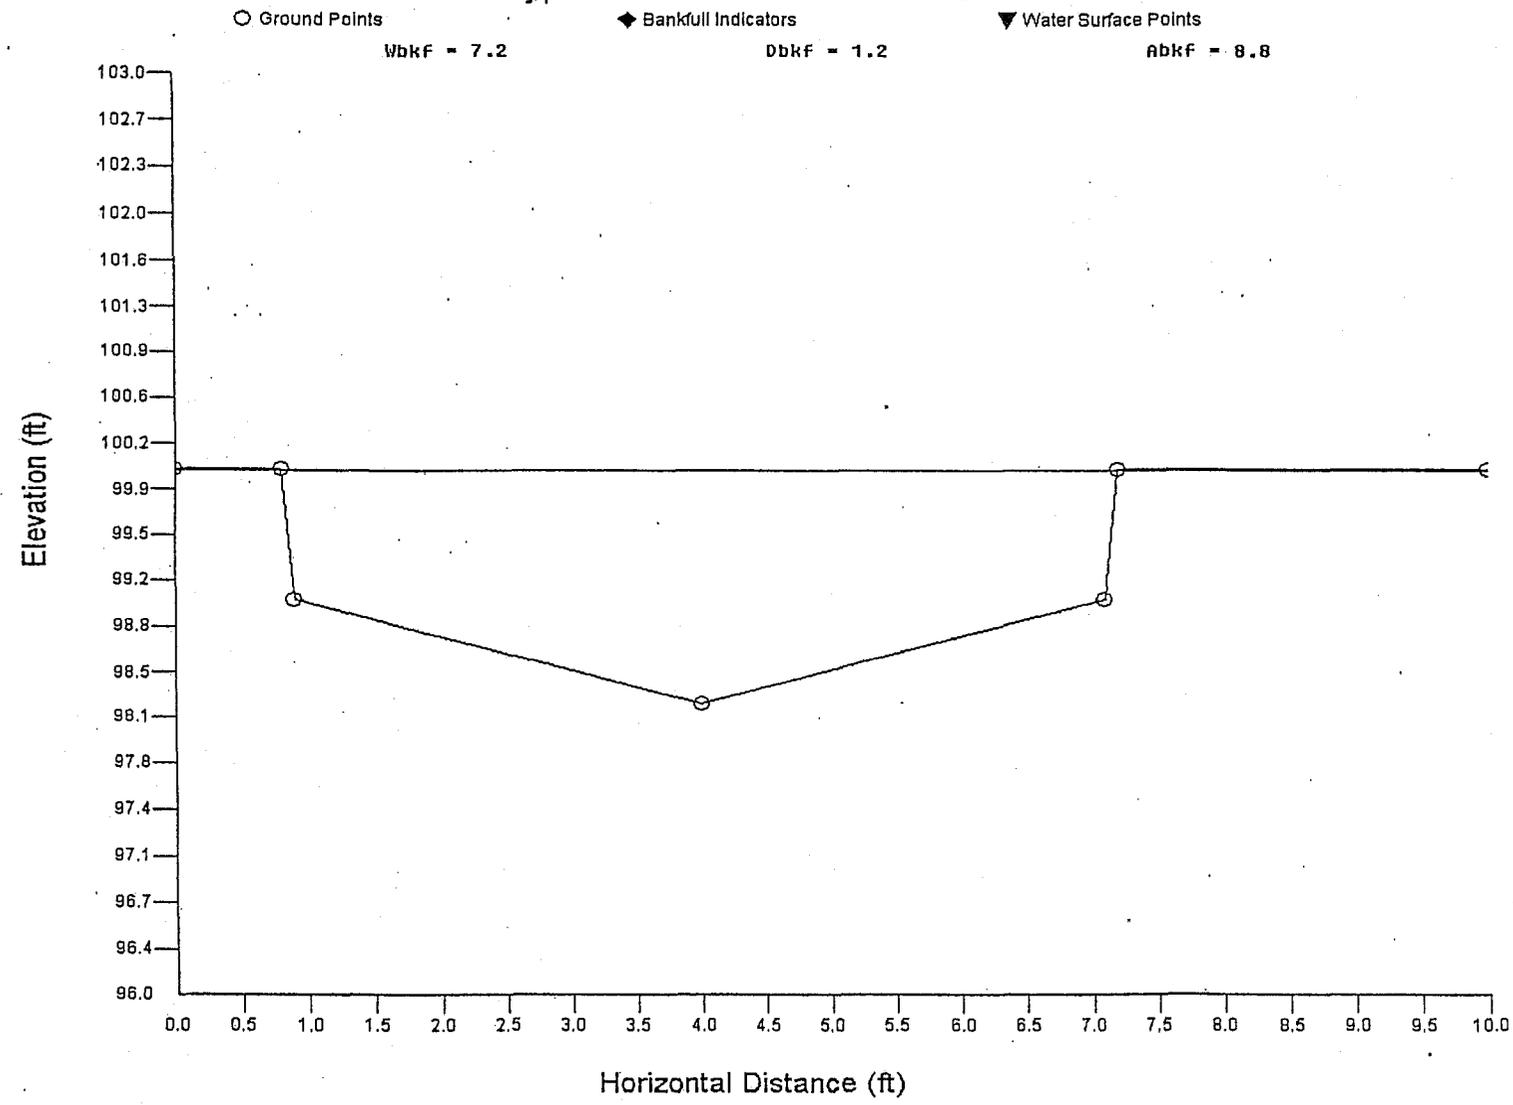
Typical B Riffle -xs area = 9

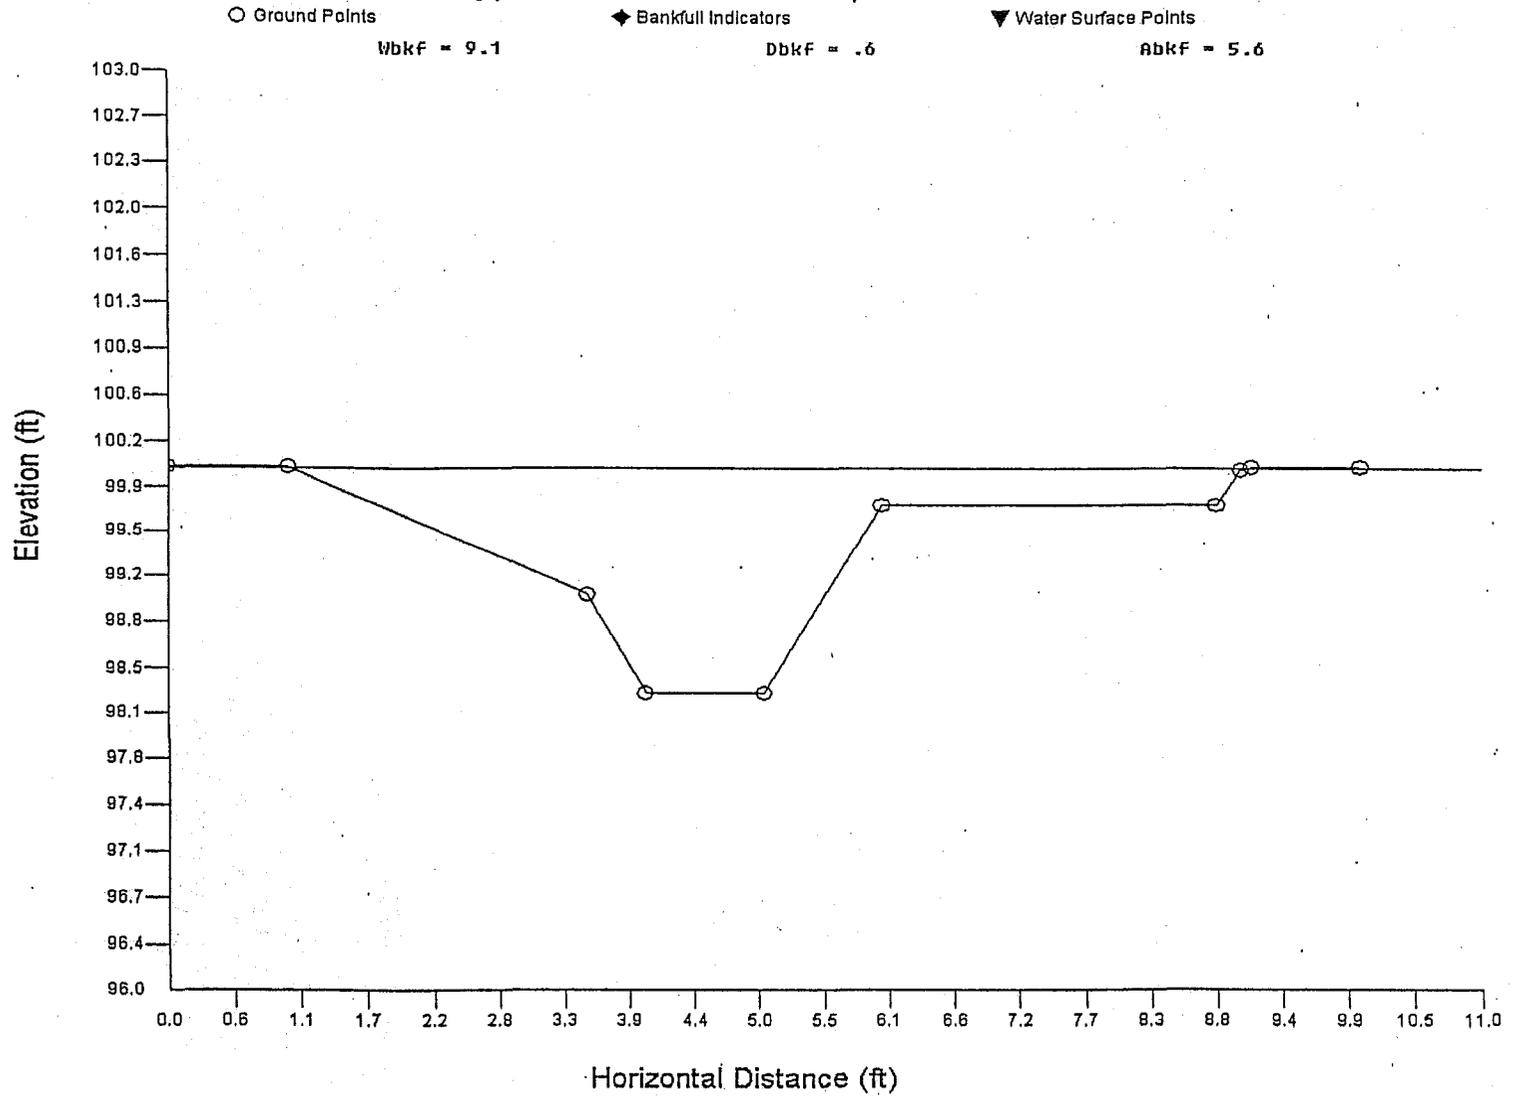
Typical B Pool -max depth 1.75 ft

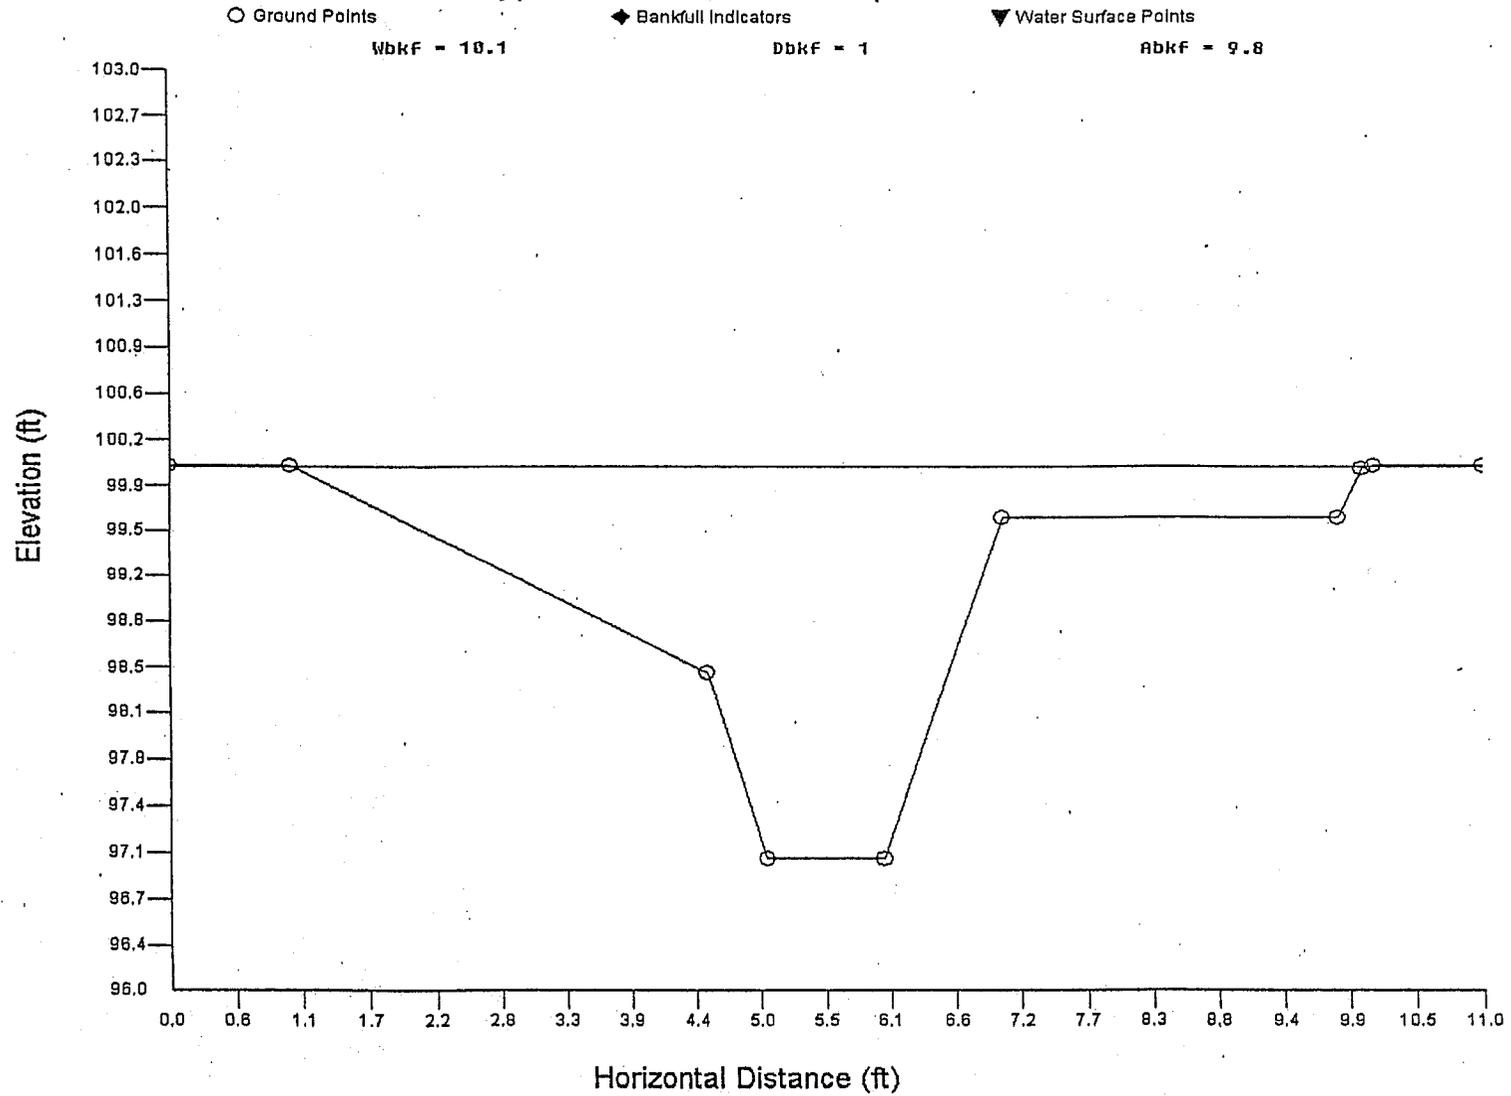
*Corresponds to Monitoring Cross
Section : Pool XS 5
See Map*

Typical B Pool -max depth 3 ft

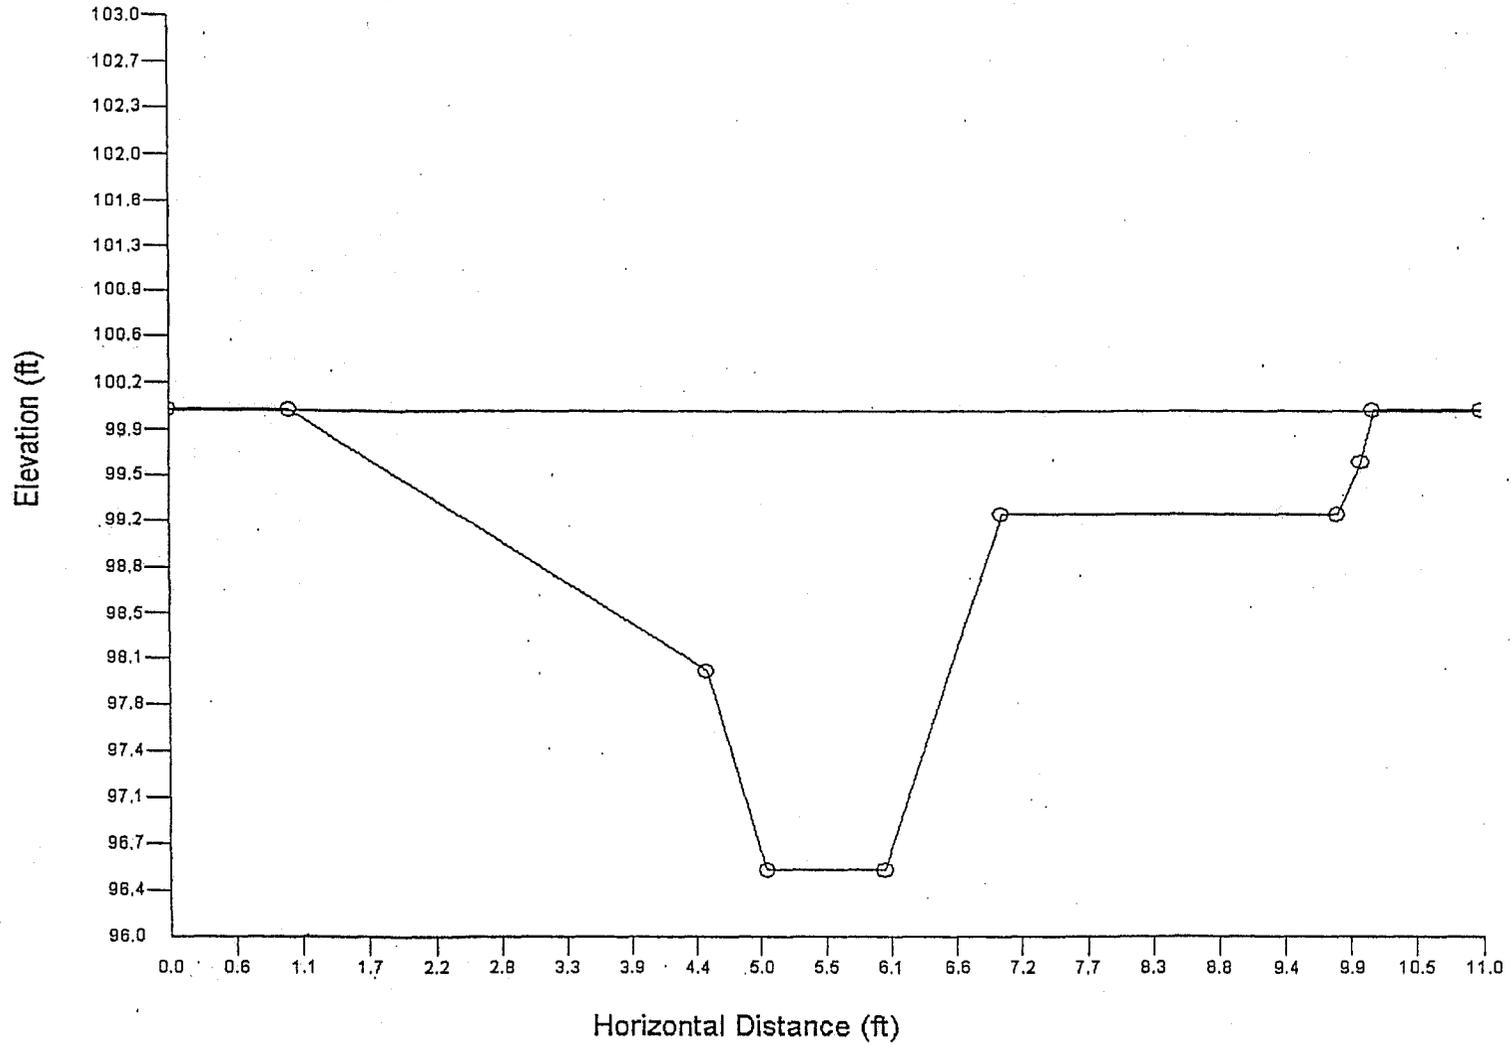
Typical B Pool -max depth 3.5 ft

Dbkf = 1.3

Abkf = 12.9
