# **Elliott Bay/Duwamish Restoration Program: Intertidal Habitat Projects Monitoring Report 2007 Report**

# **Elliott Bay/Duwamish Restoration Program: Intertidal Habitat Projects Monitoring Report**

## **2007 Report**

**Prepared By:  
U.S. Fish and Wildlife Service  
Western Washington Fish and Wildlife Office**

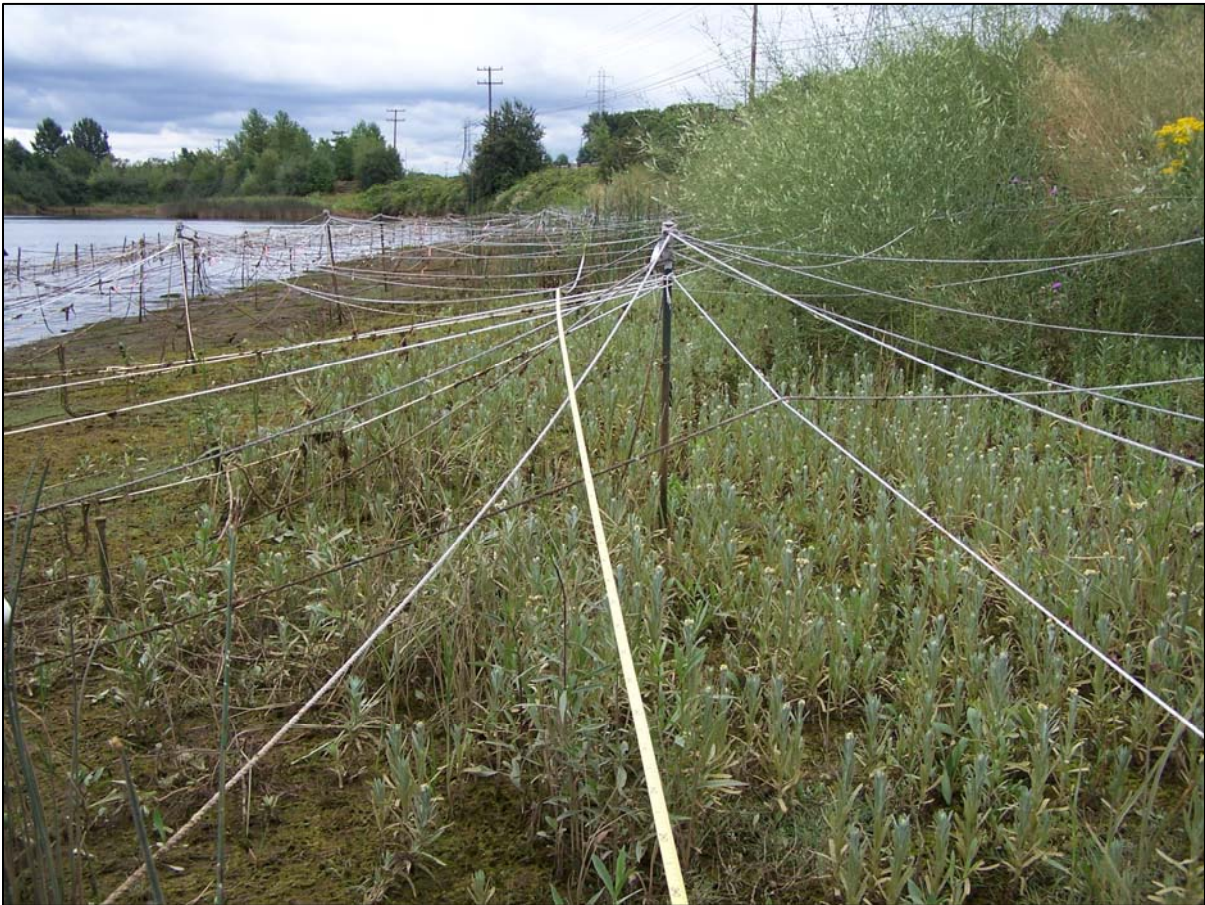
*Cover photo:* Goose excluder fencing on the Kenco Marine restoration site.

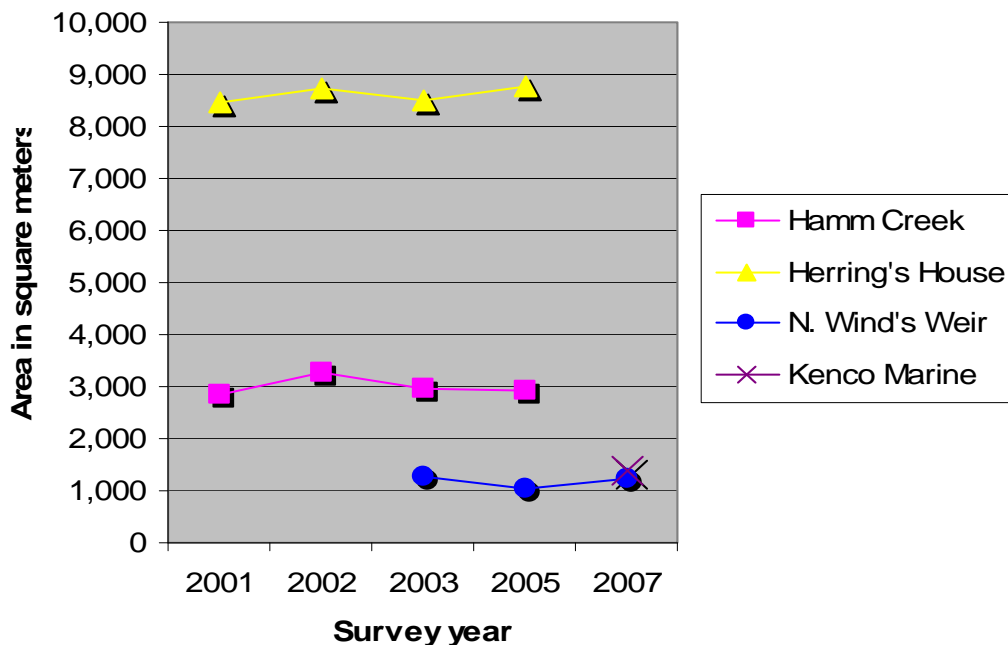
**Figure 5. Intertidal area measurements by survey year for restoration sites.**

The intertidal area estimates for the restoration sites are provided in **Figure 5** from the data in **Table 2**.

The intertidal area at North Wind's Weir has remained at 0.3 acre since construction. The small difference in estimated intertidal area from 2003 to 2005 (-248 m<sup>2</sup>) is likely due in part to random error and measurement error. From visual observations, the site continues to appear stable with no noticeable signs of erosion or deposition of sediments. The intertidal area estimate does not meet Physical Success Criterion 1 of 0.9 acre (90 percent of 1 acre) for the site. The monitoring plan (EBDRP 2000) states that the entire area of the North Wind's Weir site is 1 acre in size. The 0.7-acre difference in intertidal area between the estimated value and the expected value (1 acre) suggests that the site was not constructed as originally planned and/or does not take into consideration the riparian area around the basin.

The Kenco Marine site was constructed and initially planted in 2006 with some replacement planting occurring in 2007. Measurements for area were taken using the goose excluder fence as a reference point and extending approximately 10 ft beyond fence line to approximately the 2.3 ft MLLW line. Hamm Creek and Herring's House sites continue to appear stable since their construction and were not monitored for intertidal area in 2007.

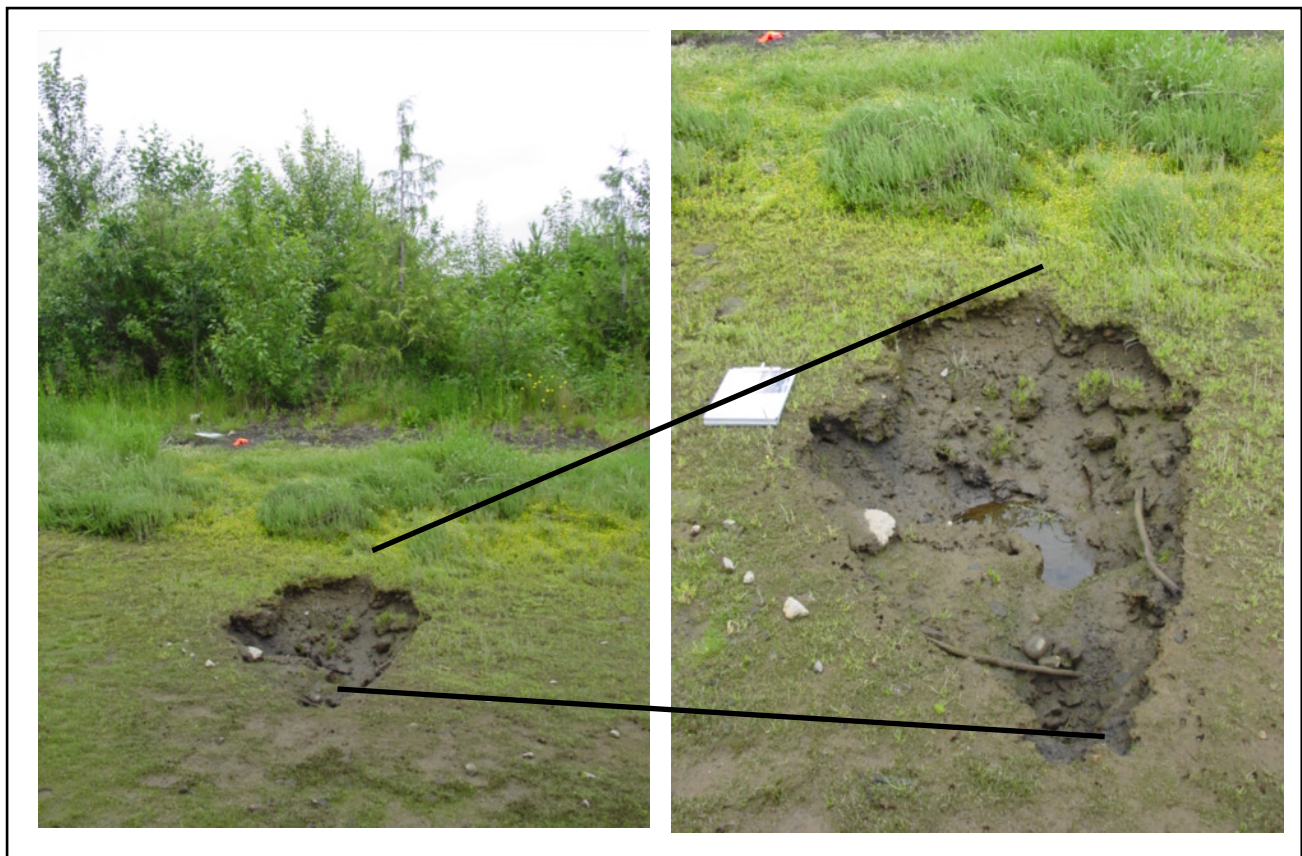
**Figure 6. Sink-hole erosion located in the intertidal area at Herring's House restoration site in 2005.**

The only sign of erosion-related change at Herring's House was the 'sink hole' first observed in the intertidal area in 2005 (**Figure 6**). This sink hole has doubled in size to approximately 1.5- meters wide by 3-meters long (**Figure 7**). The North Wind's Weir site has remained stable since construction was completed. No signs of erosion were seen at the Kenco Marine site.

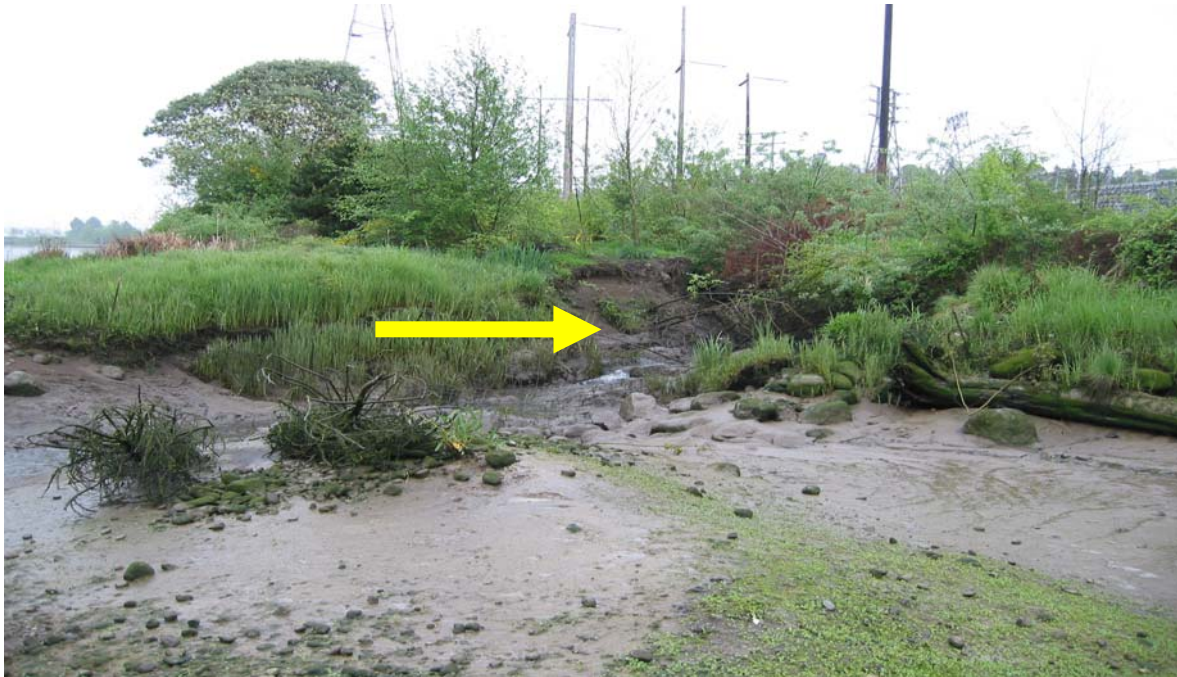
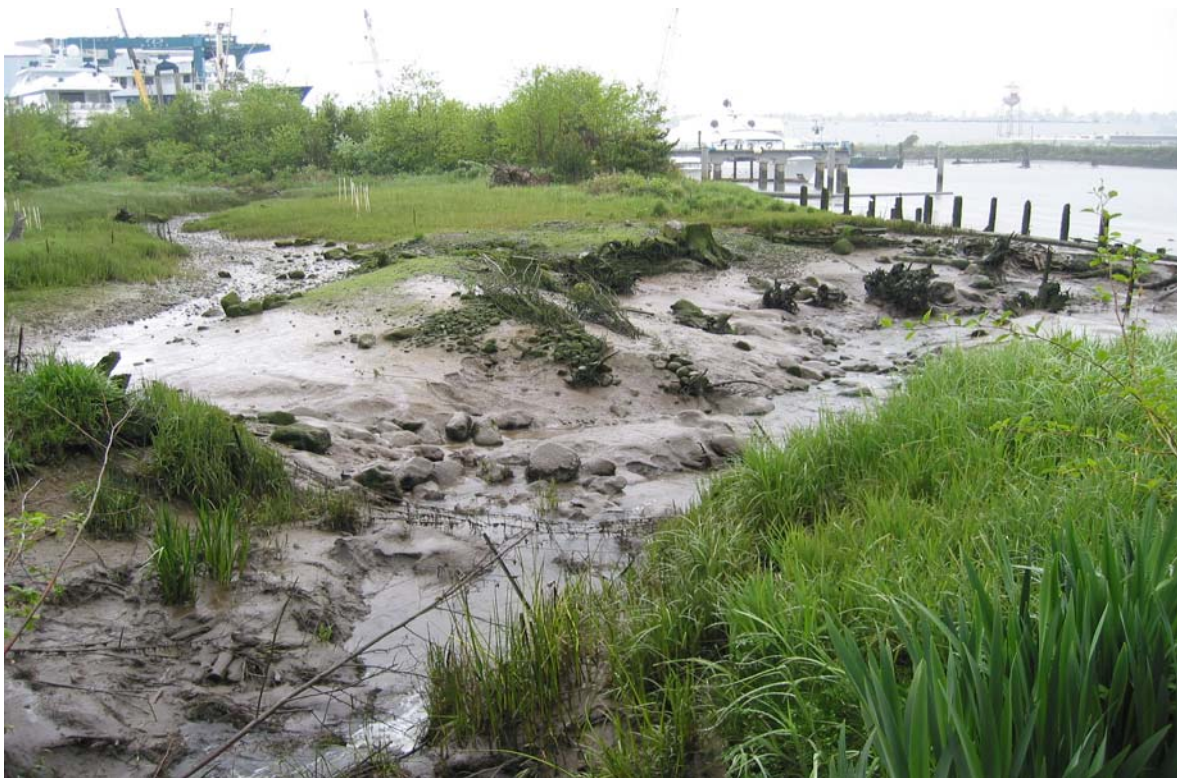
**Figure 8. Stream channel changes and erosion at Hamm Creek in 2007.**

Major erosion occurred at the Hamm Creek restoration site during winter storm events in 2006/2007. In addition, beaver dams along the creek have caused water to back up and create a new creek channel cutting through the berm that previously separated the freshwater and saltwater marshes (**Figure 8**). The County currently has permits pending to restore the site to its prior condition.

The Hamm Creek site was not constructed with riprap or armoring where the creek flows into the Duwamish River. The confluence of the creek with the Duwamish River is a dynamic area and the creek's course continues to meander. After the erosion event in 2002, King County strategically placed large boulders, cobble, and root wads along the north bank of the creek to protect the eroding peninsula and slow the rate of erosion at the site. In 2005 that erosion appeared to have slowed considerably. However, in 2007 there was further erosion on the north bank at the mouth of the creek and considerable erosion caused by the creek cutting a new channel through the freshwater marsh.

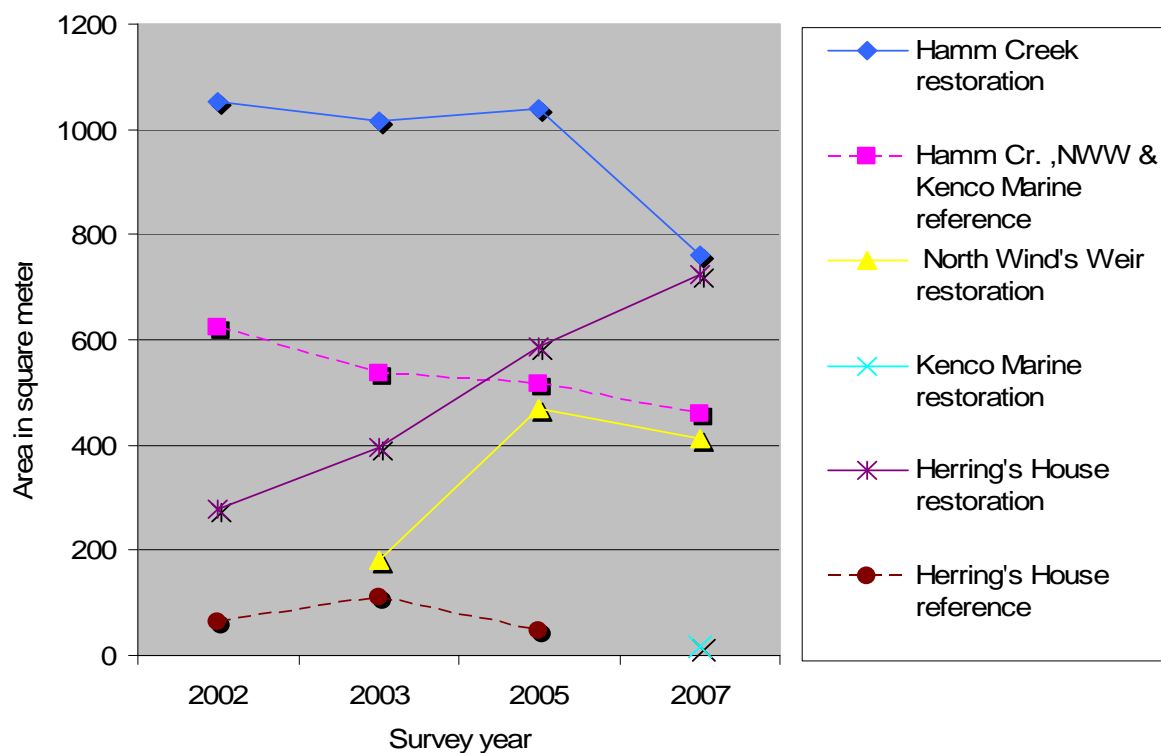
**Figure 11. Comparison of the total area of marsh vegetation patches (Lyngby's sedge and bulrush) at the restoration sites and their associated reference sites by survey year.**

At the reference site for Hamm Creek, North Wind's Weir, and Kenco Marine, the area for the target species Lyngby's sedge and bulrush area has steadily declined each year (**Table 3** and **Figure 11**). The declines from the previous sampling years were 87 m<sup>2</sup> (14 %) in 2003, 18 m<sup>2</sup> (3%) in 2005, and 57 m<sup>2</sup> (11 %) in 2007, for a total decrease of 27 percent since 2002. Possible causes of this steady decline include: the erosion of soils, an increase in invasive species and public use, and random and measurement errors.

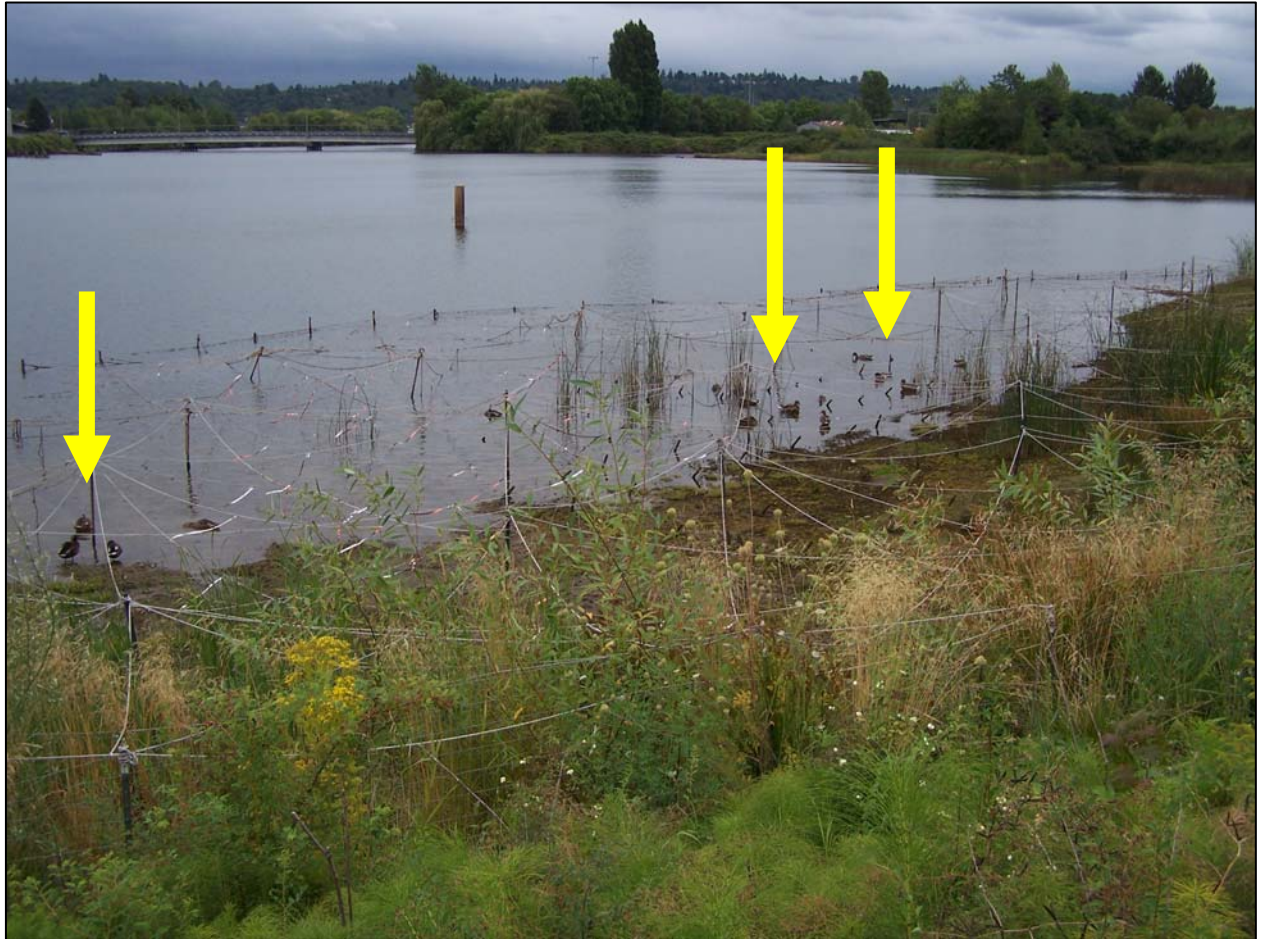
**Figure 12. Waterfowl feeding inside goose excluder fencing at Kenco Marine.**

The areal extent of marsh vegetation at Kenco Marine restoration site was 0.06 acre. This marsh was initially planted in 2006 and re-planted in the spring of 2007. It was noted during monitoring that the goose excluder fences were not completely successful. Waterfowl were observed swimming over the outer fence at high tide and foraging within the restoration site (**Figure 12**).

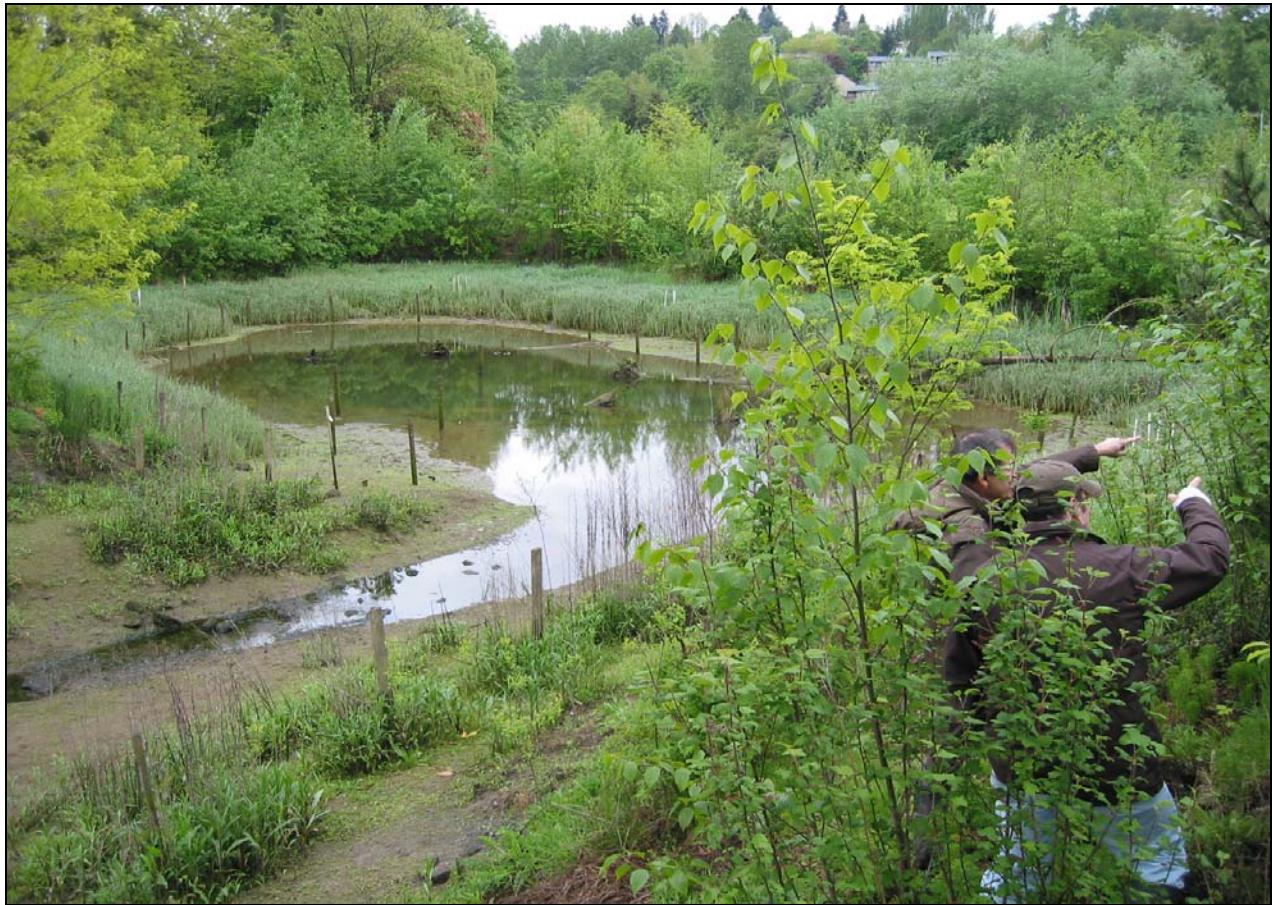
**Figure 13. Lyngby's sedge marsh at North Wind's Weir.**

At North Wind's Weir patches of Lyngby's sedge have increased by 231 m<sup>2</sup> since planting in 2003. Lyngby's sedge patches encompass most of the intertidal area above standing water in the basin. The total area of Lyngby's sedge patches increased by 158 percent in 2005 and decreased by 12 percent in 2007. Random error and measurement error likely account for a portion of the decrease noted between 2005 and 2007. The Lyngby's sedge marsh at the site still appears to encompass the entire suitable habitat at the site (**Figure 13**) and declined at a similar rate as the reference site. The overall increase in area of Lyngby's sedge patches since construction, and the similar decrease in patch size between 2005 and 2007 at both the restoration and reference sites, indicates that the marsh vegetation at North Wind's Weir restoration site is comparably similar and meets Biological Success Criterion 1.

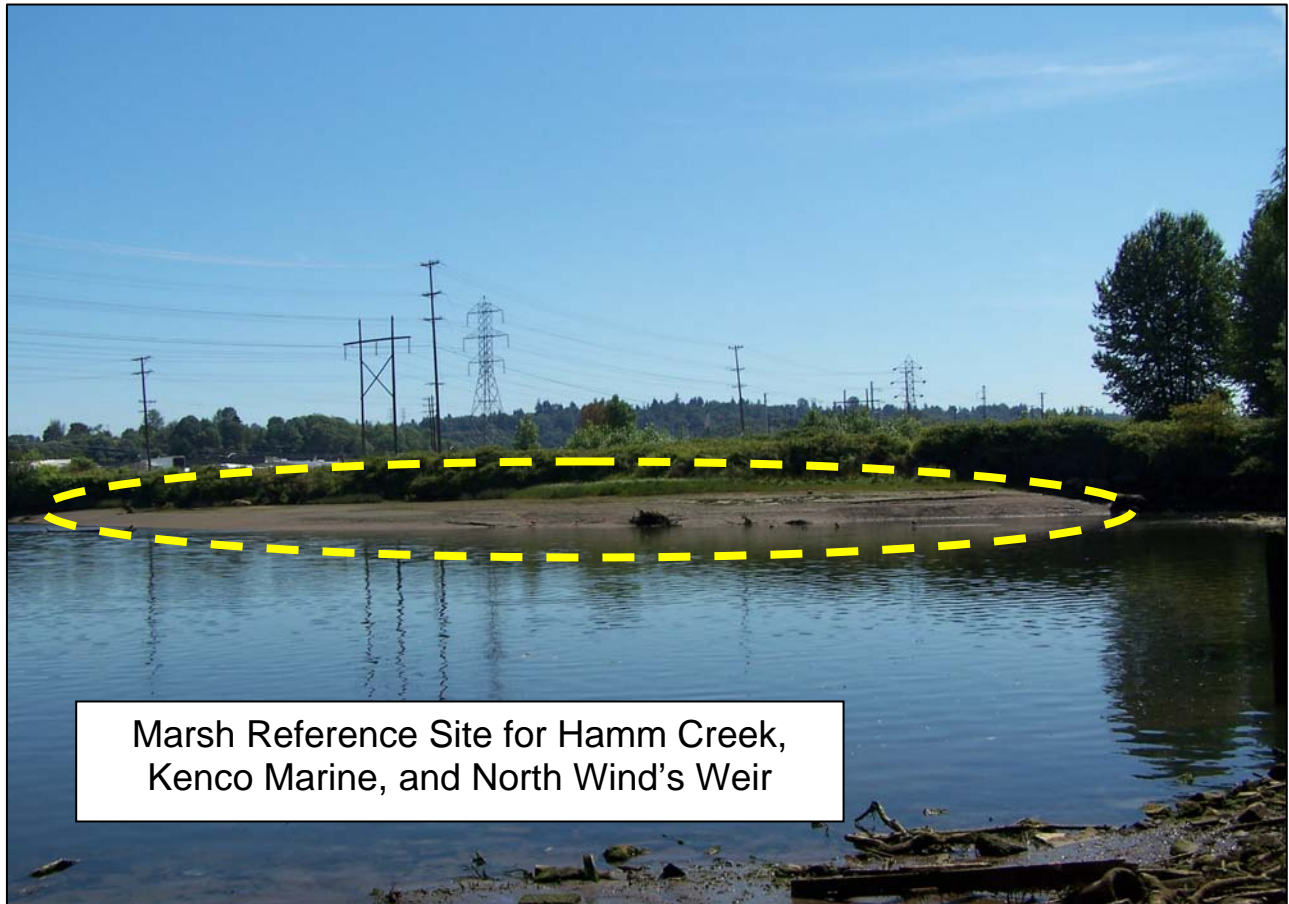
Figure 15. Marsh reference site across from North Wind's Weir looking southwest.

on percent cover and density measurements were not readily apparent. Therefore, species composition and percent cover at this reference site are expected to remain relatively stable overtime (**Figure 15**).

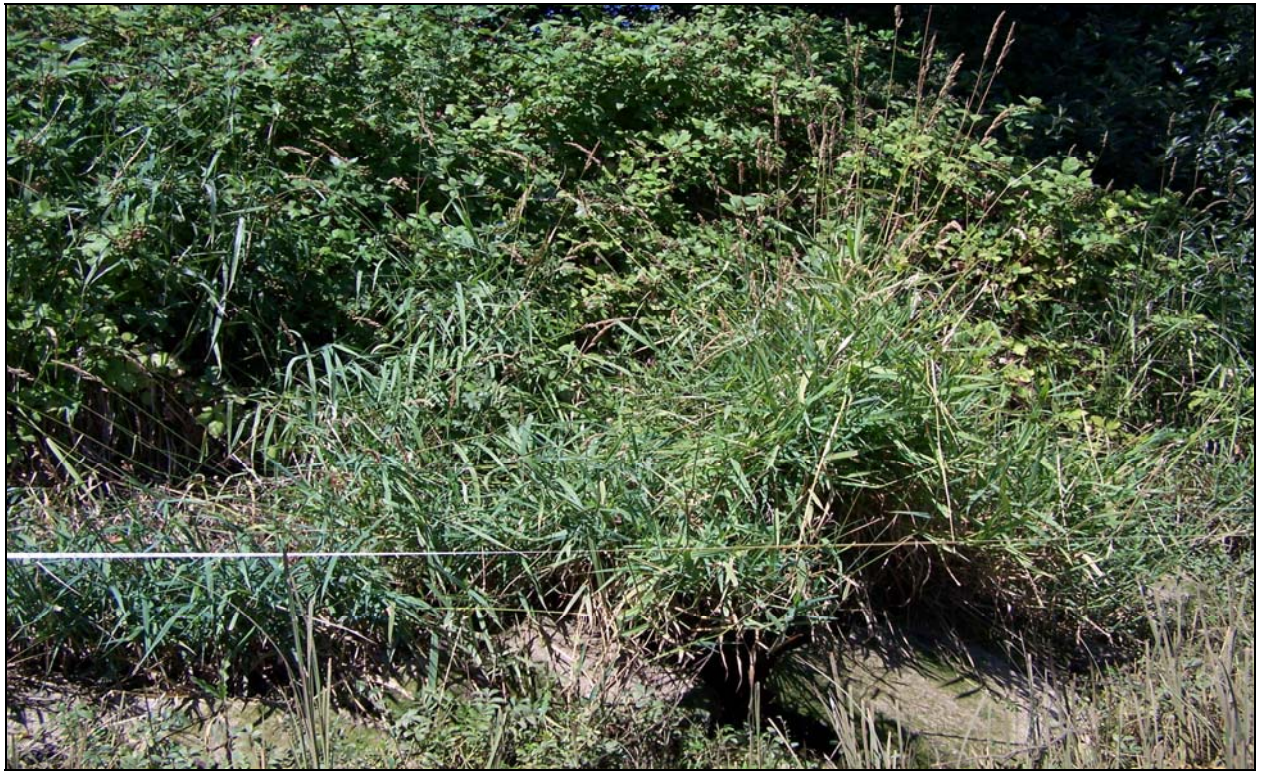
**Figure 17. Reed canarygrass growing near Transect 1 of Hamm Creek.**

In 2005, reed canarygrass (*Phalaris arundinacea*) was found in a transect plot at Hamm Creek. Of the four species listed in the EBD RP monitoring plan as invasive species of special concern, reed canarygrass is the only species of special concern found in marsh transects at the restoration and reference sites since 2001. In 2007, several species of special concern were noted at the Hamm Creek restoration site growing in areas not sampled by the transects. A clump of common reed (*Phragmites communis*) was noted in the upper marsh (**Figure 16**). A clump of reed canarygrass (*Phalaris arundinacea*) was growing near the start of transect 1, and several others were located at the upper edge of the marsh (**Figure 17**).

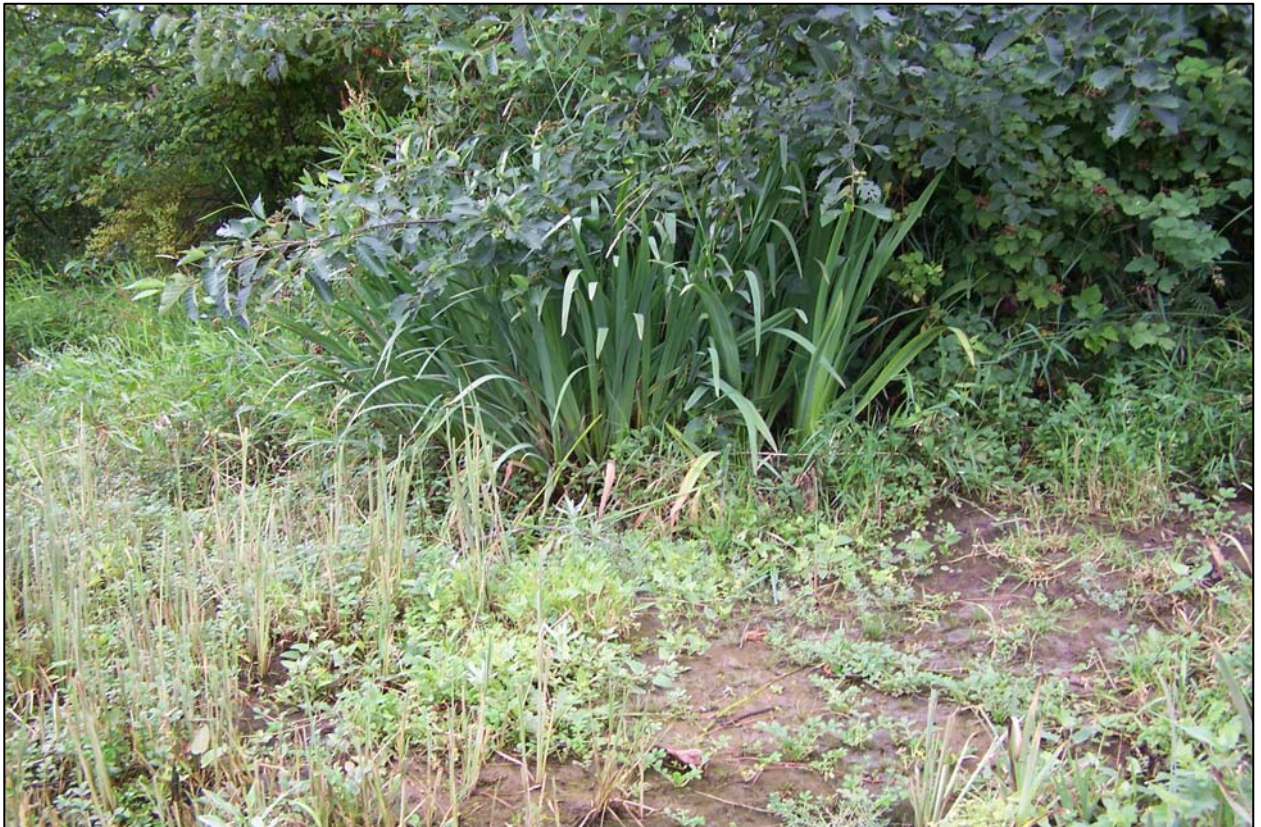
**Figure 18. Yellow flag iris growing adjacent to transect 3 in Hamm Creek.**

During a site reconnaissance visit in May 2007, it was noted that some invasive species removal had occurred. Numerous clumps of yellow flag iris (*Iris pseudacorus*) had been removed from the Hamm Creek marsh and were piled in various areas. Some clumps of iris had not been removed during the May visit and were flowering at the time of the marsh vegetation sampling in July including clumps adjacent to transect 3 (**Figure 18**). Linear leaved cattail was noted near the previously established end of transect 2 (since washed out) and above transect 4 (**Figure 19**). Single occurrences of perennial pepperweed (*Lepidium latifolium*), a state-listed species to be controlled, were found at several of the sites and removed when feasible.

As mentioned in the report, other invasive species were noted during the 2007 monitoring event besides the four invasive plant species of special concern listed in the EBD RP monitoring plan. These species included yellow flag iris and perennial pepperweed (*Lepidium latifolium*). Yellow flag iris is listed as a Class C noxious weed and perennial pepperweed is listed as a Class B weed in Washington State. It will be critical for future success of these sites to control occurrences of these invasives while they are relatively small in number and while control methods have a negligible impact on site restoration efforts.
