# Interagency Aviation SAFETY ALERT

No. IASA 19-04

**Subject: Parrot Anafi Small Unmanned Aircraft System (sUAS) Propeller Blades**

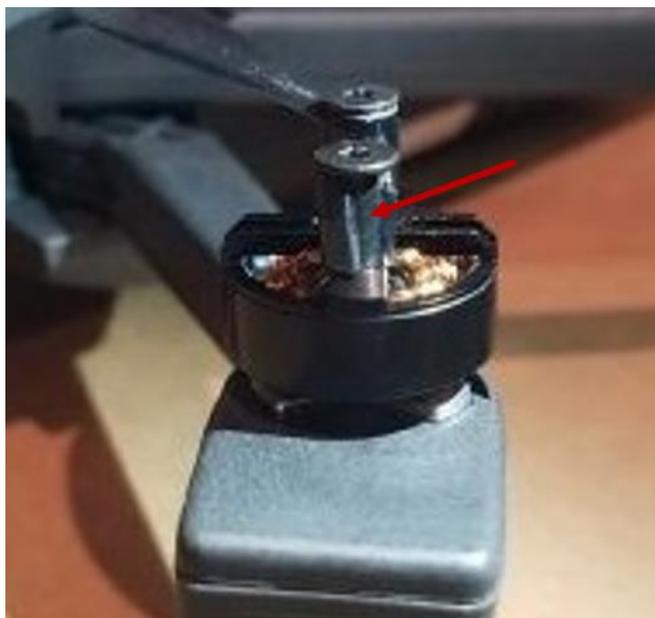
An examination by the OAS UAS Safety Specialist showed that the propeller had a failure where the seam weld was. A seam weld is common on other propellers. The screw that holds the propeller on is a shoulder screw and limits the ability of the user to overtighten the propeller. The OAS Safety Specialist installed a new propeller and test flew the sUAS with no issues. The aircraft was then placed back in service ([SAFECOM 19-0471](#)).

Motor bell housing where break occurred.

Parrot Anafi item #6. *Check prop seam for fatigue or cracks.*

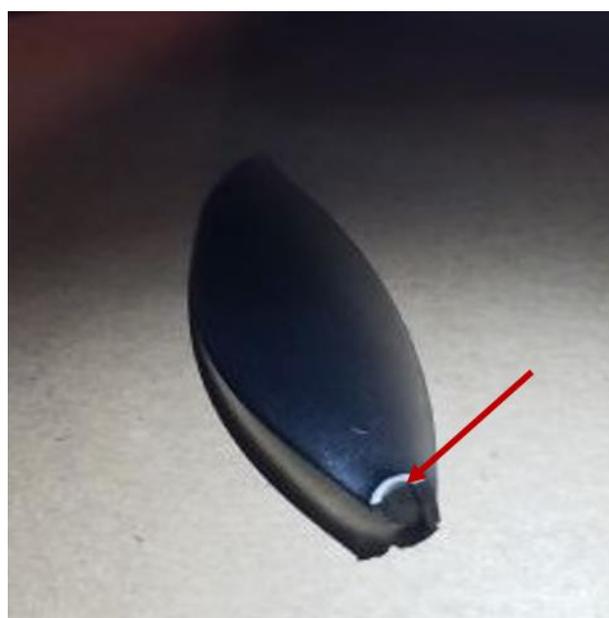
Location of propeller break.

A civil online forum addressed the issues associated with the Anafi Parrot propellers. They noted that markings (dings) and cracks can develop when the propeller contacts the mounting for the other propeller upon startup. According to the forum members, a “best practice” would be to change the propellers between every 100 and 120 flights in order to mitigate the risk associated with the loss of propeller blades.
