Interagency Aviation SAFETY ALERT

No. IASA 19-01

Subject: Aero Commander 690 Vertical Fin Attachment Bulkhead Cracks

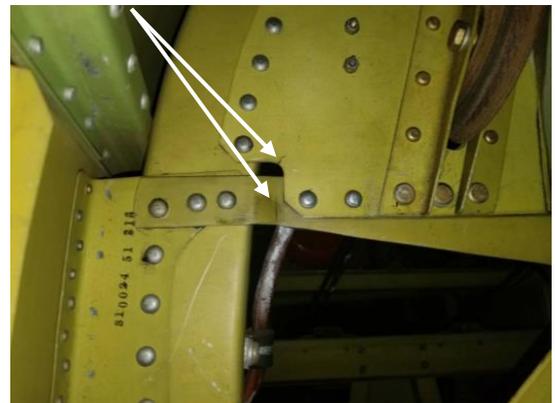
Figure 1. Cracks in aircraft bulkhead.

The first aircraft possesses minimal cracking that appears to be in the initial stage (Figure 1).

We recommend all Aero Commander 690 operators inspect their aircraft for similar cracks.

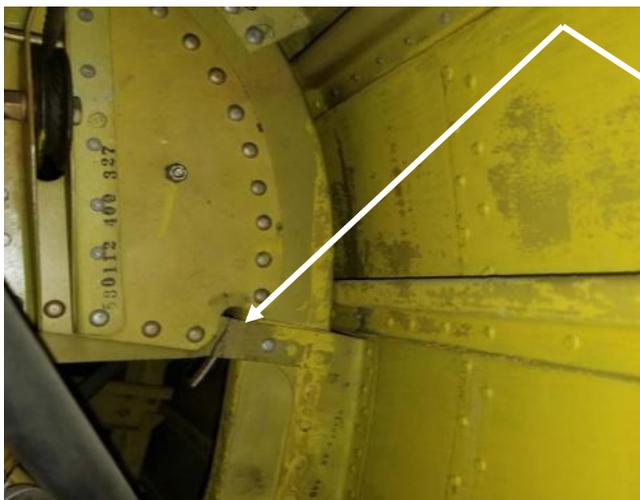
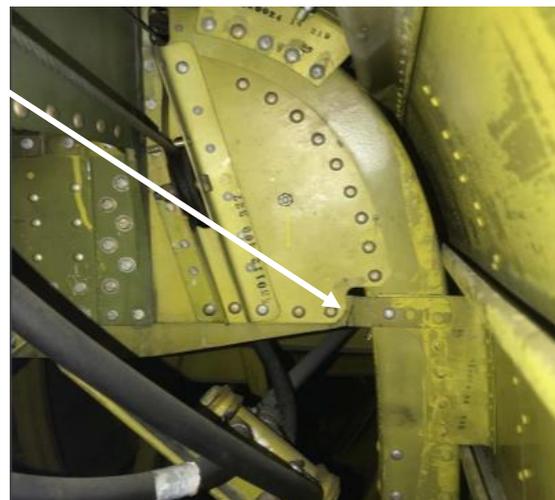
Figure 2 and 3. Cracks in aircraft bulkhead.

The second aircraft contains cracking that has progressed and is easier to identify (Figures 2 & 3).

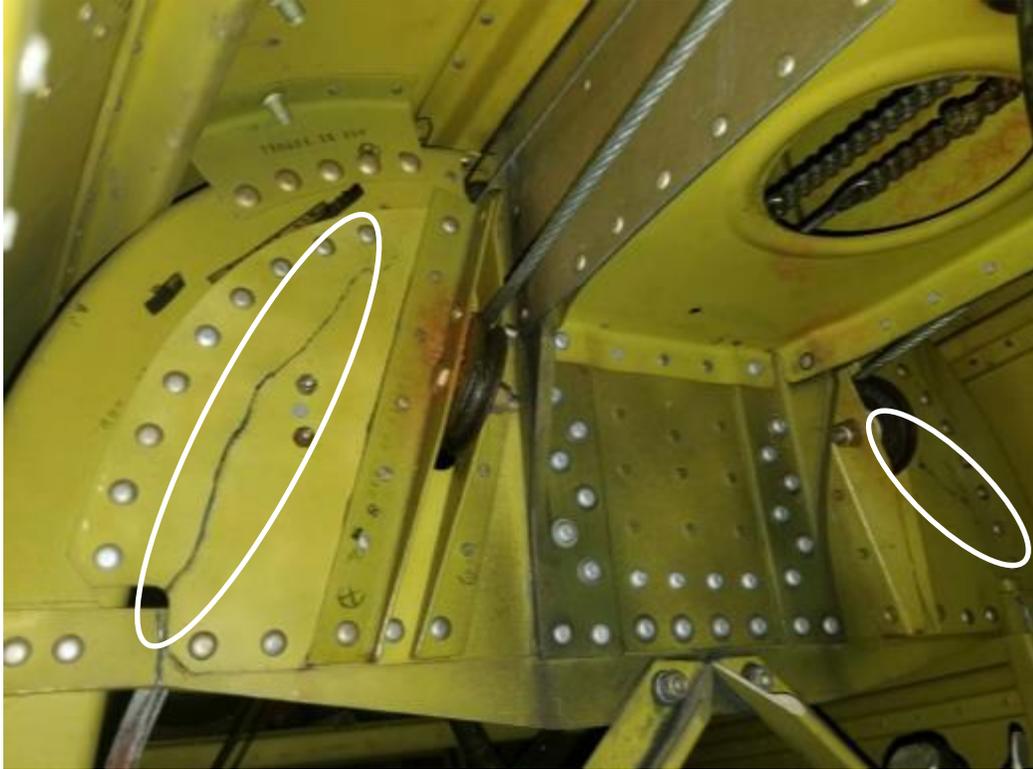
Figure 4. Cracks in aircraft bulkhead.

The cracks in the third Aero Commander progressed much further than the other two (Figure 4). This area lies within the bulkhead area forward of the vertical fin attachment bulkhead.
