**US Army Corps
of Engineers®**

**Assessment of Health Care Infrastructure and Services
Lyndon Baines Johnson Tropical Medical Center
Pago Pago, American Samoa
22-24 April 2019**

Executive Summary
Assessment of Health Care Infrastructure and Services
Lyndon Baines Johnson Tropical Medical Center
Pago Pago, American Samoa

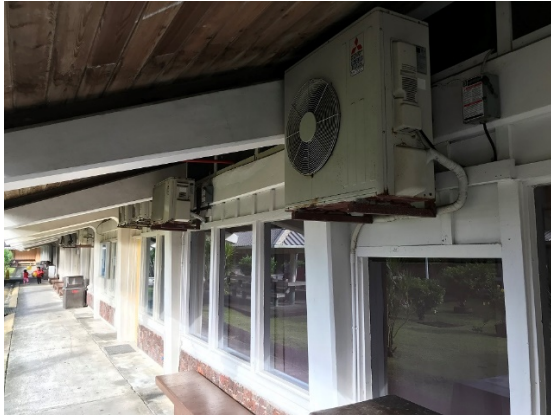
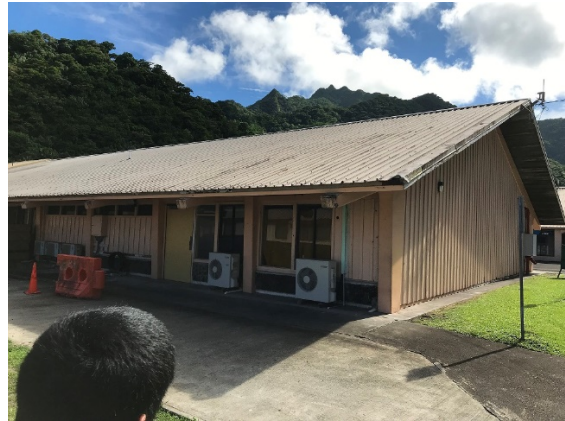
Exterior Decay/Rot/Deterioration: Some areas of the exterior wood (board & batten) paneling is in POOR condition showing significant signs of decay/rot/deterioration at corridors, bump-out locations and around the facility where the building exterior wall has been extended into the structural eaves/overhangs. Creating these short (8 to 12 inch) eave conditions which the water off the roof drops in close proximity to the vertical wall onto concrete slabs, splashing and soaking the bottom half of the wall. This decay has resulted over time. The paving at logistics area does not appear to have a positive slope away from the building. **SIGNIFICANT Repair: Removal and replacement of 35% of the building exterior may be impacted. Removal of exterior finish system full height, cut and remove lower section of wall and infill with concrete stem walls with stone wainscot similar to other portions of the hospital or CMU up at least 3 feet (bottom of window sill). Install a proper flashing, air barrier and new siding material, seal, caulk and paint.**

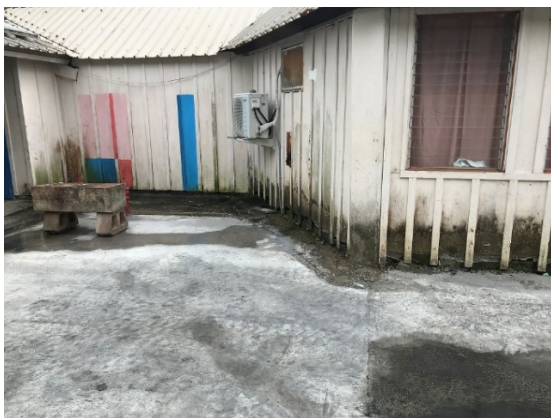
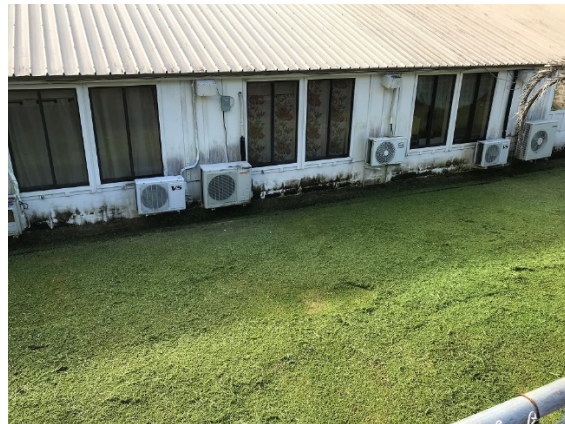
Exterior Envelope: The majority of the buildings have a significant amount of mold growth on the exterior wood surface which is in FAIR condition. American Samoa is located in a tropical extreme humid location. Although some of the mold may be located on the surface, other areas appear to be more significant. Mold feeds on organic materials, such as wood, paper, many fabrics, and even some types of glue. It literally eats away at these materials, causing them to rot

Outside mold does carry health risks, but the risks are not as great as with inside mold. There were a lot of patients sitting, standing, and congregating outdoors near these areas. Although the concentration of mold will be less outside in the open air than it would be indoors. However, that doesn't mean exterior mold cannot lead to health problems. If someone does spend time outdoors in areas with significant amounts of mold, one's health will be at risk. Children are particularly susceptible to mold-related health problems.

This mold may be caused from the moist conditions/environment, low quality paint, from an inferior, damaged or missing vapor barrier or simply the exterior materials used. Another influence, could be negative pressure rooms located at/near the exterior wall drawing the moisture into the building. Buildings in general should be positively pressured. The Dialysis building, although a relatively newer renovation in 2017 is showing significant signs of mold at the exterior walls and under the canopy. Original drawings were very limited in regards to validation of the construction/components of the exterior wall. Without destructive investigation, it is impossible to confirm the cause, extent of the mold, or quality of evidence of an exterior envelope vapor barrier. **MAJOR REPAIR: Recommend a destructive investigation at severe areas by removing sections of the exterior finish to check extent of damage and envelope composition for repairs. The entire exterior of the facility should be sprayed with chemicals and power washed, then sealed, caulked and painted with a high quality mold resistant paint. Implement a mold prevention/ maintenance plan to clean the exterior regularly. Consider using materials less susceptible to mold than wood such as concrete, CMU, brick, stone, etc.**

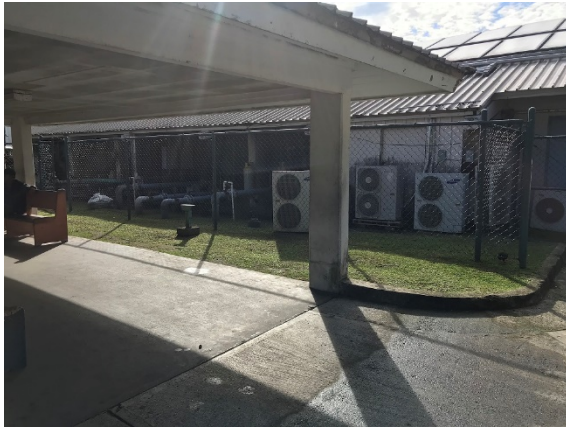
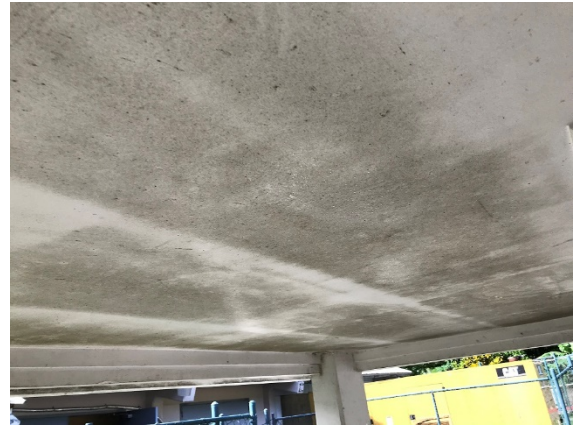
Frieze/Transom/Top of Wall (Open): There are redwood framed openings above the horizontal concrete beams at the exterior walls which is in FAIR condition. The original building design intent appears to have been a passive approach to have these eaves open to transfer air in and thru the attic space. The majority of these openings (3 panels) are located at sides of administrative/business buildings. Some have screens for protection, some screens are damaged or the screens have been removed entirely (open). These openings allows insects, bugs (hornets, bees, ants, etc.) birds and other critters access into the attic or building. As well as all the hot/humid exterior outside temperatures to enter the attic space.

The only barrier between the attic space and occupied areas is the ceiling system (acoustical tile or gyp). These occupied spaces are typically conditioned by small DX units mounted to the walls. Lay-in ceiling tiles are warping along with corrosion on the grid system due to heat/temperature difference and moisture. These ceiling materials are not thermal or vapor barriers. Controlling the occupied temperature is very problematic which results in added maintenance and cost. Ceiling system components (tile, grid, gyp, etc.) are continuously being replaced, repaired or painted. **MAJOR Repair: Recommend closing off these transoms with screens at the administrative buildings and installing a proper horizontal barrier (Batt Insulation with vapor barrier) above the ceiling system. Recommend evaluating these buildings closer to design and create a project to seal up the exterior and provide the most efficient/effective mechanical system for these buildings.**

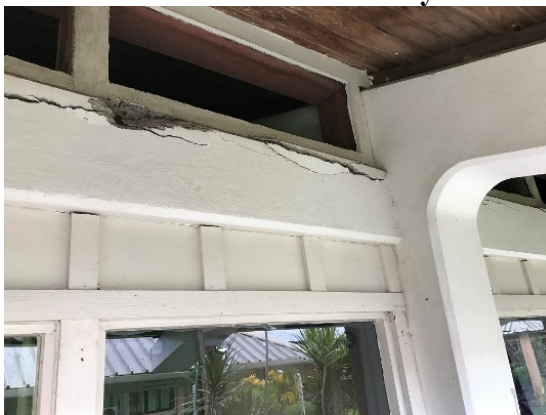
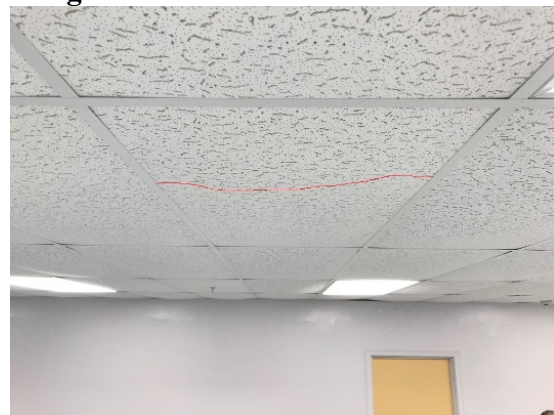
Frieze/Transom/Top of Wall (Closed) Vertical Air Barrier: The treatment/medical/hospital buildings typically have these openings at the top of the wall, above the beam, closed off with either windows, wood paneling matching existing (B & B) or by an interior wall (metal stud and interior gyp). These areas are in POOR condition which do not appear to have a vapor/air barrier or appropriate exterior wall construction provided to seal this area from moisture and air infiltration.

Dedicated AHU's are typically located within these attic spaces which serve each treatment/medical unit. With the exterior wall not properly sealed at these locations or proper separation between the occupied spaces below and attic, the cool air mixes with the hot humid air which generates moisture, condensation and mold growth within the attic.

It is vital to assure careful integration of different construction material/system interfaces within the façade/exterior wall in order to improve building performance and overall integrity of moisture, air, and thermal barriers. The building enclosure system plays a vital role in how much energy the building uses. It includes both the vertical (walls, windows and doors) and horizontal (slab & roof) system encasing the building (all six sides). The HVAC system and Building Envelope work together.

There are a number of related issues at the exterior and attic areas, with the air barrier being one of them. All of these related issues has resulted in widespread mold throughout the entire attic (top of ceilings, on support structure, on and within AHU systems, etc.). Which is a serious infection control issue. **SIGNIFICANT Repair: Recommend removing all of the existing walls above these horizontal beams and rebuilding with proper framing members, insulation, vapor/air barrier and exterior finish system. Seal, caulk and paint. The attic mold also needs to be addressed with possible remediation to a complete demolition. Please also see Mechanical Facilities Condition Assessment for additional evaluation and recommendations.**

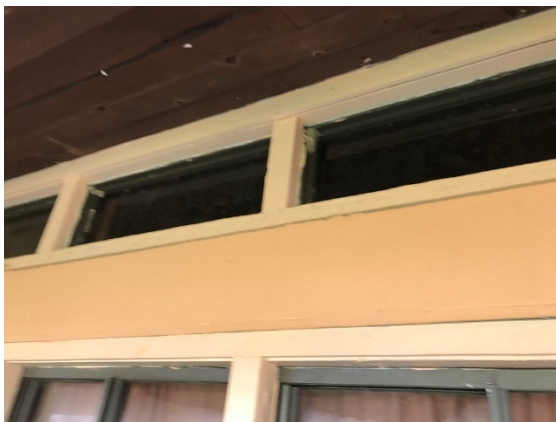
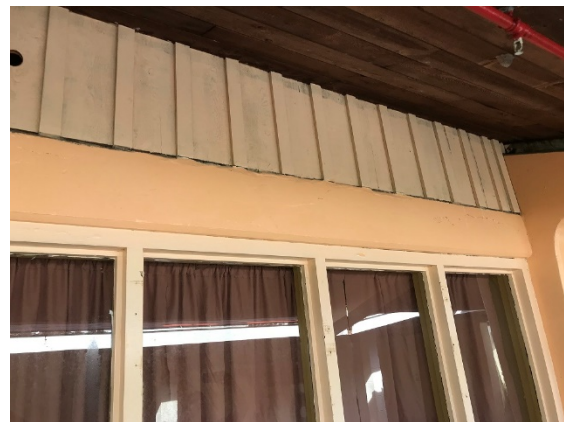
Horizontal Barrier: Another major area of concern at the treatment/medical/hospital buildings, is that there is no horizontal barrier or physical separation between the attic area and actual treatment/ occupied conditioned space below with the exception of the lay-in or gypsum ceiling systems, which is in POOR condition. These materials are not thermal or air barriers. The DoD and DVA standards require AHU's be located in condition spaces. IBC and NFPA 101 require these different occupancies to be physically separated by a 2 hour rated barrier (IBC Table 508.4) for healthcare (I-2) and Mechanical (F). The center AHU platform also has a huge safety risk to maintenance personnel and patients below as there is no guardrail or protection at the edges prohibiting someone or something from accidentally falling over and thru the ceiling.

SIGNIFICANT Repair: Recommend that either a rated vertical or horizontal barrier be installed within the attic separating the AHU space and occupied/conditioned space. This could be done horizontally with a concrete floor similar to an Interstitial Building System (IBS). Significant structural supports and design considerations will be necessary.

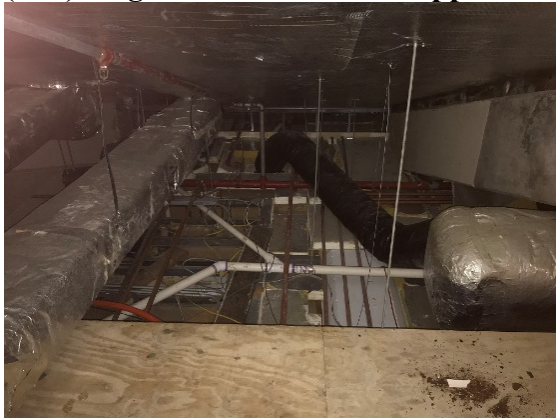
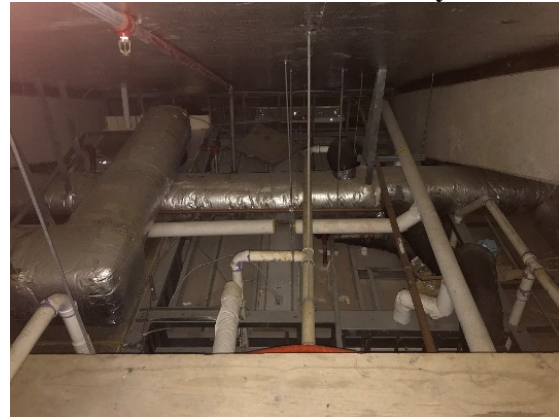
AHU Access/Repair and Replacement: With the AHU's installed in the attic areas, physical access to these AHU is a huge challenge for maintenance staff. Access to these areas is at the gable ends of the building module/units thru a 4 ft x 4 ft double door opening approximately 16 feet above ground level. These doors do not have gaskets or seals and require a ladder for entering. The center building has this door opening located in the unconditioned corridor, which conflicts with utilities. If the AHU's need repair, filters, etc. facility staff must climb a ladder with tools, parts, etc. If the AHU needs to be replaced for any reason, it would have to be dismantled into pieces and removed thru the small door opening. **MAJOR Repair: Recommend installing a permanent galvanized open grate steel framed stairs (4 ft wide) system with a large steel grate platform at the top for access. The guardrail at the top could be removable with tie off (safety) brackets. A crane or lift (hoist) system could also be beneficial to remove equipment. SIGNIFICANT Repair: An alternative approach would be an enclosed elevator/lift system constructed at one end of the building while the other end can have a stair for egress. The center corridors would need to be connected to create one large open attic.**

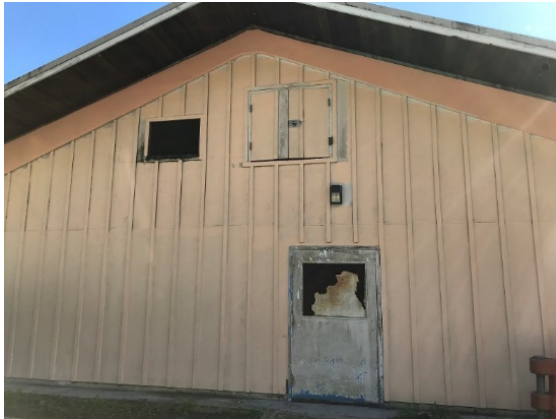
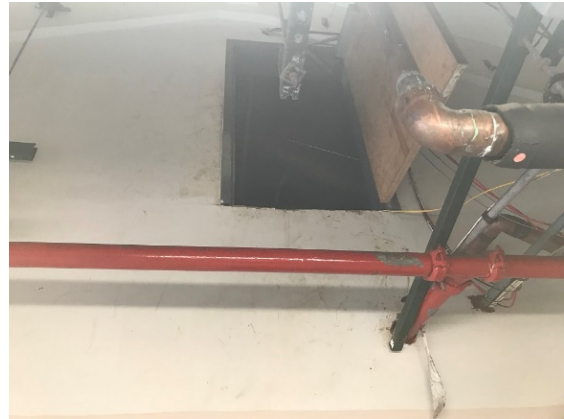
Attic Lighting: The attic lighting is in FAIR condition which the areas are very dark, dim and do not appear to have sufficient lighting to meet foot candle requirements for DoD, DVA or commercial (National Electric Code) standards. This is a huge safety concern and would also be hard to maintain or repair the mechanical equipment, utilities or infrastructure due to limited light levels provided. **MINOR Repair: Recommend providing additional lights throughout attic spaces to properly cover each structural bay and attic AHU platform.**

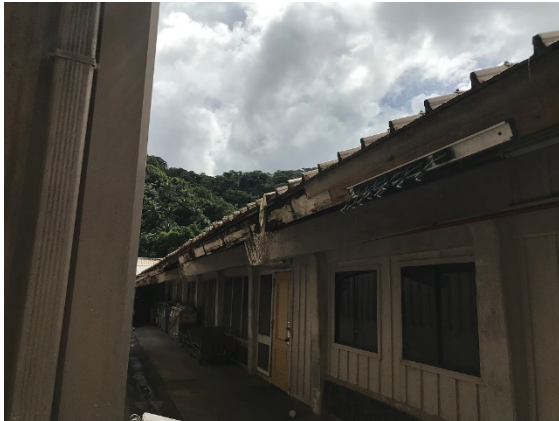
Exterior Wall Penetrations: There are numerous locations around the facility where utilities (sprinkler pipe, etc.) are penetrating the exterior wall/eave/frieze that are not sealed. These openings allow hot humid/moist air to enter attic or building. With the exterior wall not properly sealed at these locations the AHU or occupied space cool air mixes with the hot humid air which generates moisture, condensation and mold growth within the attic. **MAJOR Repair: Recommend sealing all penetrations with appropriate materials and vapor/air barrier to minimize air infiltration.**

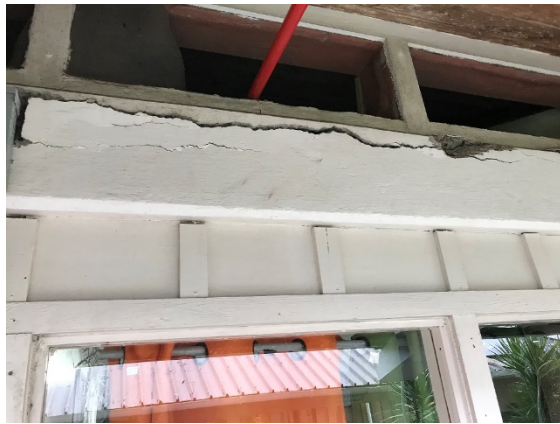
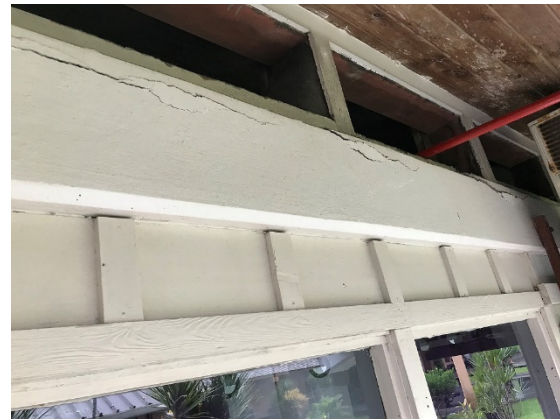
Structural Cracks: Significant cracks have been found at numerous beams between concrete bents in the horizontal direction on multiple buildings. These cracks appear to be similar in location (all at the top) about 2 to 3 inches down, but not uniform across all buildings.

See Structural Condition Assessment and detailed trip report in Appendix G for more detailed information.

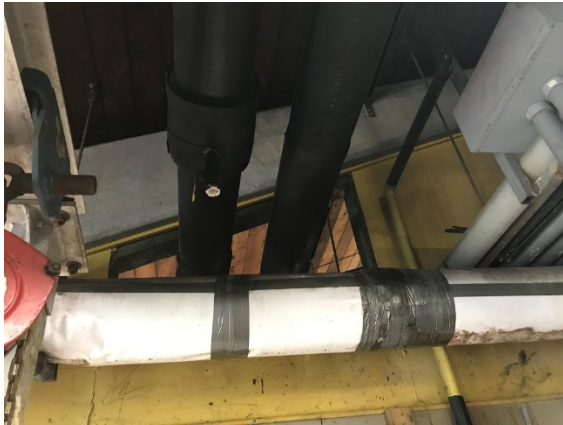
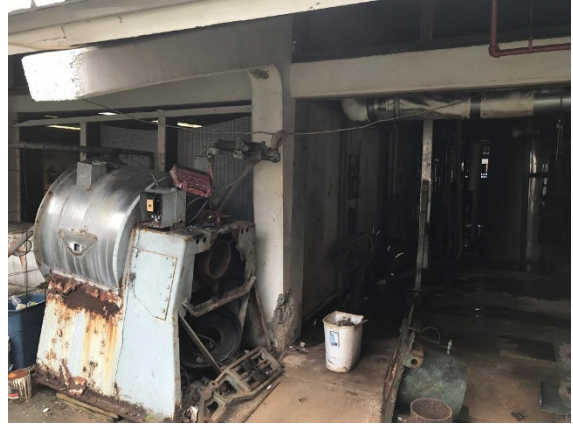
Mechanical Room Penetrations: Wall between Laundry (over 100 SF) and Mechanical room, which contains boilers, chillers, maintenance shops, etc. is required to be protected/ 1 hour rated per IBC (Table 509 Incidental Uses) and NFPA 101 (Chapter 8). There is a large opening where piping and other utilities pass. Opening and penetrations shall be protected by a tested system installed and maintained. Opening protection requirement established in IBC Section 705.8 may be applicable to the exterior side walls, both sides of the building at laundry, protected a certain distance away from the rated separation wall and open mechanical equipment. This would be to protect against fire spread at the exterior of the building where the openings are within close proximity to each other. **MAJOR Repair: Recommend sealing all penetration within rated wall between mechanical and laundry room with approved material (Example: Red Hilti bricks, caulk, etc.). As well as removing the exterior wall at sides of laundry room near mechanical area at least 2 bays in length and infill with rated wall construction. This also includes the void area above the horizontal structural beam. If the concrete stem wall exist at these locations, this can remain, with new infill above.**

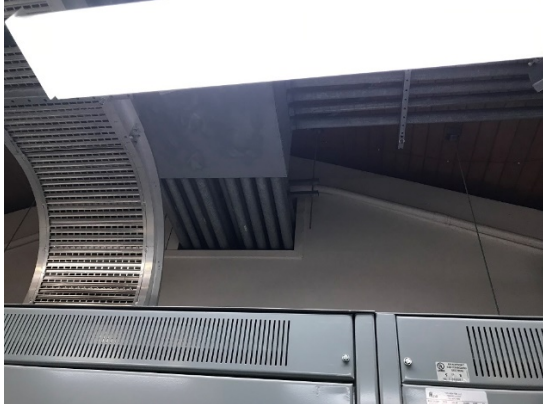
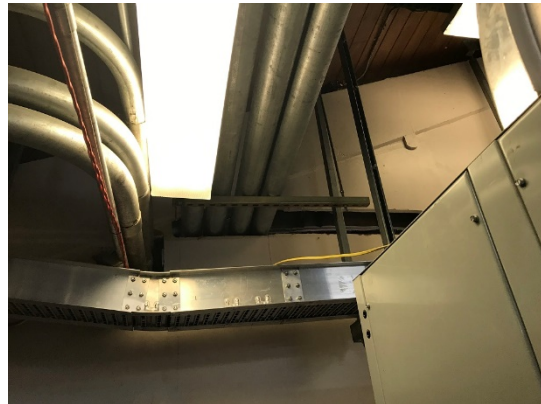
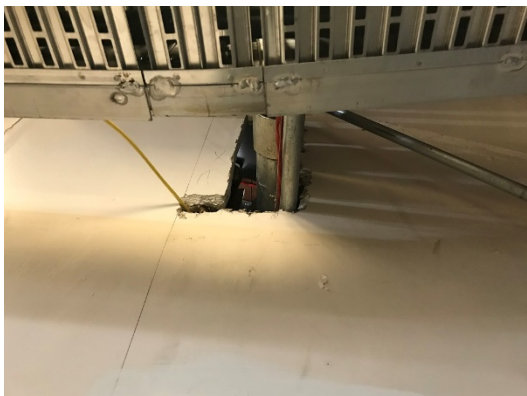
Electrical Room Penetrations: This is the LBJ's facilities main electrical room (Switch gear/ATS, etc.) located between the mechanical area and generator room, which is required to be protected according to IBC and NFPA 101. There are multiple penetrations thru the main electrical room walls from conduit that are not sealed. Opening and penetrations shall be protected by a tested system installed and maintained. **MINOR Repair: Recommend sealing all penetration within rated wall between both the mechanical and generator rooms with approved material (Example: Red Hilti bricks, caulk, etc.).**

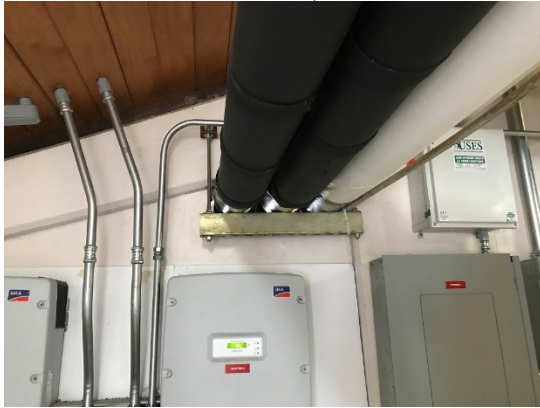
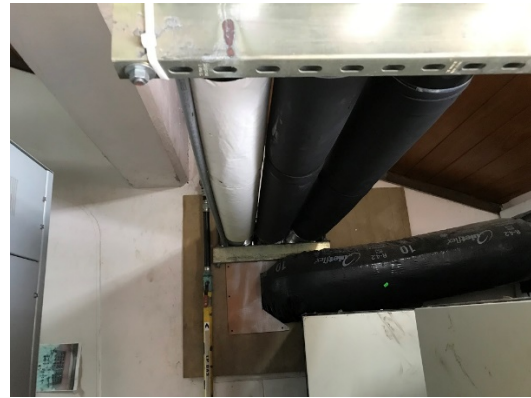
Chiller lines in Electrical Room: Chiller lines have been installed thru the main electrical room and wall penetrations are not sealed. DoD, DVA and National Electrical Codes prohibit pipes and other equipment foreign to the electrical equipment to be located in, enter, or pass through such spaces or rooms. **MAJOR Repair: Recommend that these chiller lines be removed and relocated, re-routed elsewhere and sealing all penetration within rated wall between both the mechanical and generator rooms with approved material (Example: Red Hilti bricks, caulk, etc.).**

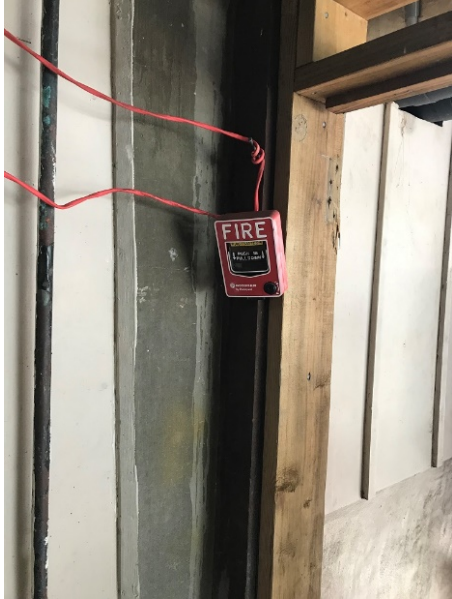
Pull Station: Fire alarm pull station in generator room is NOT securely or properly mounted to wall. Wiring should be located in approved conduit, not exposed or looped around a nail.

MINOR Repair: Recommend installing device per NFPA 72 and conduit installation for survivability requirement per NFPA 72 and/or per DoD or DVA criteria.

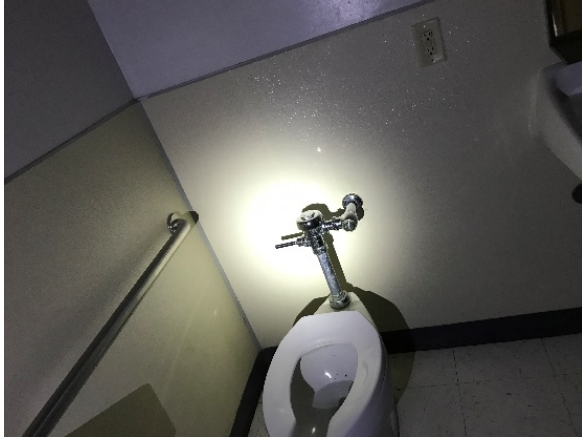
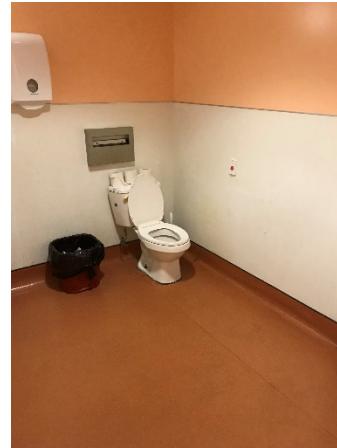
Single Occupancy Toilet Rooms: There are a number of toilet rooms throughout the facility that do not comply with ABA standards as grab bars may not be provided or may be only on one wall (side or back), not both walls per code. **MAJOR Repair: Recommend installing code compliant grab bars to walls per ABA standards. Wall backing and other support structure may need to be added. Therefore, removal of drywall, replacement and painting may be necessary.**

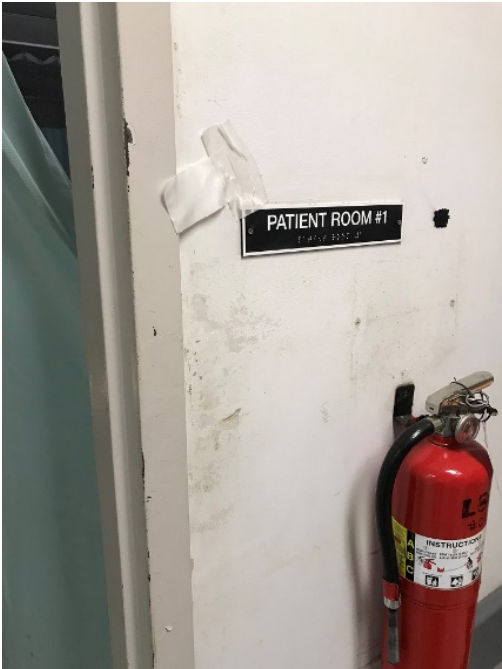
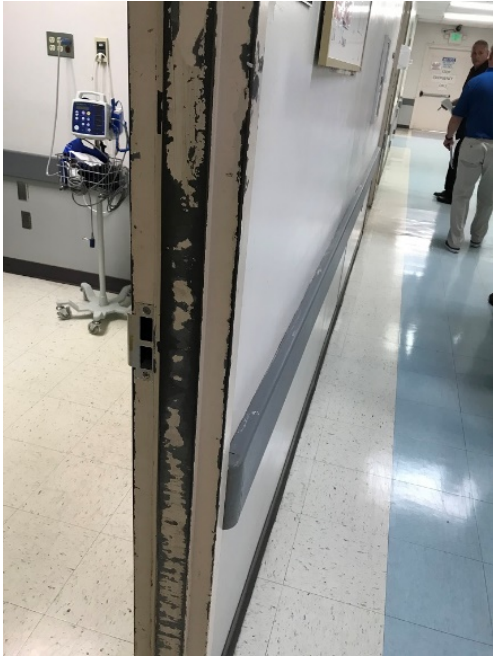
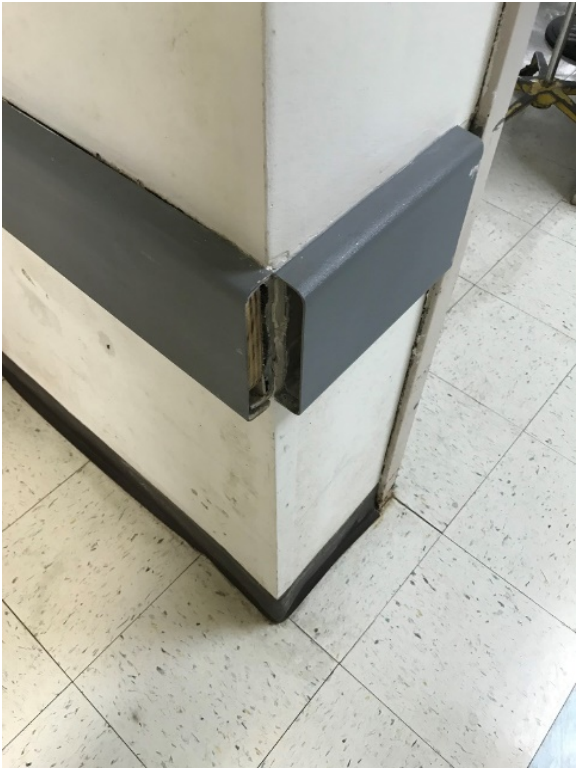
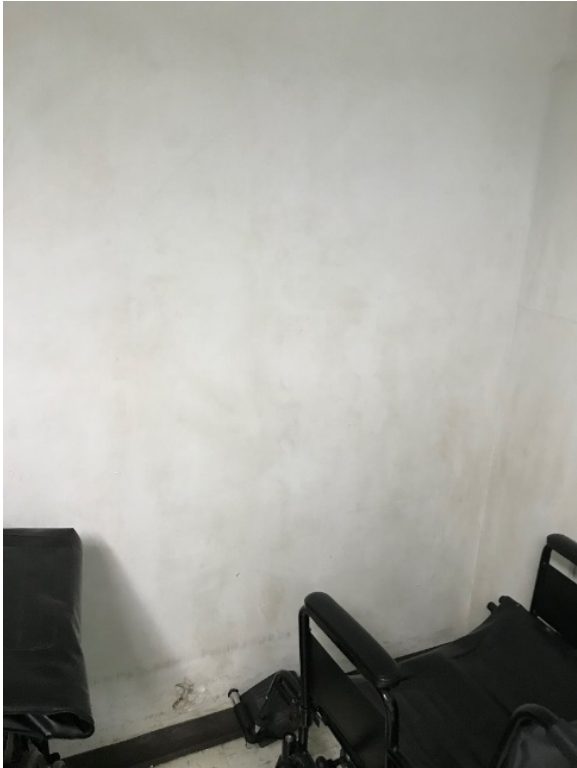
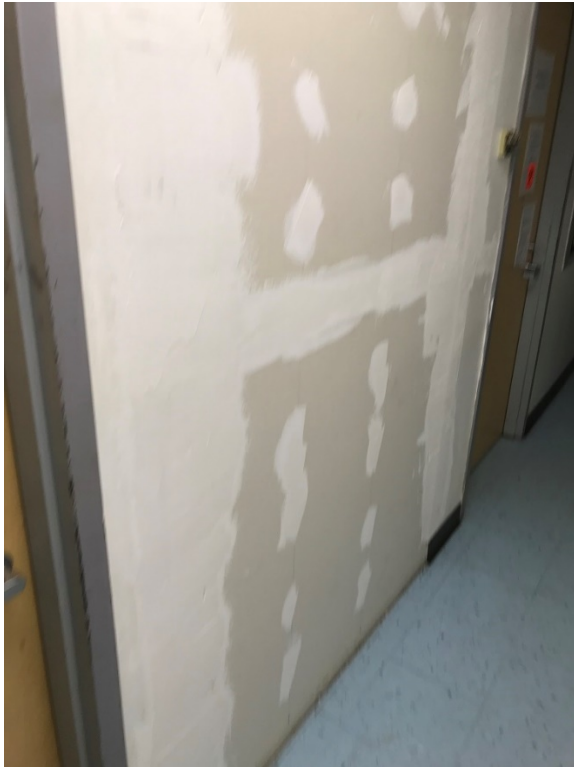
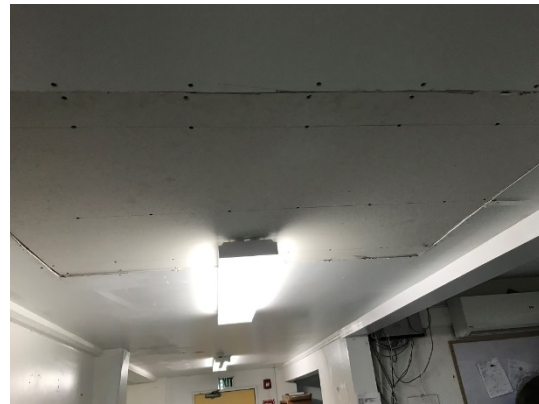
Interior Doors: Interior doors are typically laminated, wood or metal with hollow metal frames. The majority of the frames are in FAIR to POOR condition. Numerous doors throughout the facility are damaged, chipped and/or delaminating. **MAJOR to SIGNIFICANT Repair: Recommend all interior doors throughout the facility be replaced. Frames in most of the openings could possibly be reused saving cost and impact/interruption to patient care. However, replace frames as necessary. Highly recommend the use of FRP doors with a continuous hinge due to the weight. These doors cost much more than typical solid core wood doors but are impact resistant and will probably hold up better to climate (humidity) and maintenance is very minimal as these doors will never need to be painted. They do come in a nice wood grain finish.**

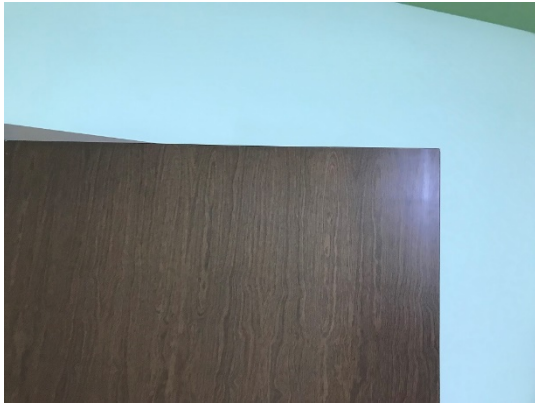
BH Patient Room Doors – Swing: Patient room doors currently swing into each private room, they all have a continuous hinge and exposed door closer. For inpatient and outpatient settings, when solid doors are installed, they should be outward swinging or utilize double acting continuous hinges. A patient can barricade themselves inside preventing the door to open or if something happens to a patient, where they pass out or are un-conscious, they could fall against the door making it very difficult to push the door open. Pivot hinges and double swinging doors can still provide security necessary but allows staff in an emergency to swing the door in the opposite direction (out) for access. **MAJOR Repair: Recommend changing the door frames and doors to swing outward per BH standard requirements. Alternative option is to use frames with no-stops with pivot hinges to allow the door to swing in both directions. Hardware will need to be coordinated with his change.**

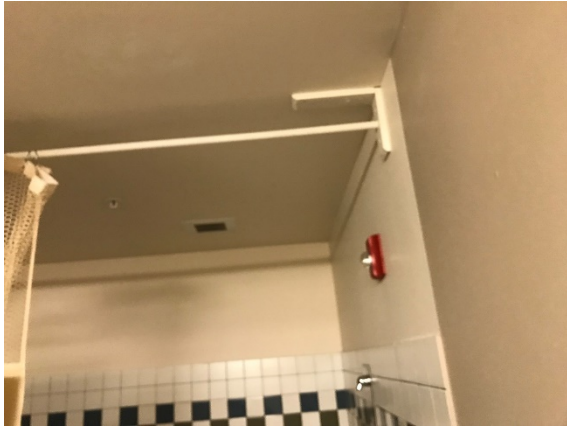
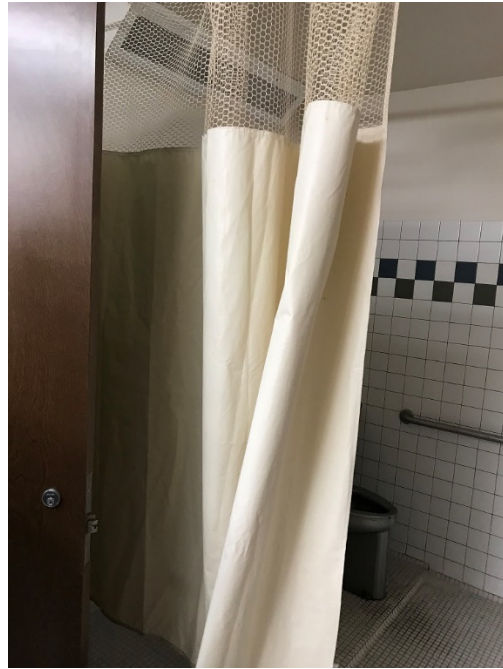
BH Out-Patient Toilet Shower: There is a toilet/ shower area for out-patients near the front entrance and waiting. This areas is separated from the adjacent corridor/waiting or clinic space area by only a shower curtain. Not much privacy. Both males and females use the toilet and when necessary will be required to shower. Privacy is of concern. **MAJOR Repair: Recommend providing a wall and door at this location. Fixtures and devices may want to be upgraded to anti-ligature.**

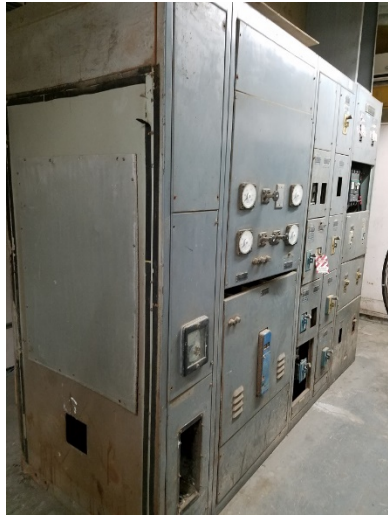
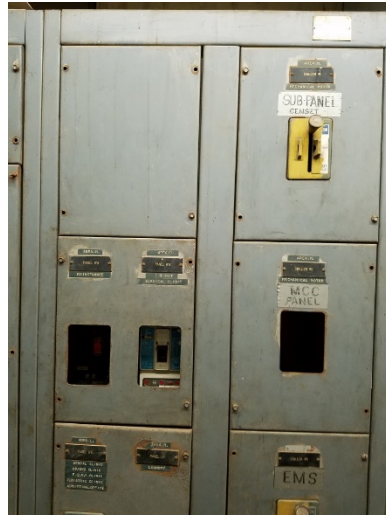
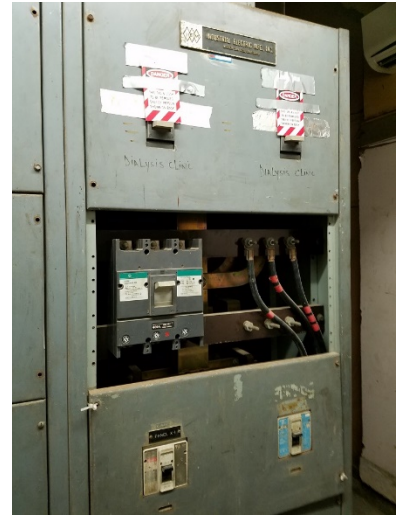
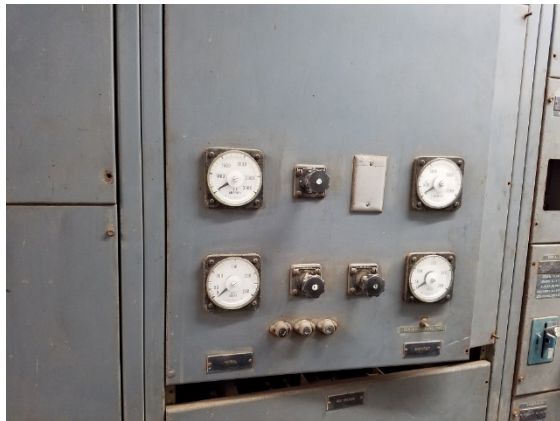
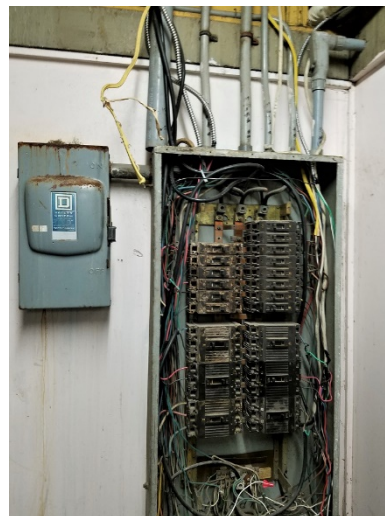
The old main transformer, transfer switch, and main switchboard were all supposed to be demolished by the new project, but cannot be de-energized until the remaining load on them has been transferred to the new system. Observation of the old main electrical room confirmed that almost everything in the room is far past its reasonable lifespan. Countless code violations exist, and it is of major concern that this equipment still powers a great portion of the hospital, given its poor condition (see pictures below).

Old Main Switchboard and Panelboard in Old Main Electrical Room

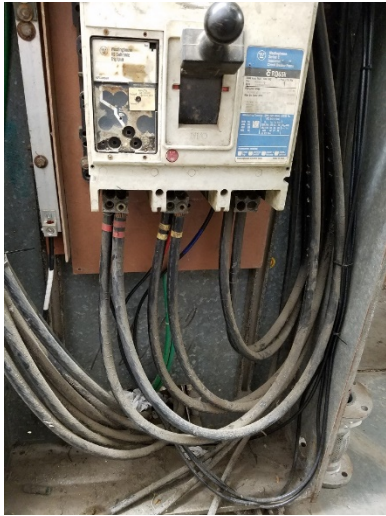
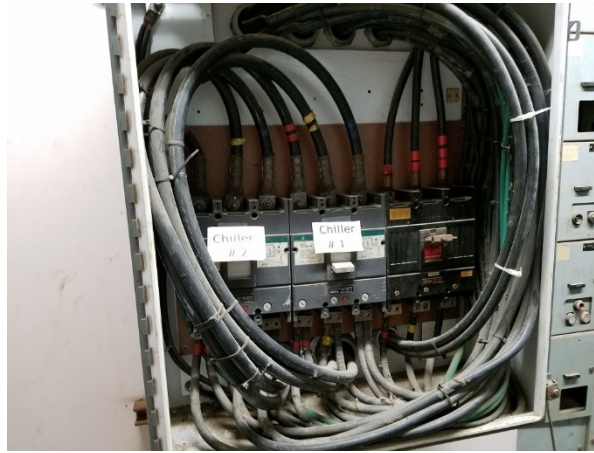
The second service transformer serving the old system is a 300kVA unit that sits in the old main electrical room. It serves a stanchion-mounted main breaker that feeds only Chiller #2. The configuration has many code violations, and many others exist in this room. The feeder from the main breaker consists of two sets of conductors that terminate on two different breakers for Chiller #1 (since demolished) and Chiller #2 (still in use). These breakers sit in a dangerous open enclosure that has a third breaker fed by the old main switchboard, which also resides in this room (see pictures below).

Service Main #2 on Old System

Box Containing Breakers for Chillers 1/2 (demo'd)

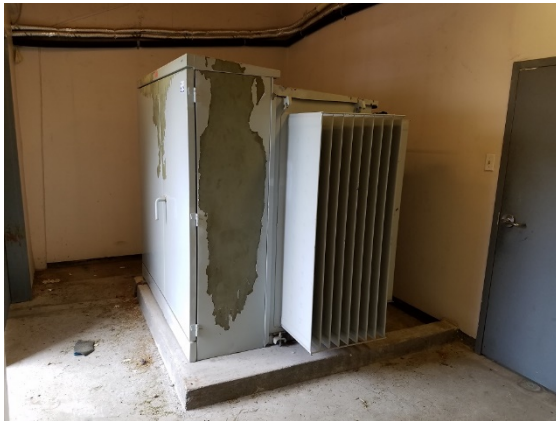
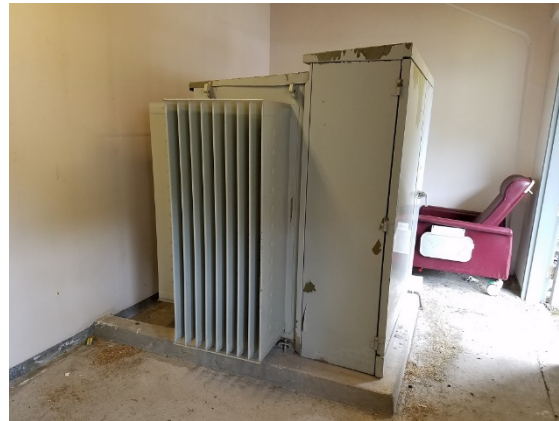
The “new project” provided two new 1500 kVA 120/208V, 3-phase, 4-wire service transformers in a room with direct access from the exterior and interior, but the space was not ventilated; the temperature is very high, and the moisture has begun to break down the painted surface of the transformers (see pictures below).

New Service Transformers Already Showing Effects of High Humidity and Lack of Ventilation

- All electrical rooms shall be air-conditioned with dedicated thermostat.
- Existing equipment not to be re-used shall be disconnected and removed from the site, such as pad-mounted primary switches and associated conduits and temporary generator sets and associated fuel tanks, piping, and conduits.

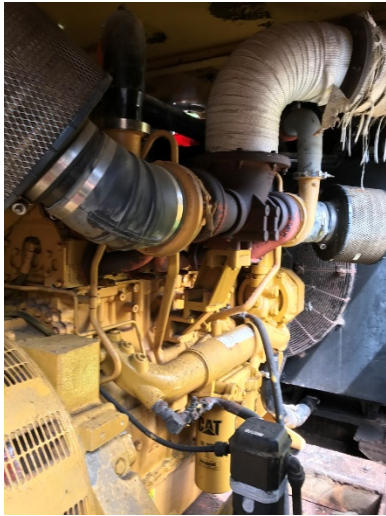
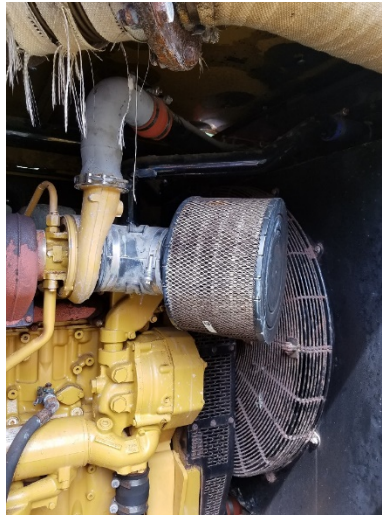
Temporary Diesel Generator that Supports the New System, Showing Effects of the Elements

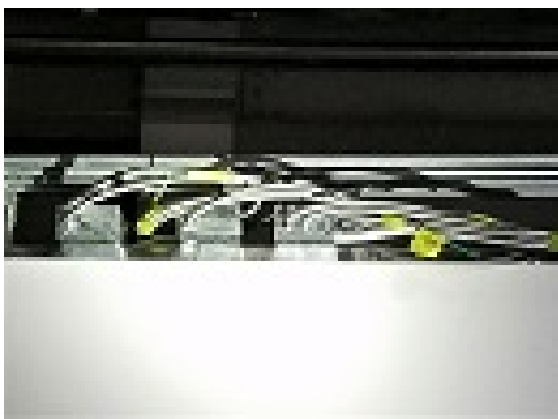
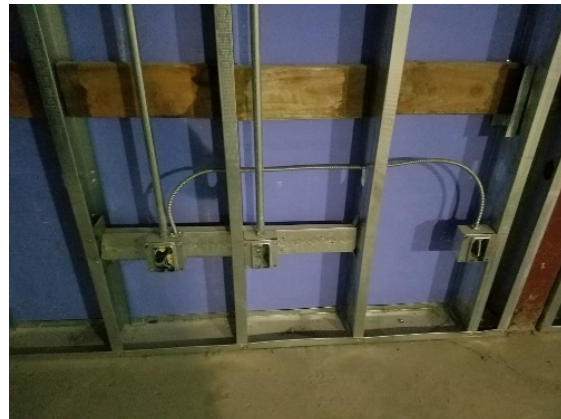
Metal-clad cable used extensively in ongoing project, not allowed by DoD or VA criteria

- If the existing 120/208V, 3-phase, 4-wire service switchboards and main switchboards for Non-Essential, Life Safety, Critical, and Equipment switchboards are NOT to be re-used, the new equipment provided to replace them shall be rated 277/480V, 3-phase, 4-wire.
- Provide new generator switchgear.
- Prohibit the use of metal-clad cable (MC Cable), which is not allowed by the DoD or VA criteria. All conductors shall be run in raceways.

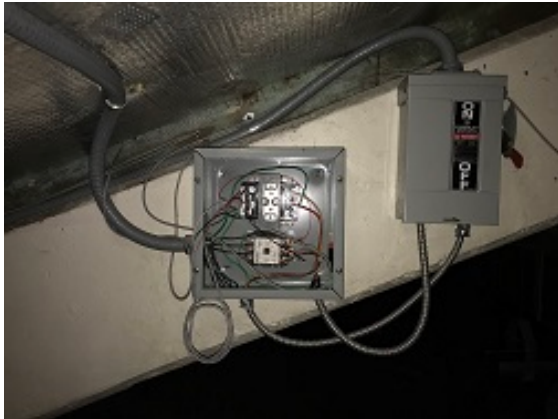
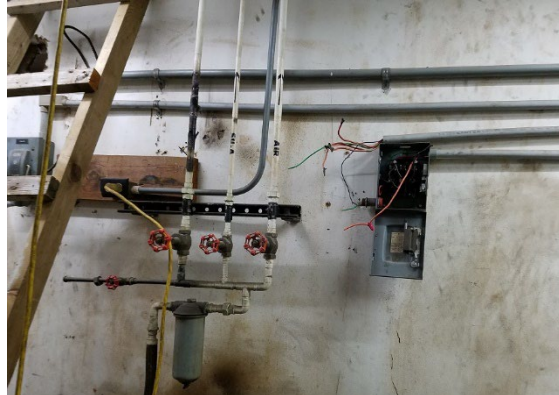
Typical open equipment with exposed wiring

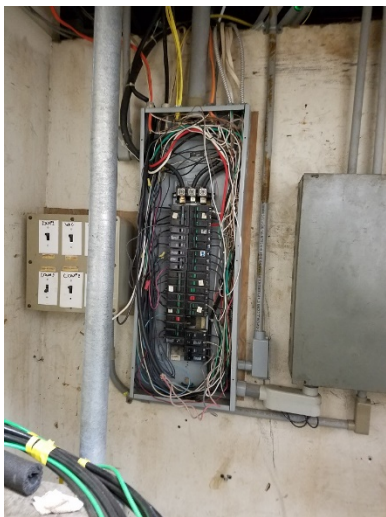
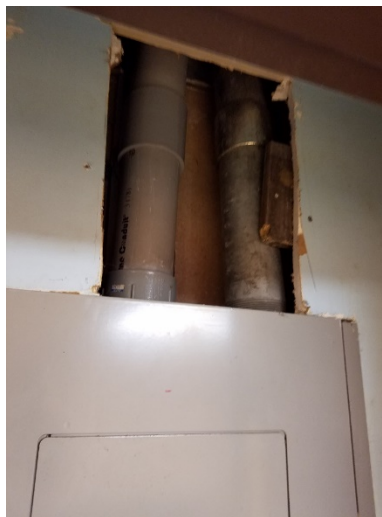
Typical open equipment with exposed wiring and use of PVC conduit indoors

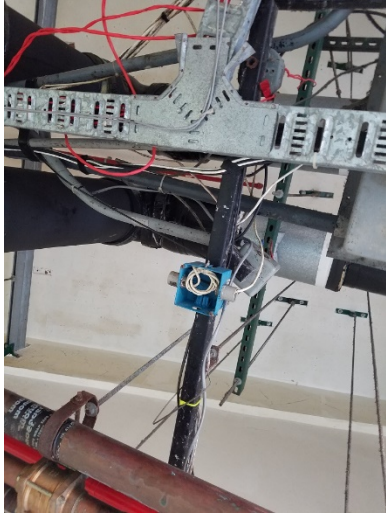
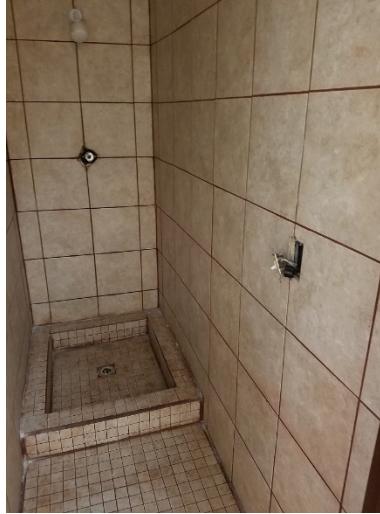
Typical corridor wiring and exposed wiring in a shower area

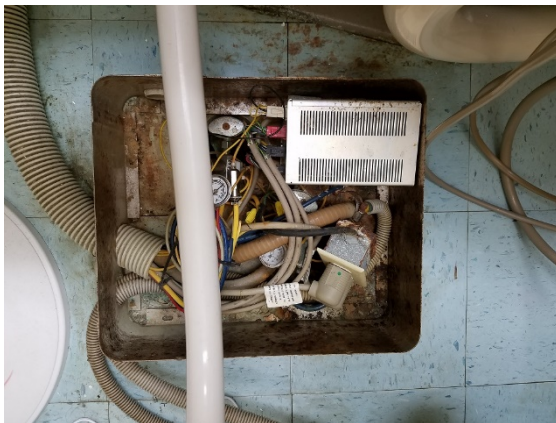
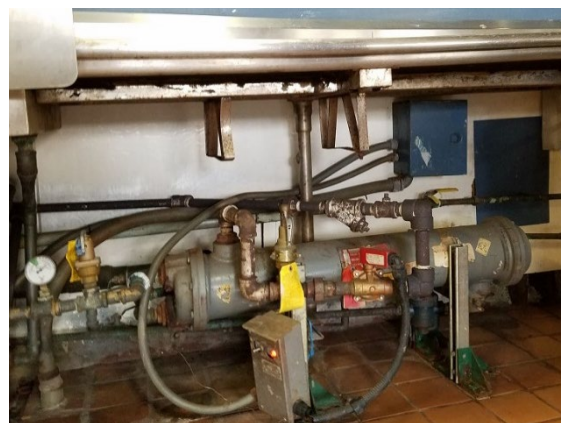
Utility services to base of a dental chair and starter sitting on floor in kitchen

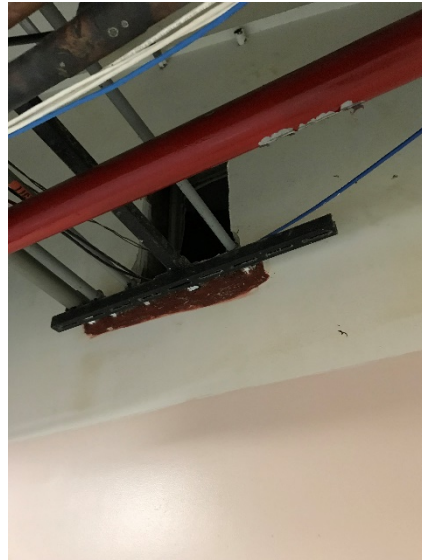
Unsealed gap above conduit, Corridor outside of the Emergency Room Building

Multiple penetrations exist throughout the interior corridors that require sealant to ensure compliance with NFPA 101-2012, Chapter 19.3.6 (Corridor Construction).

Recommendation: Immediate. Ensure corridor penetrations are properly sealed to ensure corridor walls are smoketight. Ensure sealant systems are in compliance with Underwriters Laboratories Specifications.

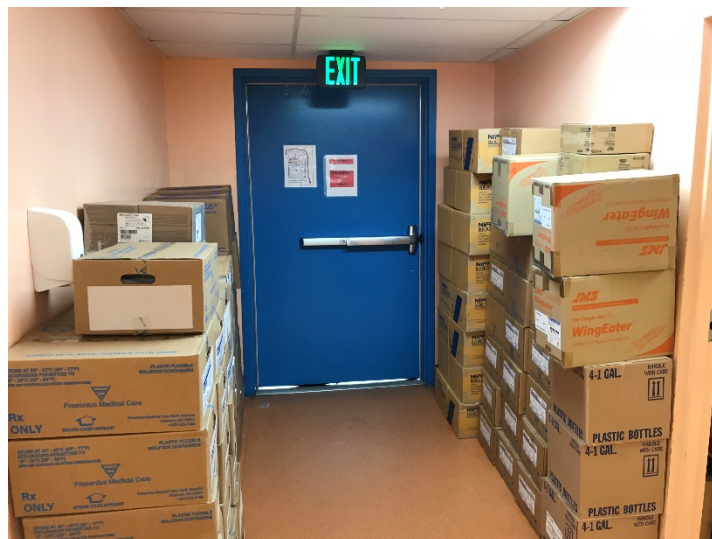
An area of concern was storage in the Dialysis Building, where rear exterior exits were obstructed.

Rear of Dialysis Clinic with Combustible Storage in Corridor

Recommendation. Immediate. Remove storage obstructions from egress corridors to ensure compliance with minimum corridor widths in accordance with NFPA 101, Life Safety Code.

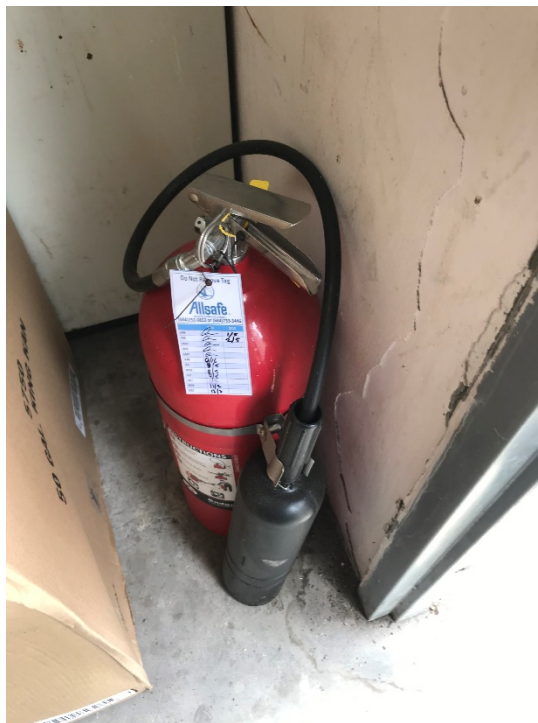
For the most part, fire extinguishers were being inspected in compliance with NFPA 10, Standard for Fire Extinguishers. However, there were extinguishers in the central utility plant and in construction areas not properly inspected or mounted.

Unsecured extinguisher in central plant, not inspected on a 30-day cycle.

Immediate. Ensure all fire extinguishers are inspected on a monthly basis in accordance with NFPA 10.

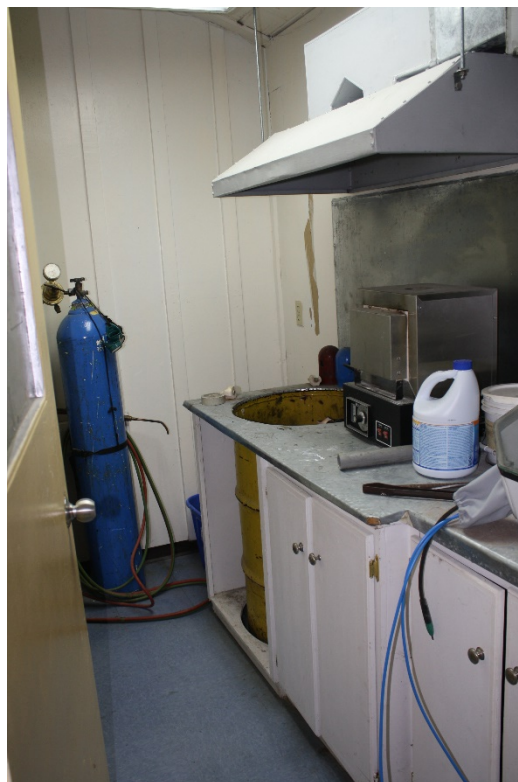
Flammable gas cylinder not secured to structure IAW OSHA Standard 1926; valve protection cap not in place, stored in same room as heating sources. Fixed furniture (broken counters & cabinets) and waste collection is not in compliance with infection control practices. Lacking storage for hazardous materials and chemicals. Insufficient space to meet ABA/ADA requirements.

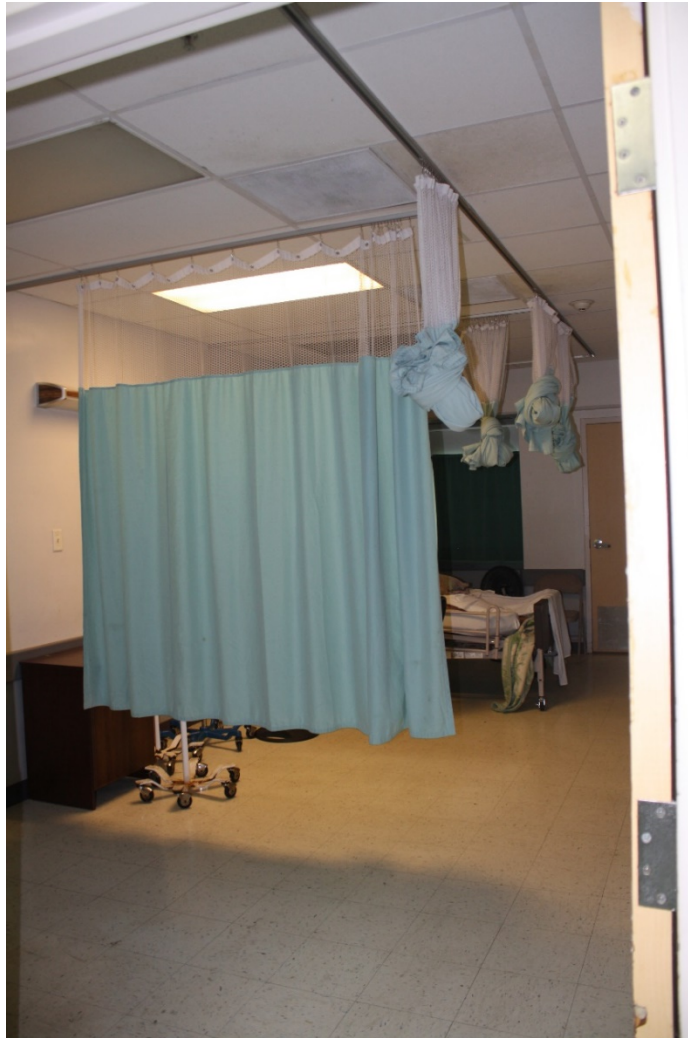
Inpatient Unit – Three Patient Room - Research supports that providing single patient rooms contributes to many factors impacting morbidity, mortality, length of stay and health outcomes. Family member support/care giver presence on the inpatient units exacerbates space limitations in these rooms.

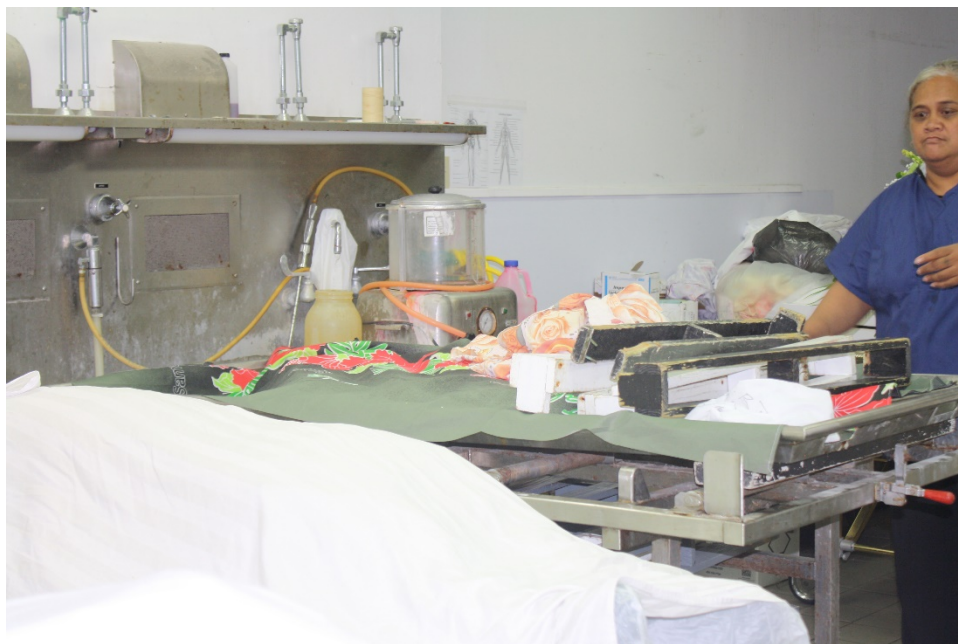
Autopsy table surrounded by corpses on gurneys.
