**US Army Corps
of Engineers®**

**Assessment of Health Care Infrastructure and Services
Lyndon Baines Johnson Tropical Medical Center
Pago Pago, American Samoa
22-24 April 2019**

Executive Summary
Assessment of Health Care Infrastructure and Services
Lyndon Baines Johnson Tropical Medical Center
Pago Pago, American Samoa

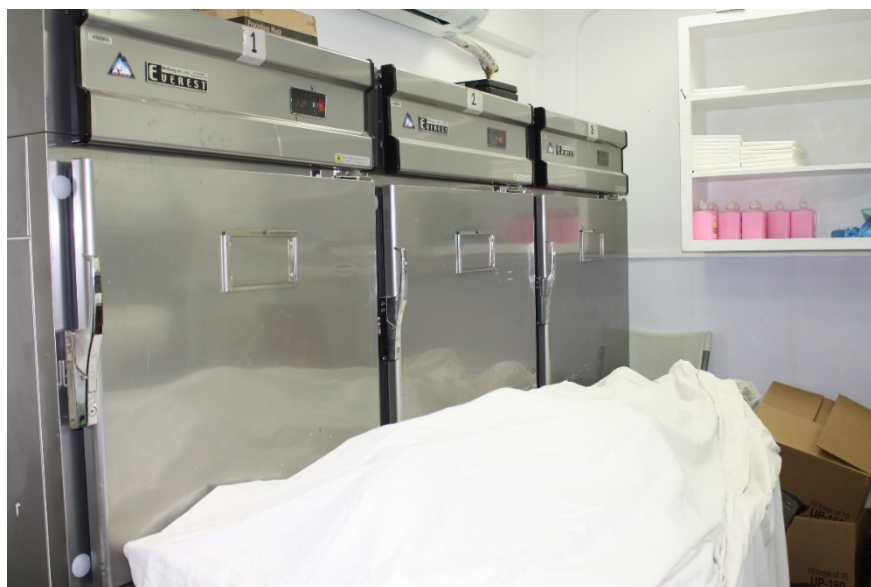
Morgue/Autopsy: Space for body storage is significantly limited by over 50%; while body preparation and viewing spaces are absent from the morgue.

Morgue Refrigerators (capacity 6 corpses); corpse on gurney as the refrigerator is full.

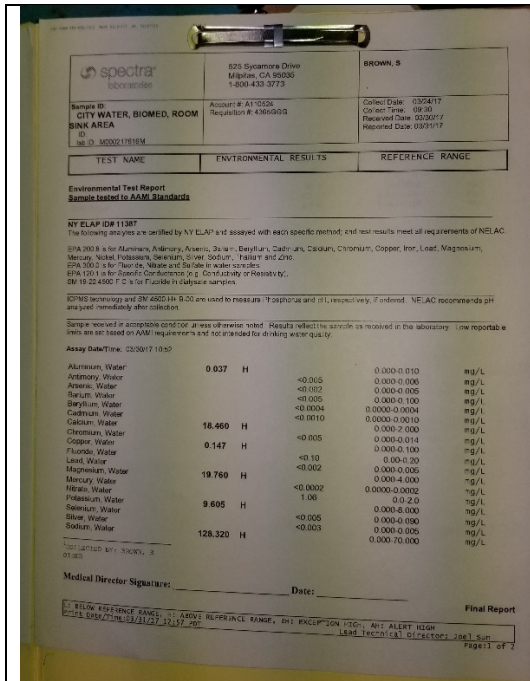
Available water quality testing was limited to Contaminant Testing in 2017. Results showed very high calcium content (18.5 mg/lit) and magnesium content (19.8 mg/lit) which results in a calculated CaCO₃ value of ~127 mg/lit or "HARD Water". Alkalinity and pH data was not available to quantify how aggressive the water is. However, the maintenance staff indicated it was very aggressive (presumably very acidic) and corrodes copper piping. Extensive visible damage to the fiberglass cooling tower which has been operating on untreated water for years supports this conclusion.

Water Contaminant Analysis

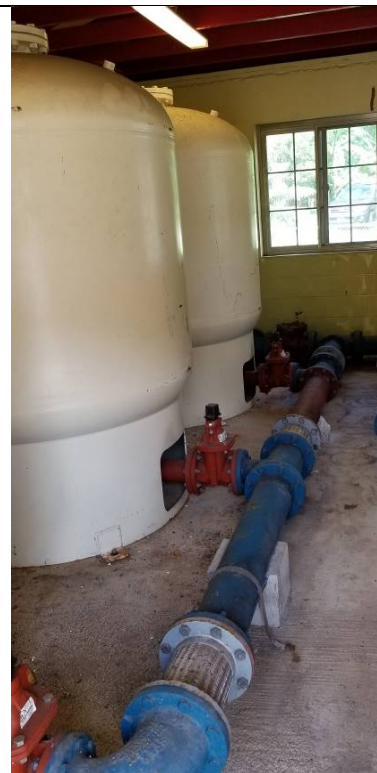
120,000 gallon Domestic and Fire Water Storage

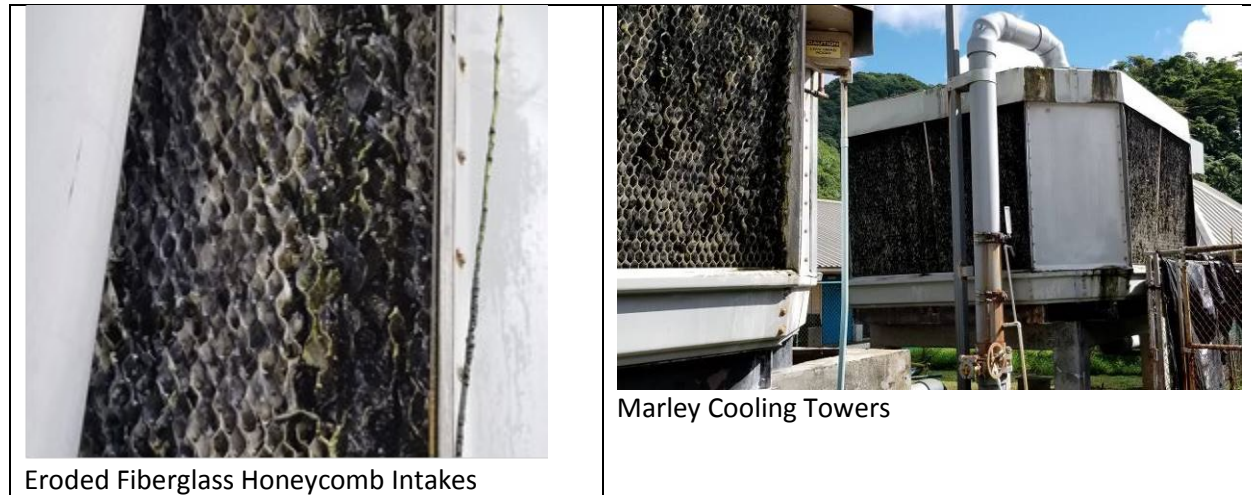
Condenser Water – The condenser water system serving the chillers consists of 2 Marley fiberglass Cooling Towers (2009 era) located between the Central Utility Plant and the Dialysis Bldg. The location is very concerning as the cooling towers are only 20ft from the Dialysis Bldg and 10ft from an outside waiting area (where the dialysis patients complained to the team about the chiller noise.). The proximity of patient care areas to the cooling towers places patients at a direct risk of legionella and other waterborne pathogen exposure. The risk is further increased by the lack of water treatment. The cooling towers appear to be at the end of their useful life due to degradation of the fiberglass air intake grids which are degraded beyond repair. Inadequate water treatment and insufficient blowdown appear to be the main causes.

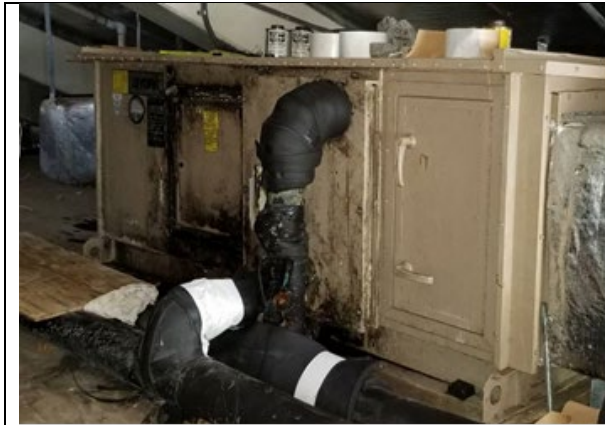
Surgical Ward (2000 era HVAC) - Condition of the HVAC serving the Surgical Ward (equipment located above the patient care areas on the mechanical mezzanine) is deteriorated beyond repair with extensive mold growth both inside and outside each air handling unit. The mechanical mezzanine area is unconditioned and exposed to the outside conditions and has no rated separation between the equipment area and the clinical spaces. The only separation between the mechanical area and the patient care area consists of acoustic ceiling tiles (ACT) and vented lighting which allow nearly unlimited vapor and air movement, exposing the patients to all the mold present in the mezzanine area. Condensation created by imperfections in the chilled water insulation also is a source of water and mold growth which was noted on the ceiling tiles as well. The HVAC is arranged as recirculating AHU's (qty 5) each with outside air ducted to the return side. There was no apparent provision for relief air. The outside air system consisted of an inline fan and filter banks. The filters were completely clogged and disintegrated. The recirculating AHU's are arranged in a draw-through configuration with 2 pre-filters and no final filter (i.e. filter after the cooling coil and fan) which does not meet FGI (ASHRAE 170) standards.

The mold is so prevalent throughout the AHU system and Surgical Ward building (e.g. inside and outside all AHU's, on diffusers, ceiling tiles, on the support structure, on piping insulation, etc.) that targeted mold remediation would be impossible and a complete renovation of the building down to the structure would be needed to address.

Air Handler – Surgical Ward

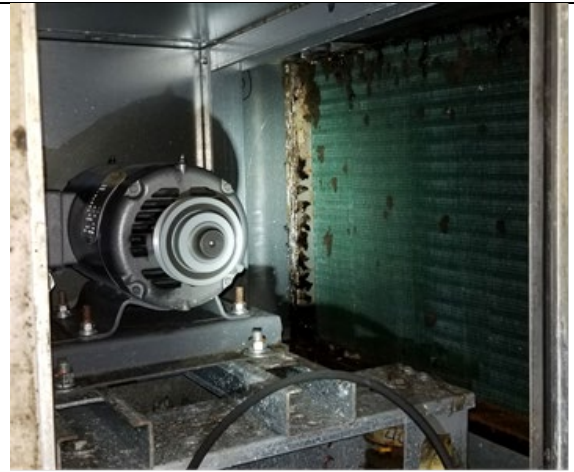
Fan Section and Cooling Coil

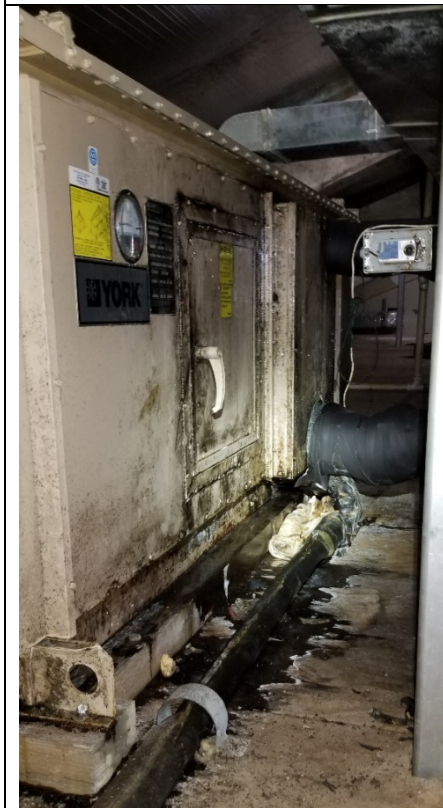
Air Handler – Surgical Ward

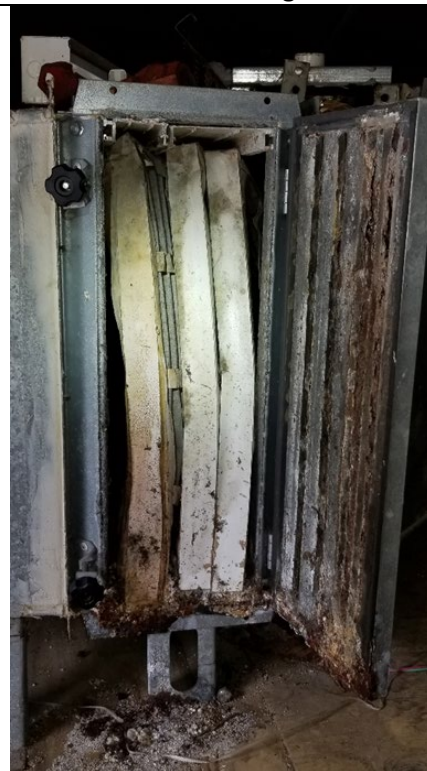
Outside Air Filters

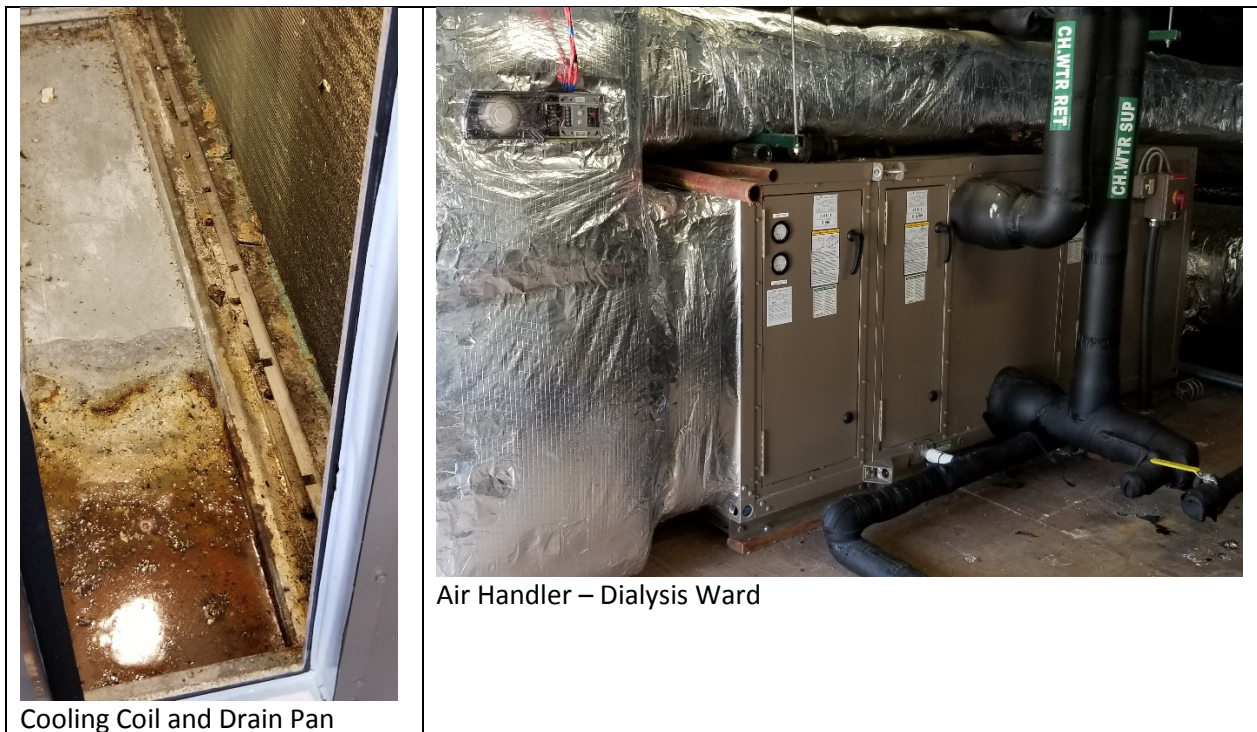
Cooling coil carryover is present in the fan section. It is unclear if this is due to operation at higher than design velocities or inadequate distance between the coil and fan section (manufacturer's design issue). The cooling coil carryover in combination with the lack of filtration creates the perfect conditions for mold growth which is readily evident in the fan section. And the lack of final filter enables the mold spores to be freely distributed to the patient care areas which is especially concerning for these potentially immunocompromised patients.

Given that these AHU's have been in place for only 2 years, the interior condition is likely to rapidly degrade unless the units are remediated for mold and the filters are replaced and filter bypass eliminated.

Cooling Coil and Drain Pan

Air Handler – Dialysis Ward

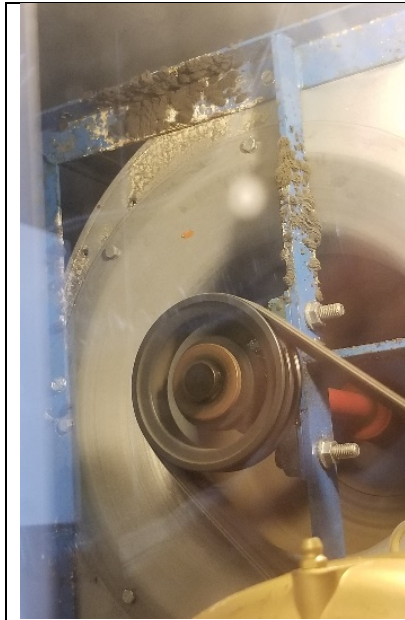
Fan Section – Mold Contaminated

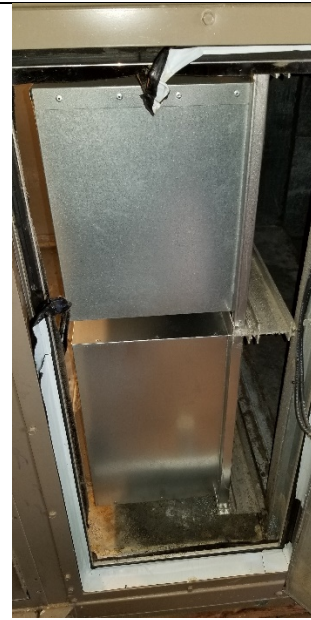
The AHU's are draw-thru type with chilled water cooling coils. Terminal units are VAV with some electric reheat. Several deficiencies were noted in the AHU leading to the present mold conditions: Prefilter frames are in place but no filters were present. Merv 11 filters are installed but there is significant bypass around the filter bank rendering it useless. It is unclear if this was poor frame design or if the filters were replaced with an incorrect dimension. Bypass of unfiltered air is evident by the dust and debris on the inlet face of the cooling coil. There is also no final filter module incorporated after the fan/coil as is required by ASHRAE 170 and DVA/DoD criteria. An outside air duct is connected to the return duct work bringing in an uncontrolled amount of outside air likely only in response to any space exhaust.

Air Filters – Merv 11 Filters installed. Prefilter frame present but no filter installed.

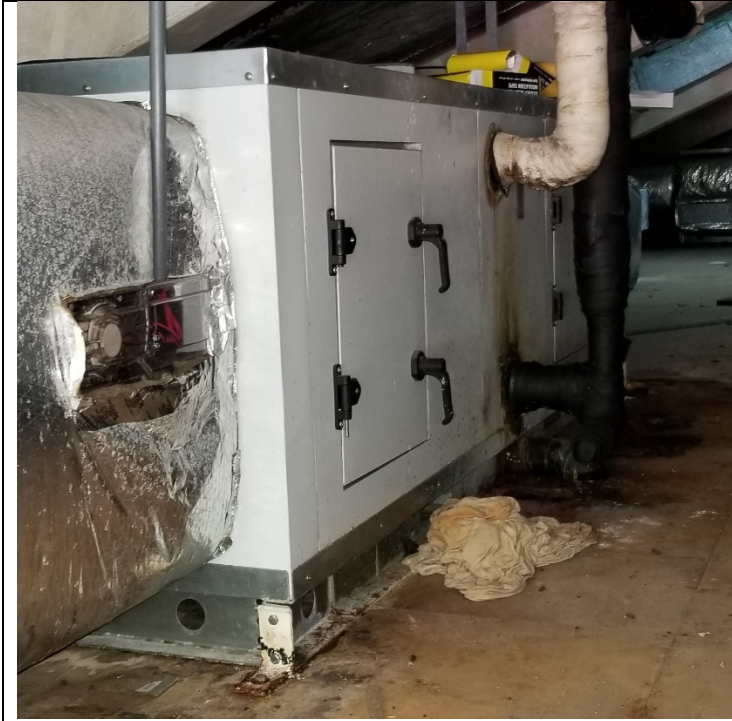
OB Ward (2008 era HVAC) – Similar HVAC condition and configuration to the Surgical Ward only slightly newer. There is a single fresh air supply serving the return side of each air treatment unit (qty 5). The outside air filters are completely destroyed from lack of regular replacement. The outside air fan is operational, however the air intake is 75% blocked on the outside (apparently it was a temporary measure for nearby construction that was never removed). Furthermore, the rust present within the outside air fan and duct demonstrates the high humidity environment. Mold is growing on the intake filter due to the constant high humidity of the intake air. Mold is further prevalent inside every AHU which is due to the lack of any functional filtration (presence of dust and outside contaminants) and cooling coil carryover. Cooling coil condensate is not draining properly, likely a trap sizing issue. All fan belts are either missing or in need of replacement.

Typical air handling unit (OB Ward)

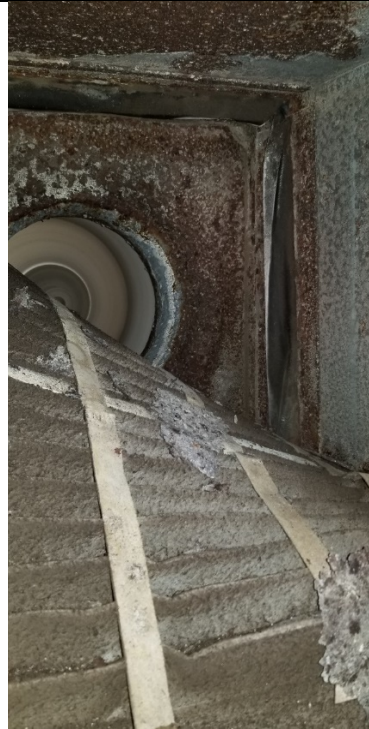
Outside air fan and filter

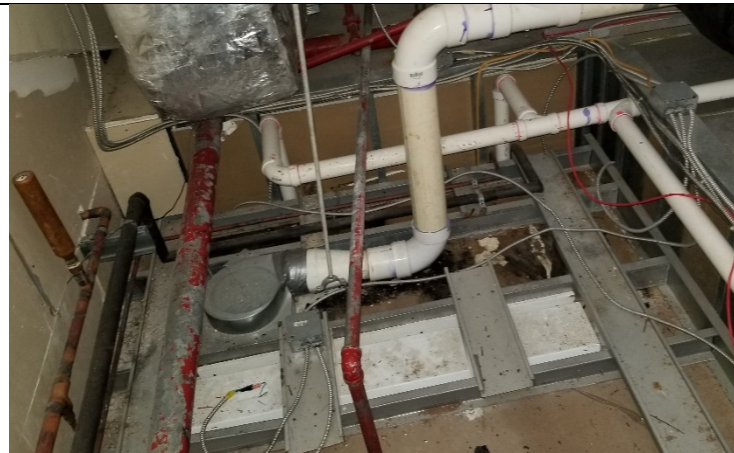
The mechanical space is better isolated from the outside than the Surgical Ward (eaves are better sealed) resulting in less surface condensation but there is still significant mold and dust in the above ceiling area. The space communicates directly with the clinical space since the mezzanine is only a partial floor structure with no rated partition.

View of the ceiling from the mechanical mezzanine - no rated partition or barrier

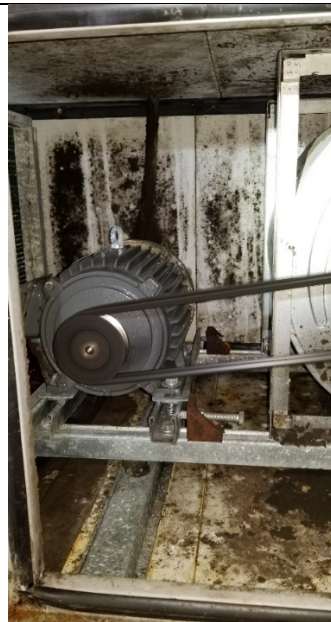
Air handling unit - fan section - mold present

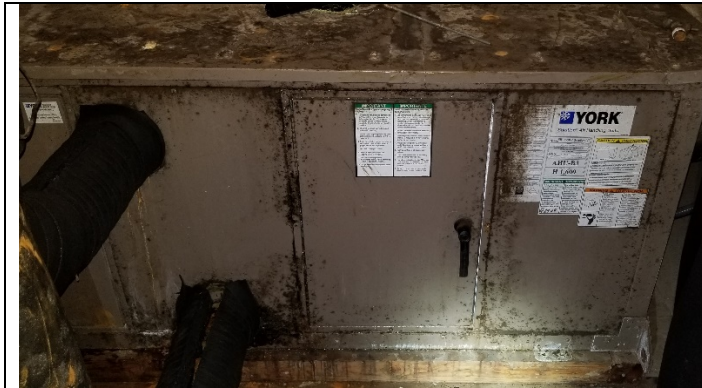
Medical Ward (2009 era) - Similar HVAC condition and configuration to the OB Ward.

Typical air handling unit (Medical Ward) – mold present

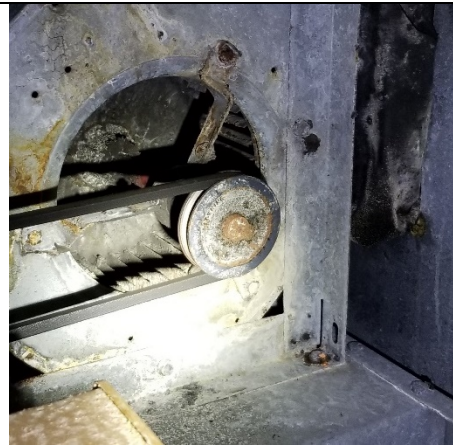
Air handling unit – fan not functional

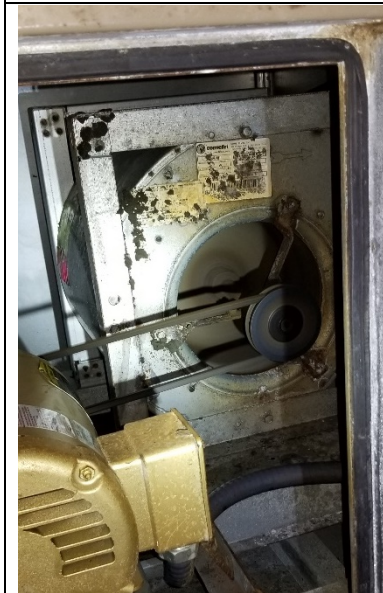
Typical Fan Section – Mold present

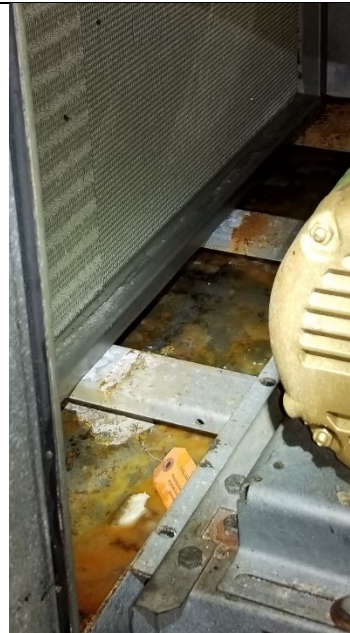
Typical Cooling Coil Drain Pan – mold/biofilm present

13. Condensate drainage must be addressed to ensure drain pans readily drain water (i.e. appropriate trap design). Condensate drain pans must be stainless.

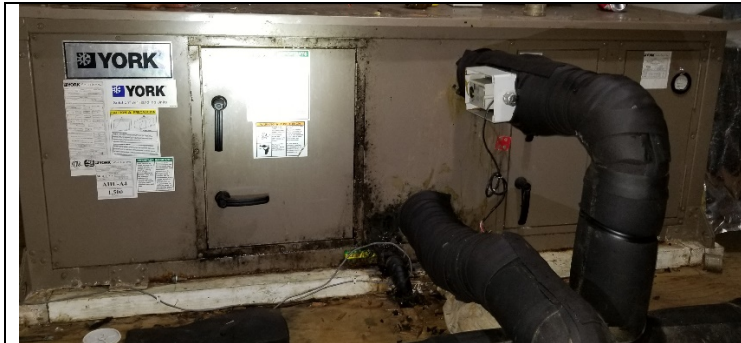
Pediatrics Ward (2002 ERA HVAC) – Similar HVAC condition and configuration to the Surgical Ward.

Typical Recirculation Air Handling Unit (Pediatrics Ward)

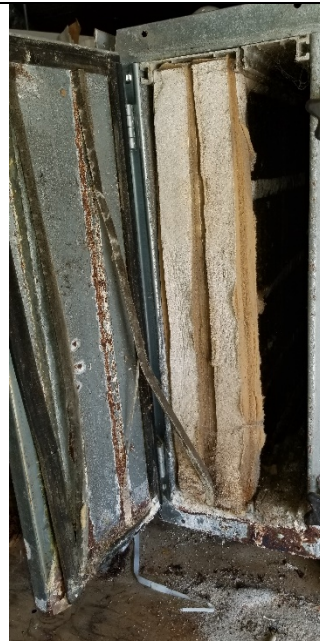
Outside Air Filters

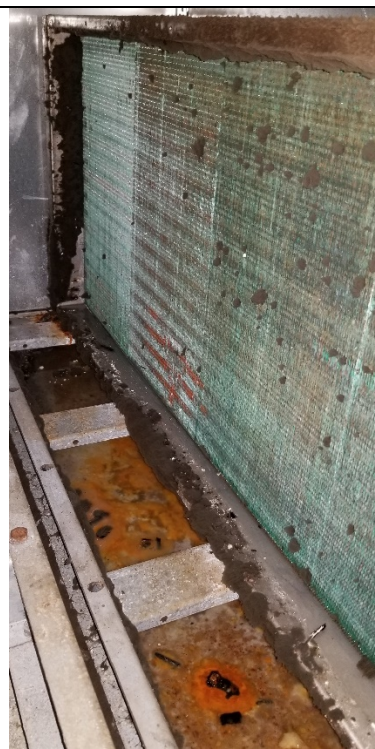
Typical cooling coil and drain pan.

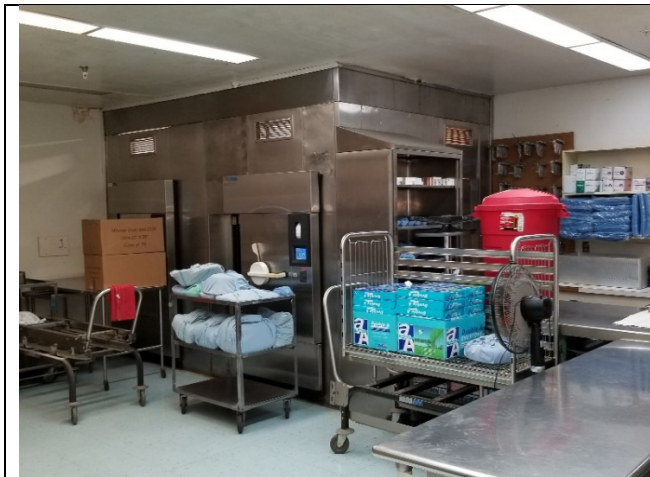
CMS (Central Sterilization) – Deficient HVAC is compromising the infection control requirements of this department and potentially the entire supply chain for surgery etc. A split system is being used to cool the department. The only operational central HVAC is an exhaust located in the sterilizer equipment room (back side of the autoclave). This area is (and should be) negative to the clean side however there is no functional supply or exhaust on the clean-side to maintain appropriate room pressurization. The exhaust on the equipment side is causing the entire department (including the clean-side) to be negative to the corridor when it is required to be positive. This allows for direct re-contamination of devices which have just been sterilized. Furthermore the sterilizer equipment room has uncontrolled steam condensate which is leading to a very humid and damp environment in this critical area. Also, this equipment area is not separated from the above ceiling plenum space, which is unconditioned. A non-functional washer-disinfector is also leading to compromises of the intended positive and negative areas.

Sterilizer – Loading / Unloading

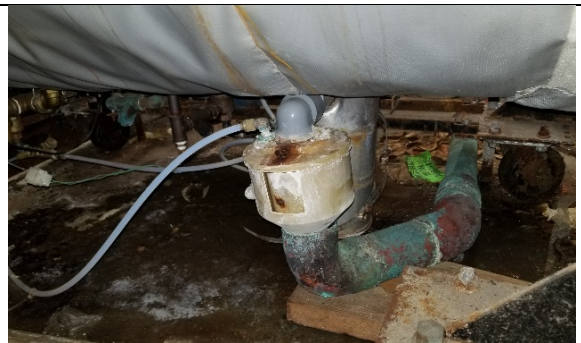
Sterilizer Drain

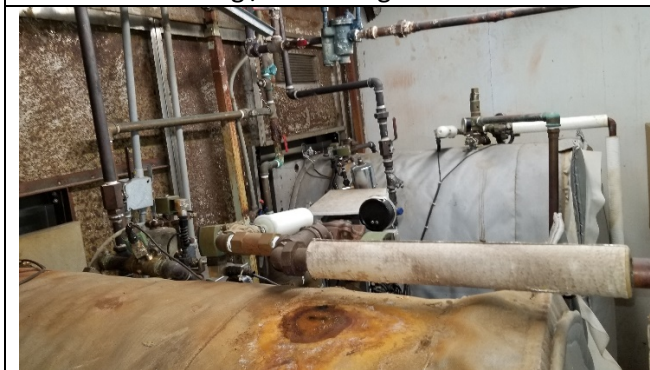
Equipment Side of Sterilizers

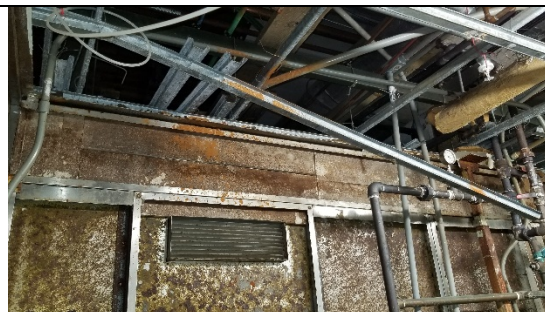
Sterilizer equipment room open to unconditioned ceiling plenum

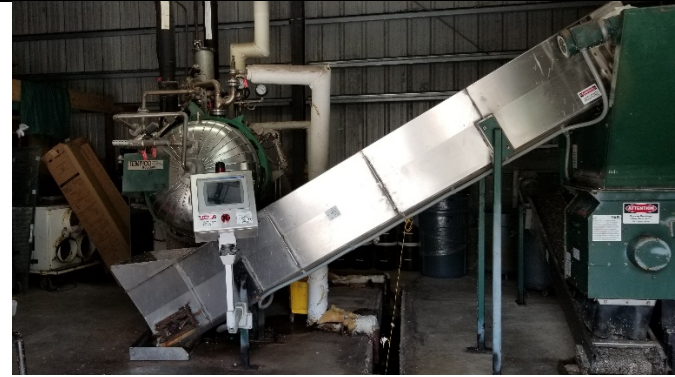
Autoclave – Hazardous biological waste (“red bag”) items are processed at the hospital in a steam autoclave (Rotoclave - Tempico) where the waste is disinfected and sterilized. The unit is located in a stand-alone building but the large roll-up doors were wide open at the time of the survey apparently due to a lack of climate control. This compromises any designed for space pressurization. The lack of controlled space pressurization (negative) presents an infection control risk. Bio-hazard waste handling and processing is a highly regulated process that requires careful attention to infection control procedures and is not typically performed at a medical facility. The exposure of this equipment to the marine climate and the proximity of this process to the hospital (~30 ft from the kitchen/dining area) is very concerning.

Rotoclave - Tempico

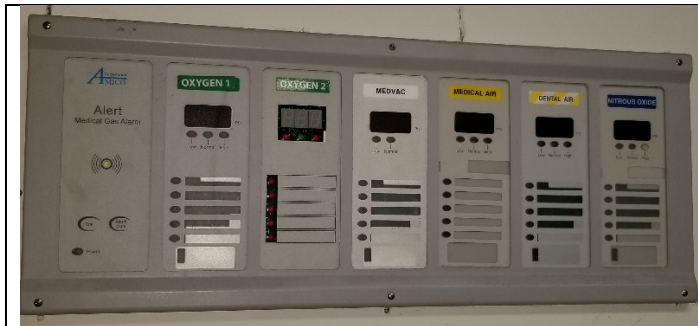
Zone Valves and Alarming – Zone valves appear to be present where required by NFPA 99 however many zone valves are unlabeled for the gas nor the location that they serve (Joint Commission and NFPA 99 violation). Many Area Alarms are also unlabeled as required by NFPA 99. The Vacuum and Medical Air Systems are in constant alarm and so it is unlikely that any change of alarm condition would be noticed by the staff placing patients at high risk. The Master Alarm Panel (located in the supervised Communications Room) is not functional. NFPA 99 requires two master alarm panels in two separate locations for Category 1 Medical Gas Systems including notification of the local alarms (equipment alarms) which are not even routed to the master alarm panel.

Master Alarm Panel

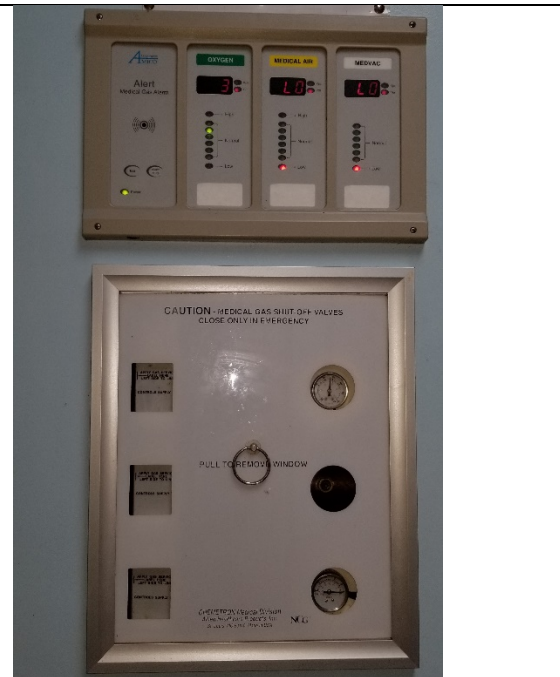
Typical Zone Valves and Area Alarms in Patient Wards

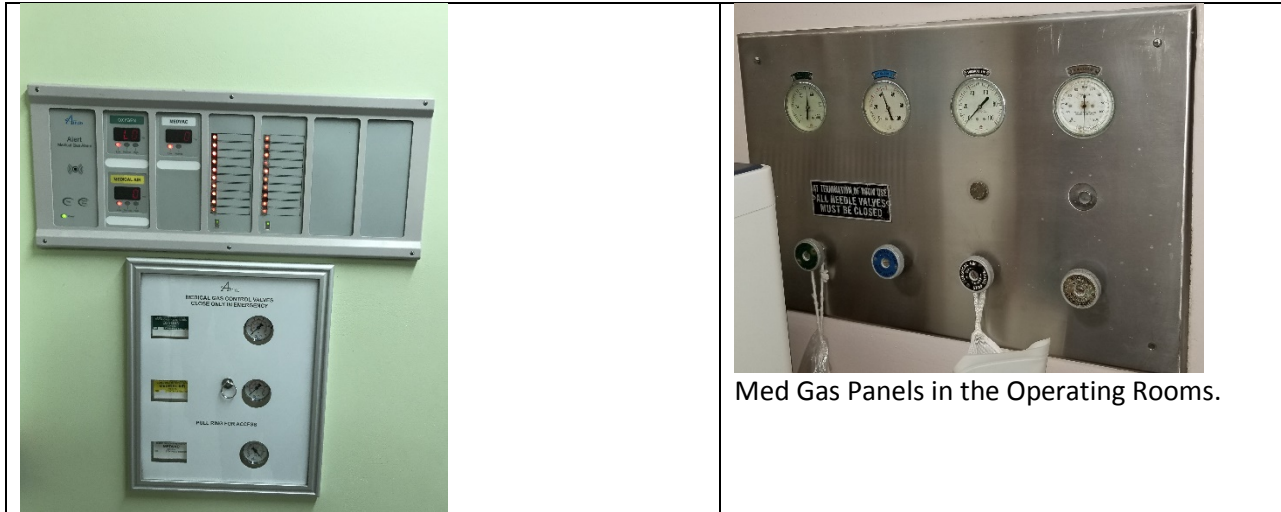
Medical gas inlets/outlets in several areas were said to be problematic including the wall outlets/inlets in the OR's which were said to be non-functional. Also in PACU the wall outlets/inlets leaked when connected and therefore bottled gases were being used instead.

Med Gas Panels in the Operating Rooms.

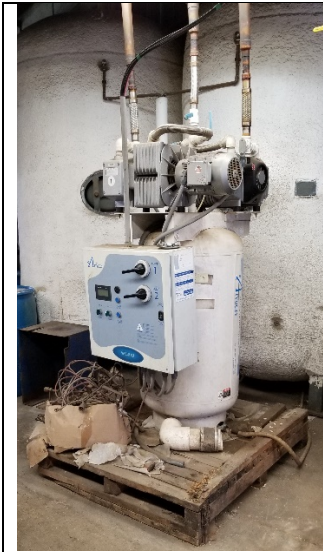
Waste Anesthetic Gas Disposal (WAGD), Medical Vacuum (MV) and Oral Evacuation (OE) – All three systems are being served by a common vacuum system. The Amico Vacuum Pumps (era 2015) at the CUP indicate an operating pressure of 8 to 9 in hg but in the wards, the pressure monitors indicate significantly higher pressures 12 to 13 in hg. The source of the discrepancy is unknown. The vacuum pumps were also both in “system fault” although there was no specific visible local alarm. Also, all vacuum Area Alarms were in alarm for low vacuum pressure. This is due to the fact that the Medical Vacuum is required to be at 15-19 in Hg but the system is operating at 8-9 in Hg apparently due to the use of the single system to serve WAGD and Oral Evacuation in addition to Medical Vacuum.

The Amico Vacuum pump has been installed on a wooded shipping pallet which is subject to decay.

Medical Vacuum Pump (operational)

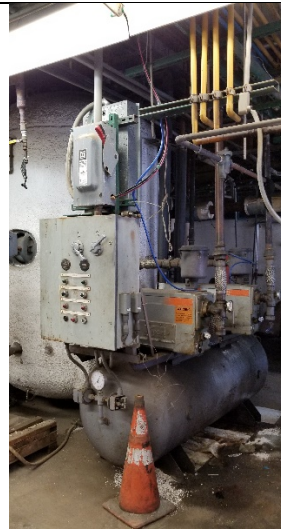
Old Medical Vacuum System (abandoned)

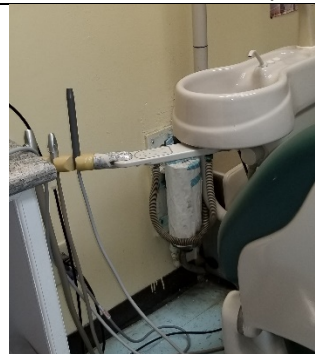
The use of a dry medical vacuum system for Oral Evacuation is prohibited by commercial and DVA/DoD standards as Oral Evacuation is a lower pressure wet-system with mandatory central liquid separation and amalgam separation. Liquid separators are present in each DTR and manually drained periodically which introduces a “dirty” process within the patient care area. Furthermore the local separator requiring manual waste disposal likely does not capture all the liquid and solids risking damage to the vacuum pumps. Also, amalgam separator are not being provided as required by U.S. law and DVA/DoD criteria.

Chairside Liquid-Separator in each DTR

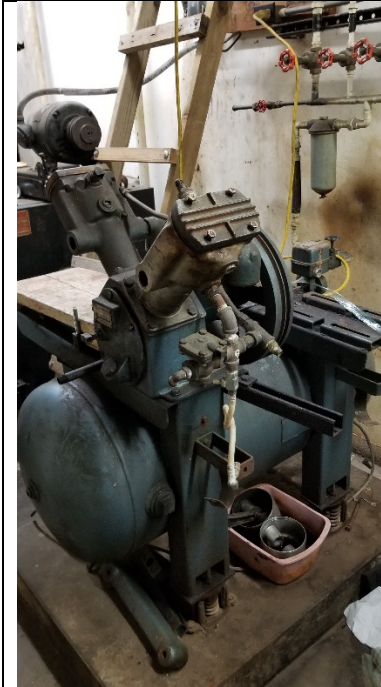
Medical Air (MA) – No medical air is currently available. The old MA compressors are beyond their useful life and disconnected. The lack of medical air provides additional logistical challenges to the Hospital due to a large increase in the need for bottled oxygen to support ventilators as well as and the use of non-medical grade air for some anesthesia machines which could pose a risk to the patient.

Old Medical Air Compressor

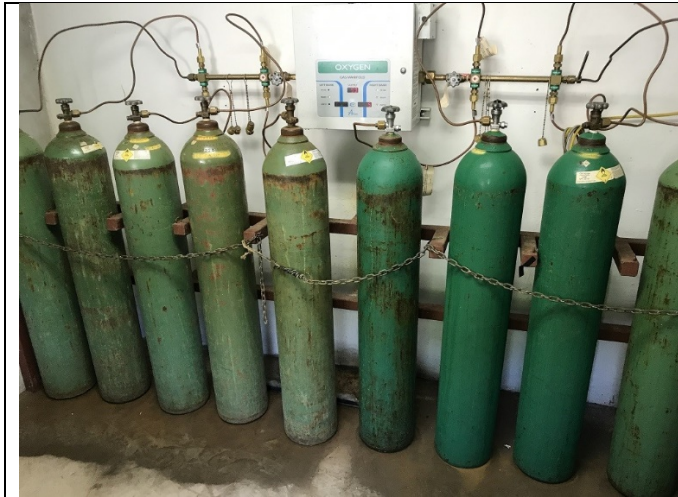
Functional Oxygen Manifold

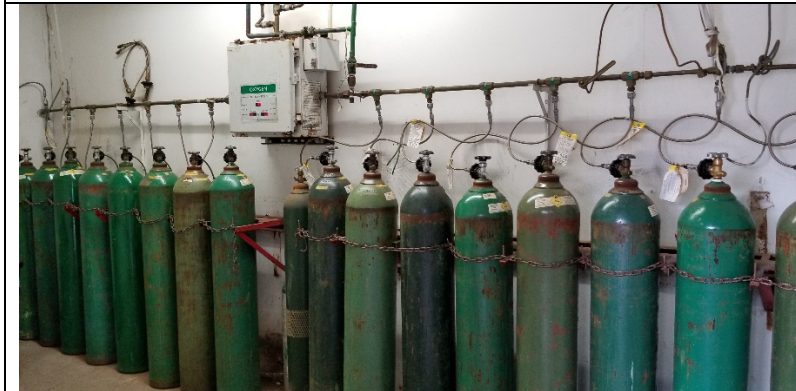
Oxygen – There are two oxygen manifold rooms. One within the CUP and another nearby. The manifold room in the CUP is valved off and in alarm. The manifold controller appears to be degraded beyond repair. Notably the system pressure is indicated to be 95 psi but the relief valve (set at 75psi) is not relieving. The degradation of the controller is a direct result of environmental exposure. The system needs to be installed in a humidity controlled environment. The second oxygen manifold is functional and appeared to be serving the system at the correct pressure (50-55 psi). The second oxygen system was apparently intended to serve a Hyperbaric Chamber (as a separate system) but was interconnected to the main oxygen system, resulting in one system. The Hyperbaric chamber is apparently not used. Cylinders were often found unrestrained.

Non-Functional Oxygen Manifold

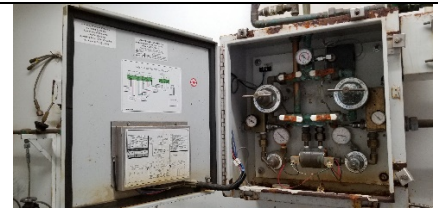
Non-Functional O2 Manifold

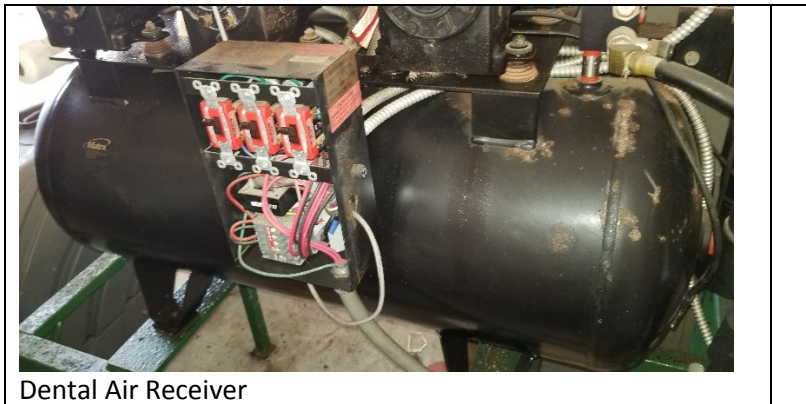
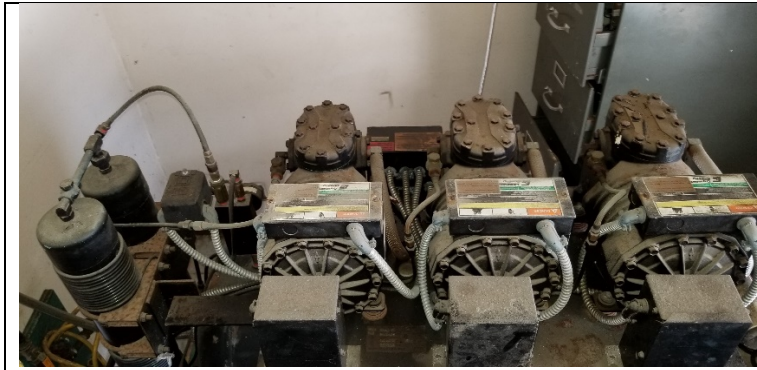
Dental Air – Served by a triplex system with a single receiver tank. Compressors appear very old but are functional. Many critical NFPA 99 requirements are not being met. The compressors are not oil free. The air intake is not from a clean source and is inadequately filtered. There is also no air dryer for dew-point control. This combination of inadequate filtration and dew-point control creates a high risk of system contamination placing the patient at risk with the contaminated air being delivered near the breathing zone. Furthermore the air source is drawn from the compressor room instead of from the outside or other clean/filtered source.

Dental Air Compressors

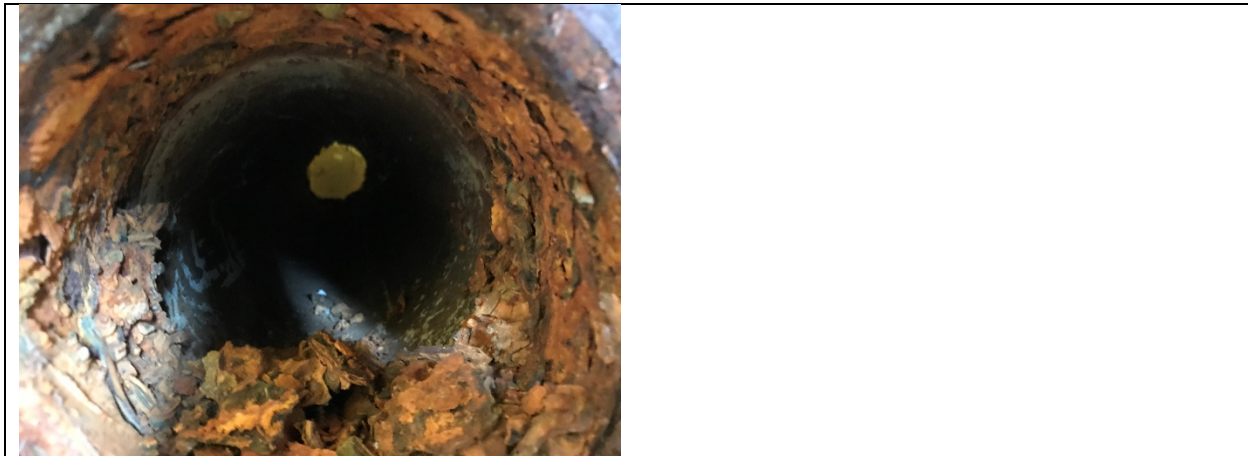
Domestic water is said to be chlorinated by ASPA at the well sources. No water quality test was available to validate potability although some water test data (contaminant testing) was available related to the dialysis water treatment system installed. There is no chlorination monitoring or secondary water treatment (e.g. chlorination, copper/silver ionization etc.) provided after the 120,000 gallon storage tank, which is concerning as the dwell time will allow the residual chlorine from the source water to dissipate before it enters the distribution. It is likely that little or no chlorine residual is present within the hospital. Also, the available test data showed the water to be very hard (and facilities indicated it is also aggressive to copper). With no functional water softener, the fixtures show noticeable mineral deposition. As most of the domestic water system is constructed of copper (including the new OR building) it is likely that the piping distribution system is in very poor condition. The sample piece of main piping (photo below) supports this presumption with heavy tuberculation noted.

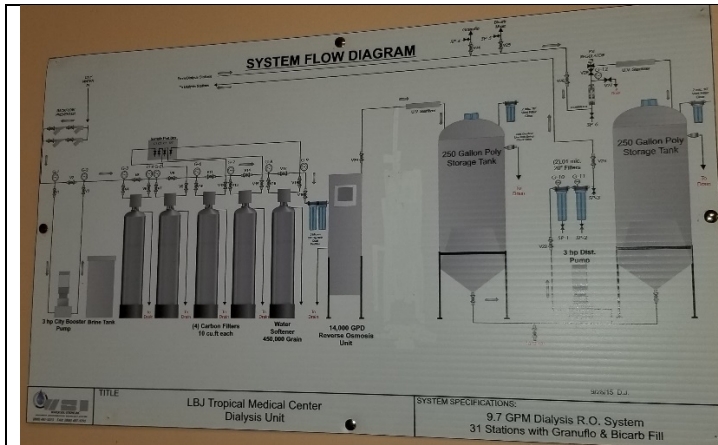
Dialysis Water Diagram

Dialysis has an extensive pure water generation system that is new and appears to be in very good condition and code compliant with the required backflow prevention etc.

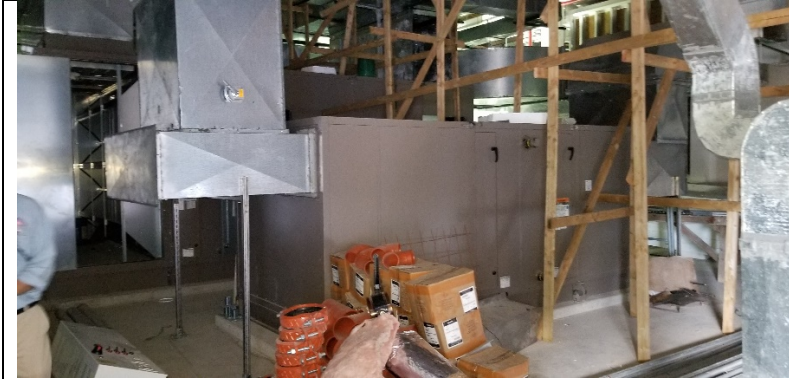
However, the most concerning issue is that the construction of Phase 2 has enclosed the existing air intakes for the air handling units which serve the existing operating rooms and LDR's. The construction implementation appears to only provide a new means of to serve these areas once the new HVAC system is operational. The result is that these 2 existing AHU's are drawing "outside air" from within the construction area. The filters are completely loaded and access doors are opened resulting in unfiltered construction air being delivered to these existing critical care locations. Furthermore, this makes the new construction area highly negative bringing in outside air, humidity and mold spores. New construction (and especially healthcare) must always be kept positive to not permit mold or other air borne contaminants from establishing themselves within the new building.

New Air Handling Units.

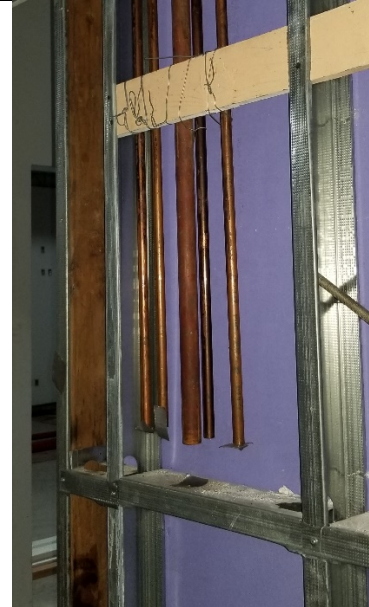
Uncapped/Unpurged Med Gas Lines

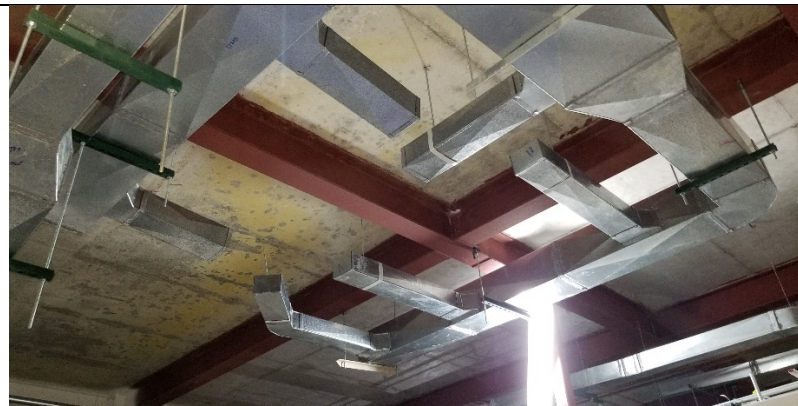
Duct rough in above the Operating Rooms for Laminar Flow Diffusers.
