Interagency Aviation Lessons Learned

No. IA LL 15-01

February 17, 2015

Subject: Helicopter Load Management**Area of Concern: Helicopter Operations****Distribution: All Aviation Activities**

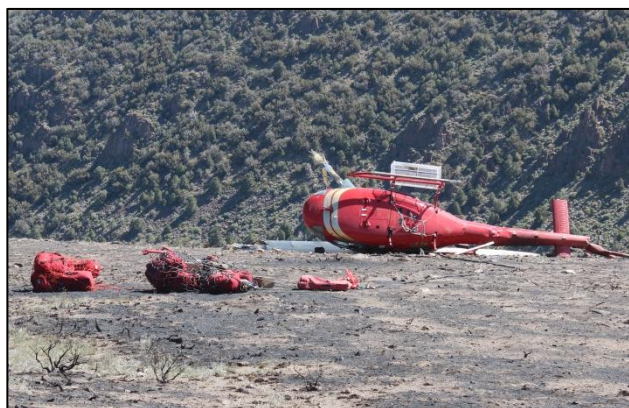
Discussion Last summer, a contracted helicopter was destroyed when the pilot lost control of the aircraft while conducting external load operations in support of wildland fire operations. Fortunately, neither the pilot nor the firefighters who were in close proximity of the aircraft were injured. The investigation revealed the accident involved several links in that famous chain and lined up all the holes in the Swiss cheese model that contributed to the accident. In other words, it took a village.
