**US Army Corps
of Engineers®**

**Facilities Condition Assessment
Guam Memorial Hospital
Tamuning, Guam**

08 April 2020

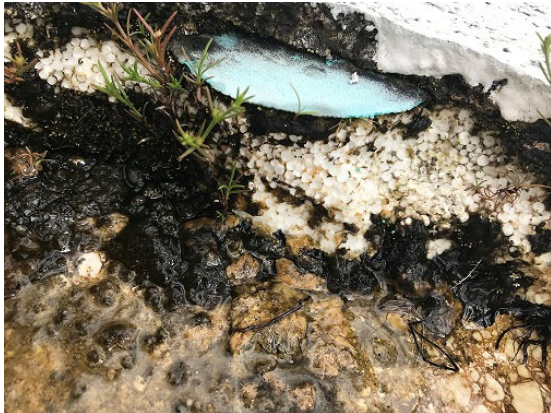
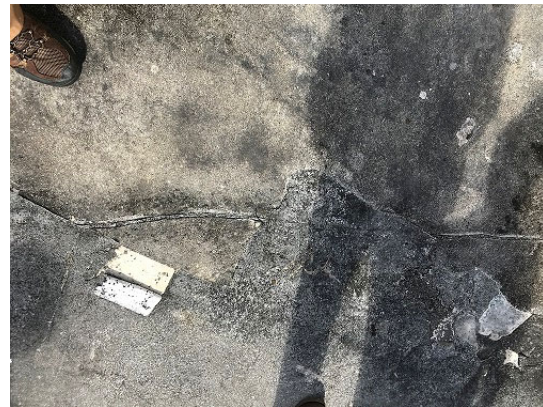
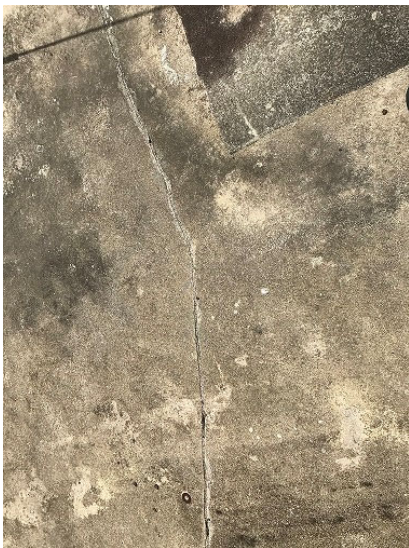
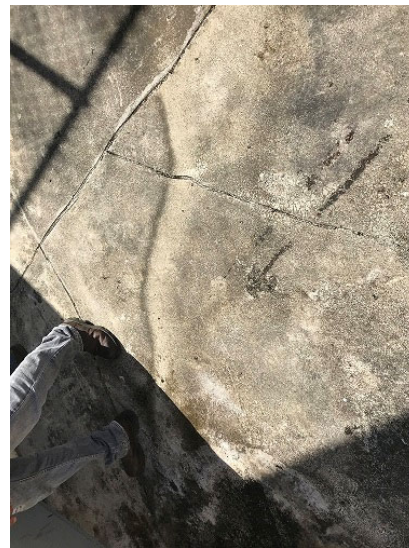
Roof: The roof is composed of Styrofoam (tapered insulation), with some sort of top membrane then 1/2 inch thick concrete topping with painted top coat installed over a flat structural concrete roof slab. Major cracking has occurred throughout this top layer allowing moisture to infiltrate. Moisture can cause roofing systems to degrade, lose adhesion, develop mold growth, curl and even lead to total system failure. Although the facility has attempted to repair, patch and recoat some of the damaged areas, the roof still leaks causing interior damage to ceilings, walls, equipment, etc. All Roofs should be replaced, to include the original A & B wings and E wing fourth floor. Roofing over the power plant as it was constructed sometime between 1978 and 1989. As well as all roofing of buildings built in 1989 (A-wing addition (D-wing), Entry Wing, S- wing, G-wing and M-wing) should be replaced. C-wing roofing was replaced in 2000 but may also want to be included to modernize the entire facility.

PRIORITY Repair: Recommend removing entire roof system down to structural slab. Dry, repair, caulk, seal, waterproof and skim coat structural slab for flat level surface. The roof system selection is an integral part of the overall building design and must take into account interior building usage and climate. When dealing with existing structures, weight, slope, existing and hazardous materials, and historic preservation may become constraints. For example, the thickness, weight, and reflectivity of the roof system has a major impact on roof/structure as already designed. Further, with an occupied building, construction noises, fumes, fire hazards, and roof access all take on increased importance. Other considerations that must be followed are determination of wind uplift pressures (corners, perimeter, or field), thermal expansion, environmental corrosive conditions, humid location based on ASHRAE climate zone, air and vapor barriers and integration with building envelope.

Install a new elastomeric membrane roofing system with new tapered rigid insulation a minimum of 1/2 inch per foot slope. When increasing slopes of existing roof decks, clearances for rooftop structures such as curbs, base flashing, access doorsills, etc. must be increased as well which can impact facility operations and increase cost.

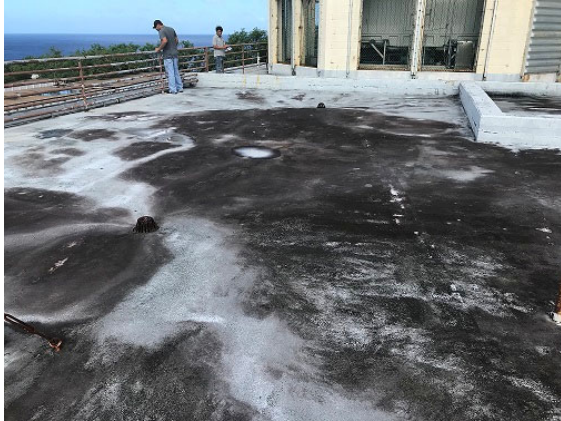
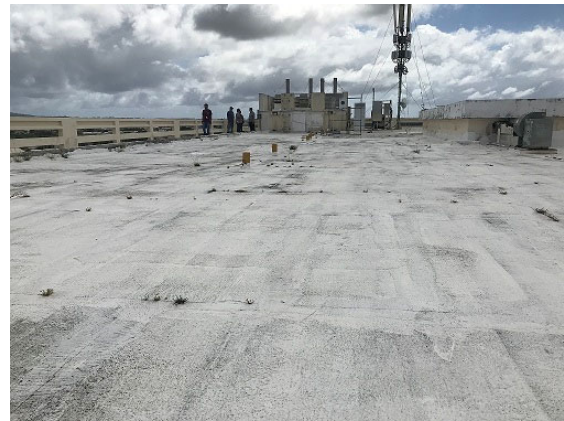
Roof Slope: The slope is very minimal to non-existent in most areas on the existing roof at the facility with the exception of the more recent ER and ICU additions (2014). Poor water drainage and ponding is quite evident with discoloration. Appropriate slopes are a minimum of 1/4 inch per foot to more appropriate and recommended 1/2 per foot which is ideal for positive drainage and potential rainfall for this region.

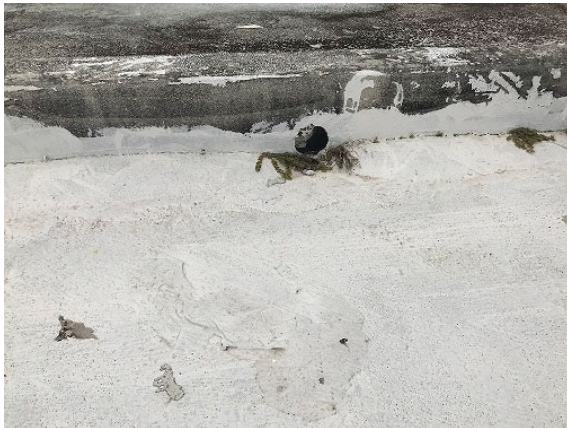
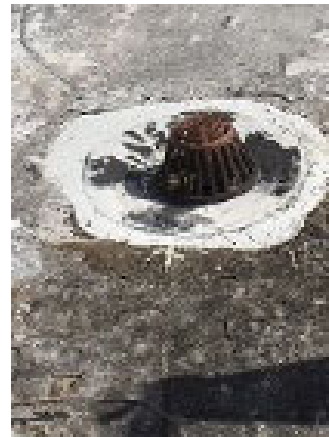
Roof Drains: Roof drains consist of primary on roofs with scupper secondary which drain down the sides of the building. Drain caps are corroded, broken or even missing, top coat does not appear to be flashed or sealed properly with high risk of leaks.

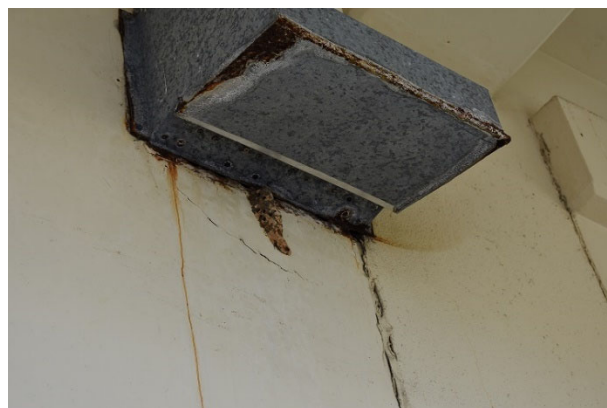
Exterior Wall Openings/Penetrations: The building envelope is severely compromised with numerous penetrations from fresh air intakes, abandoned intakes, exhaust (ISO), expansion joint to possible flashing failures. The corrosive environment has eroded not only the shroud/covering, the joint seal at the building opening and duct on almost every intake, but has also impacted the failure of the interior duct leg inside the building (5 to 20 ft). As a result, a

number of the intakes exterior shroud/covering have been removed and then covered. The courtyard exterior walls have numerous abandoned air transfer grilles/ducts thru the exterior walls that the moist humid air infiltrates into the building. Along with other fresh air intakes for AHU on the upper floors, pharmacy exhaust, isolation room exhaust, etc. All have penetration impacts to the integrity of the exterior envelope. These openings allow hot humid/moist outdoor air to enter the plenum area or building. With the exterior wall not adequately sealed at these locations the AHU or occupied space cool air mixes with the hot humid air which generates moisture, condensation and mold growth above the ceiling, on the ceiling, within walls and throughout the building. **PRIORITY Repair: Recommend sealing all penetrations, replace fresh air intakes with more appropriate material for environment along with joint/seal, etc. See Mechanical for additional information.**

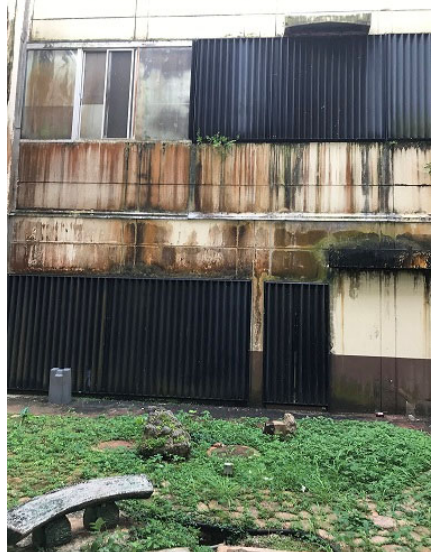
Exterior Windows: Exterior windows are generally in FAIR condition, constructed with single pane (fixed glass) aluminum framed systems either storefront or punched styles throughout the facility. All windows have a steel framed horizontal sliding metal (typhoon) accordion type

shutter system at the exterior. Numerous window sills have rot/decay/deterioration/water damage which appear to be leaking and should be replaced. Others have failed seals or gaskets. Windows that fail or are improperly sealed can cause heat and humidity to seep in, resulting in a rise of interior temperature, which will cause air conditioners to work twice as hard to keep the environment cool. This also creates moisture issues that can lead to the growth of dangerous substances such as mold.

PRIORITY Repair: Recommend removing all of the existing windows across the entire facility and install newer high efficient non-operable (Fixed) Windows. High quality (marine grade, Kynar finish or stainless steel) aluminum framed windows are common, material is lightweight, strong, energy efficient and require little maintenance. Ensure that

the window framing system has a thermal break (i.e. nylon I beam) which prevents the frames from conducting heat/cold and eliminates condensation. Insulating laminated glazing units enhances acoustical performance, ultraviolet light protection and the laminated component is designed to remain integral in the opening should glass damage occur at the exterior layer. UV resistant and provide added protection for impact resistant glass for severe weather or blast protection. The glazing should have a low coefficient rating, multi-paned and low emissive glass (low-e coating) with glass panes bonded with a polyvinyl-butylal (PVB) interlayer.

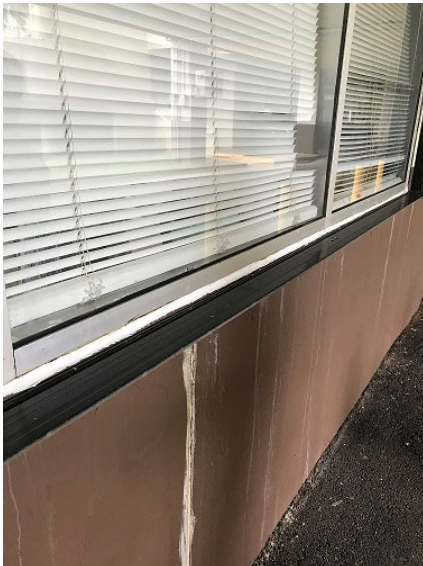
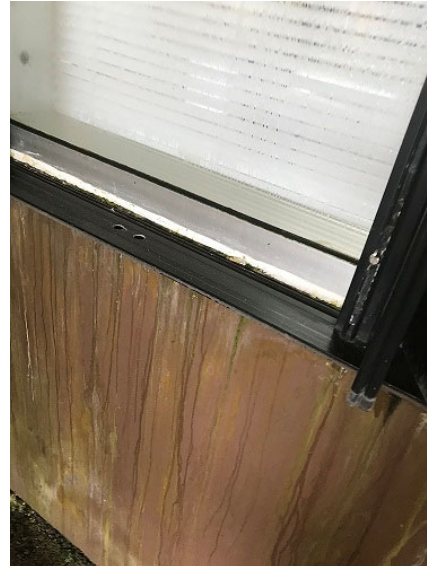
Exterior Windows (Flashing/Weeps/Caulk): Window sill flashing not provided and weeps at exterior are either not existent or sealed with caulk. Most architectural aluminum glazing system are not designed to be totally waterproof. Rather, most systems are designed to control water infiltration under extreme conditions and weep that water back to the exterior. Punched windows, storefront and curtainwall systems differ in many ways: appearance, profiles, wind loads, glazing, thermal performance and how they weep water. **Punched window** can be

operable or fixed which are located in a hole-like or predefined opening within the exterior wall. The most important consideration to understand is whether the window system is a rain screen or barrier system. A rain screen system provides internal drainage (weeps) for water that infiltrates into the system while a barrier system assumes that no water will ever infiltrate and does not need internal drainage. Fixed windows of course offer the best resistance to air infiltration or water penetration and require less maintenance. **Storefront systems** control water infiltration by directing all moisture to the sill pan. It is imperative that the sill pan be installed correctly. Most manufacturers have prefabricated or can provide custom sill pan components with integrated end dams. Without end dams, water will intrude into the jamb locations of the building. Window perimeters should have flashing (head and Jamb) that are integrated with the waterproofing at adjacent walls. Water deflectors must also be installed wherever a horizontal mullion occurs. These direct water over to the vertical mullion where it weeps out at the sill flashing. Deflectors are necessary to ensure that the water bypasses the glass lite. Without water deflectors, moisture is likely to settle on the top of the glass, allowing water to enter the interior and causing possible failure of the glass unit. **Curtainwall systems**, we want to prevent water from reaching the vertical mullions. Each horizontal mullion must have zone dams properly installed and sealed at the vertical members. Any water that makes its way to the vertical mullion will ultimately make its way to the interior of the building. Unlike storefront, which directs water to the sill, curtainwall weeps water at each individual lite of glass through holes in the pressure plate. Because curtainwall systems are used for taller elevations with higher wind loads, the amount of water entering the system is typically greater than the capacity of storefront systems. This is why each lite of glass is individually weeped. Since water is not diverted down the vertical mullions to the sill, curtainwall does not require sill flashing. However, extreme care must be taken into consideration when installing caulk joints at the sill. The exterior caulk joint must be behind the face cover since water is weeping out of the bottom.

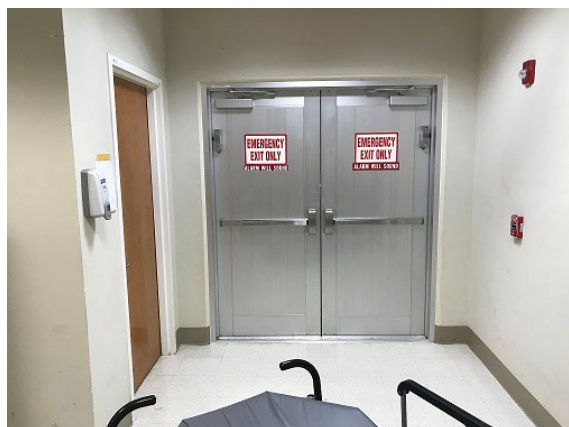
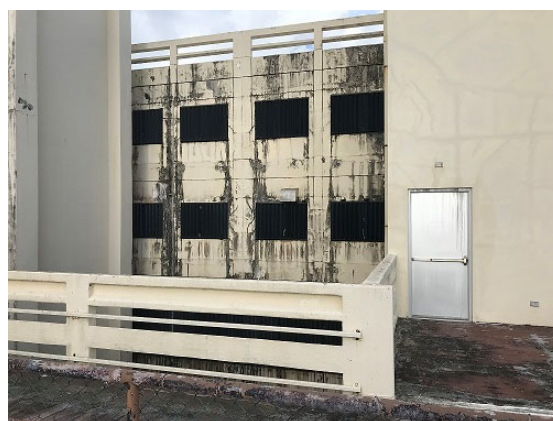
Exterior Doors: Exterior doors have a mixture of either aluminum or hollow metal. Majority of the original building doors are in GOOD condition. Typical door frames are hollow metal. The only issue identified are failed seals probably due to exposure and corrosive environment. A couple of the overhead doors at the central utility plant also needs to be replaced due to condition and damage. **PRIORIT Repair: Recommend replace all man door seals, recondition hardware to either full replacement of overhead coiling CUP doors to reconditioned (oil/lubricate) to replace latches, wheels, bearing and coil springs.**

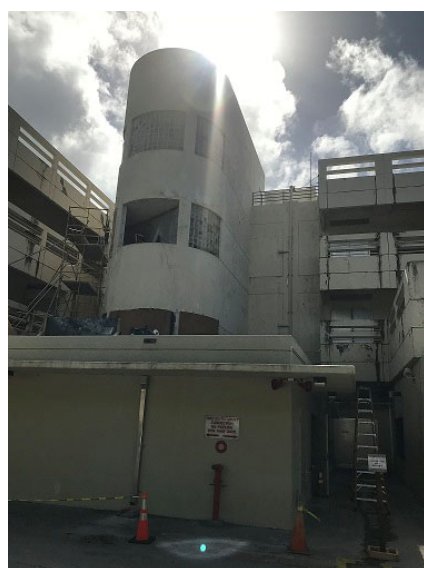
Exterior Stair Walls: Center stair enclosures (#2 & #3) at both north and south ends of building have infill poured in place concrete walls which have significant cracking issues and settlement. A project is currently underway replacing the glass block windows due to failure of rebar and leaks. **PRIORITY Repair: Recommend that a full in-depth structural analysis be conducted on the walls and foundation supporting these stairs. The wall cracks may be injected with epoxy to bond and seal the cracks within the exterior wall. The foundation may need to be expanded/enlarged, reinforced and or even replaced. The foundations could be jacked up/lifted then added concrete could be added for stability and support meeting current seismic requirements.**

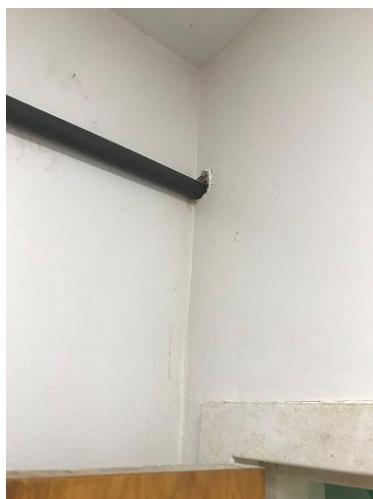
PT Storage Room/ Janitors Closet (A110) Wall Penetration: The wall mounted AC unit located on the north wall of Exercise A111 has a condensate drain line that routes through the wall and down to the floor sink. Walls are required to limit the transfer of smoke. **PRIORITY Repair: Recommend to seal penetration (both sides) with caulk to prevent the transfer of smoke.**

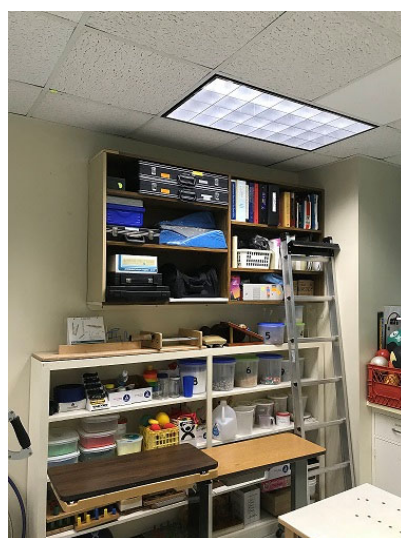
Wall Cabinet Tops/Closures: Numerous locations around the facility within healthcare occupancy had wall cabinets without any sloped tops or vertical enclosures to ceiling. Healthcare occupancies require for not only cleaning purposes due to access/reach and infection control with dust, debris accumulation but also to restrict or prevent stacking, that some sort of closure at wall cabinets be provided. (Example locations include: PT Treatment A113, Central Sterile Supply B151, Decontamination B158, ICU/CCU Treatment Rooms, ED Soiled Utility A281, CT, Mammo, Ultra Sound and others. **PRIORITY Repair: Recommend to install appropriate sloped tops at all wall cabinet locations or plastic laminate enclosures to/thru ceilings. This could not only lead to an OSHA violation, in stacking items on top of shelves above a certain height. Reaching to remove items from the tops of shelving can cause strains or other injuries that can lead to employee absence or worker's compensation claims. A safety hazard. It is common practice to provide enclosures at the top of wall cabinets, lockers and other shelving.**

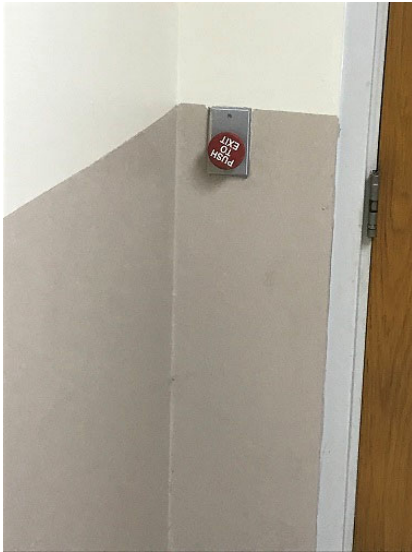
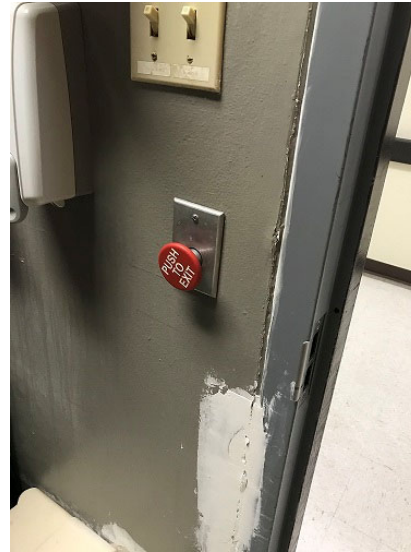
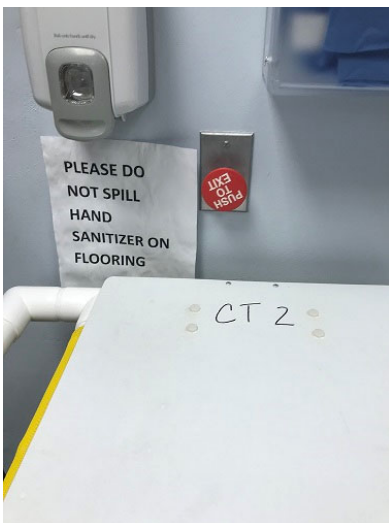
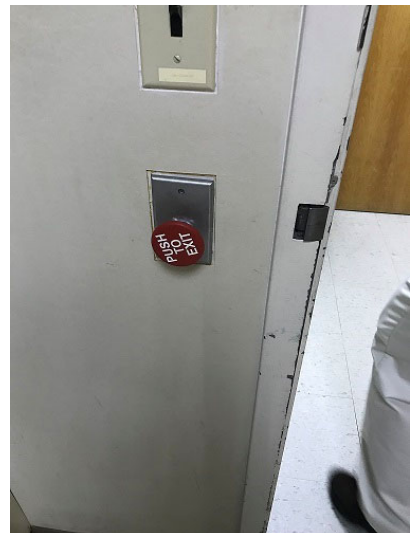
Door Access Control: There are numerous areas/rooms around the facility that utilizes “push to exit” buttons to release the magnetic locks for egress. Locations such as Doctor Corridor A117, Pharmacy Storage B125 & B127, CT 1, CT 2, Ultrasound A271, as well as others. Locking arrangement, delayed egress and access control shall comply with LS.02.01.20 EP1, NFPA 101 Sections 7.2, Chapter 18.2/19.2. Code Violation: **PRIORITY Repair: Recommend an in depth code study/assessment by a third party consultant in order to validate appropriate use and code compliance. Electronically controlled egress doors and security at OB Clinic needs to be coordinated per NFPA 101 Section 7.2.1.5.6 and 7.2.1.6.2. Manual release device shall be clearly identified by a sign that reads “PUSH TO EXIT” or per Section 7.2.1.9.1.3. A readily visible sign with letters not less than 1 in high on a contrasting background that reads “IN EMERGENCY PUSH TO OPEN”.**

- (1) Also, there is a clear cover on the device and someone would have to flip up to open in order to press the button, this is not considered readily available or accessible.

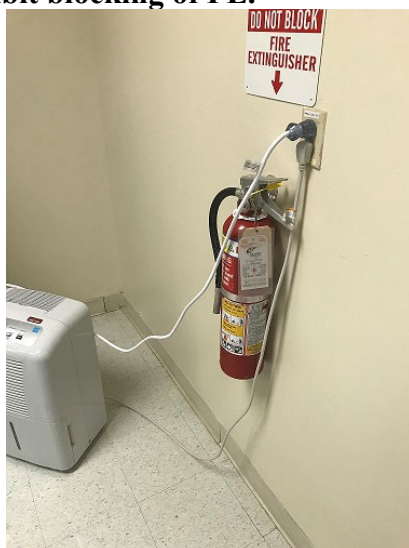
Fire Extinguisher Obstructed (Central Sterile Supply B151). Fire extinguisher obstructed with electrical cords to humidifier or other equipment. **EMERGENCY Repair: Recommend relocate equipment to prohibit blocking of FE.**

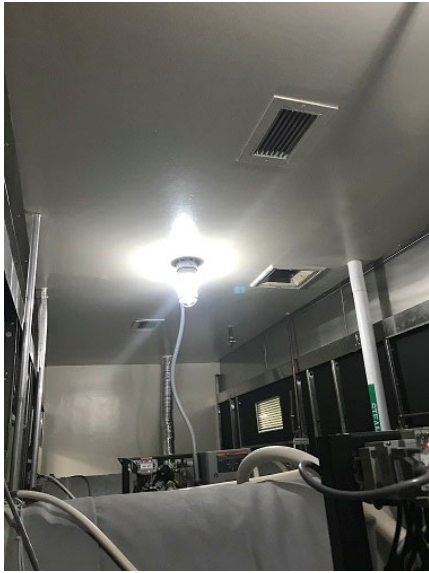
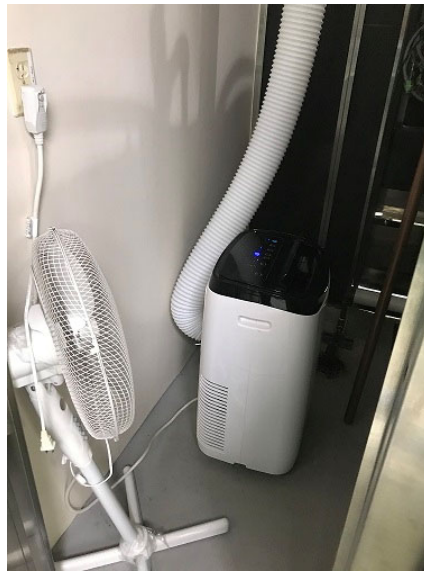
Cart Wash Ventilation: Cart washer's produce excessive amounts of heat while in operation as well as discharges steam when doors are opened. The cart washers are typically enclosed with walls creating a mechanical space for maintenance and repair. This mechanical space is required to have supply/make-up air as well as exhaust. The existing grilles and system does not appear to be adequate. The facility has installed portable fans and even a alternative cooling system to alleviate the heat in this room. **MAJOR SCHEDULED REPLACEMENT (MSR) Repair: Recommend that the AHU supply and exhaust system serving this space needs to be examined for compliance with code required air changes and ventilation (discharge) rates. New design and system requirement is probably necessary. See Mechanical for additional information.**

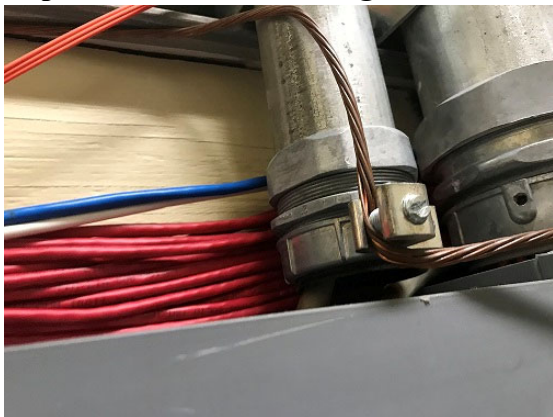
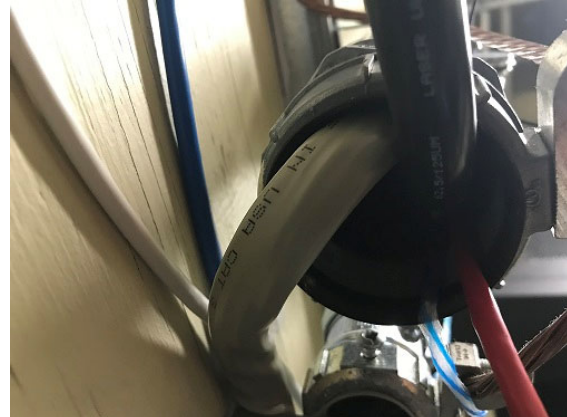
ICU/CCU COMM Room (B293) Conduit: Conduit on the far left actually routes up and then horizontally through the corridor wall, but not sure where it goes. The perimeter walls for this room are 1 hour rated, protection. This conduit needs to be sealed at the bottom. **PRIORITY Repair: Recommend filing the bottom of pipe with Hilti or equal rated caulk.**

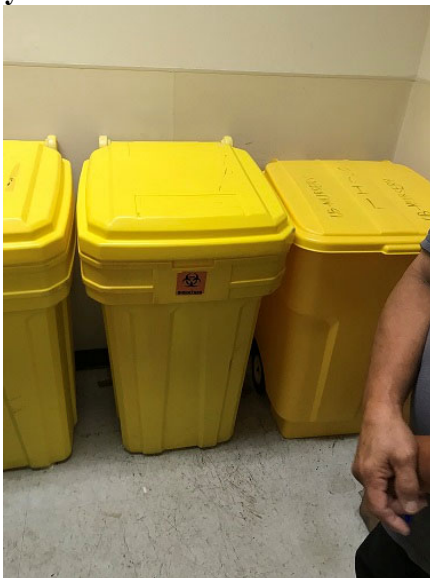
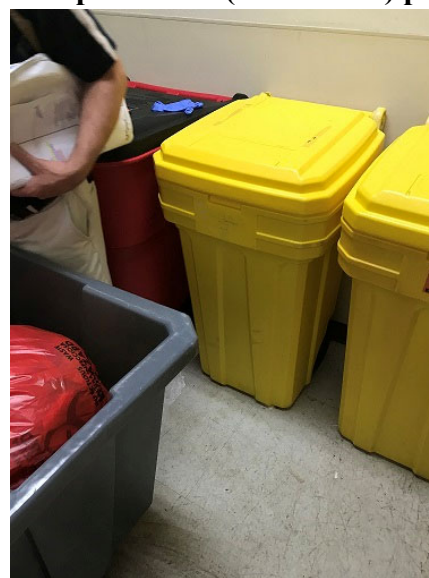
Recovery Hazardous Storage B238: Bins located in storage room appears to exceed allowable capacities. Soiled Linen and trash receptacles larger than 32 gallons (including recycling containers) are located in a room protected as a hazardous area per LS.03.01.70 and NFPA 101 18/19.7.5.7. **PRIORITY Repair:** Recommend validation each container capacity, total capacity for room and that the room has the required protection (rated walls) per code.

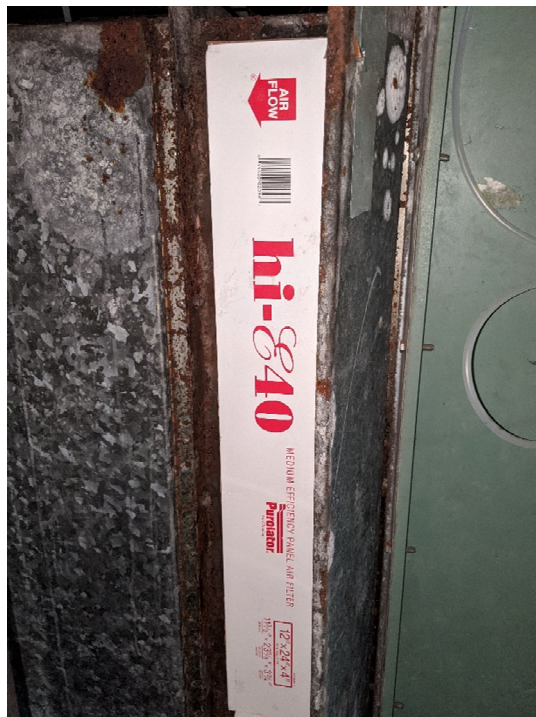
The filtration in all of the in-patient systems investigated was not in compliance with current industry guidelines (FGI/ASHRAE STD 170). Only one bank of MERV 8 filters was installed. This bank was located upstream of all coils. ASHRAE STD 170 require two sets of filters for all inpatient areas; a minimum MERV 7 upstream of all coils, and a minimum MERV 14 downstream of all wetted coils and supply fans. The installed filter meets the requirements of the first filter bank; however, no second filter bank is provided. It is important to note that even the most recently renovated areas (ICU/ED), based on the as-builts, do not have ASHRAE STD 170 compliant filtration.

MERV 8 filter, typical of all air handling units observed.

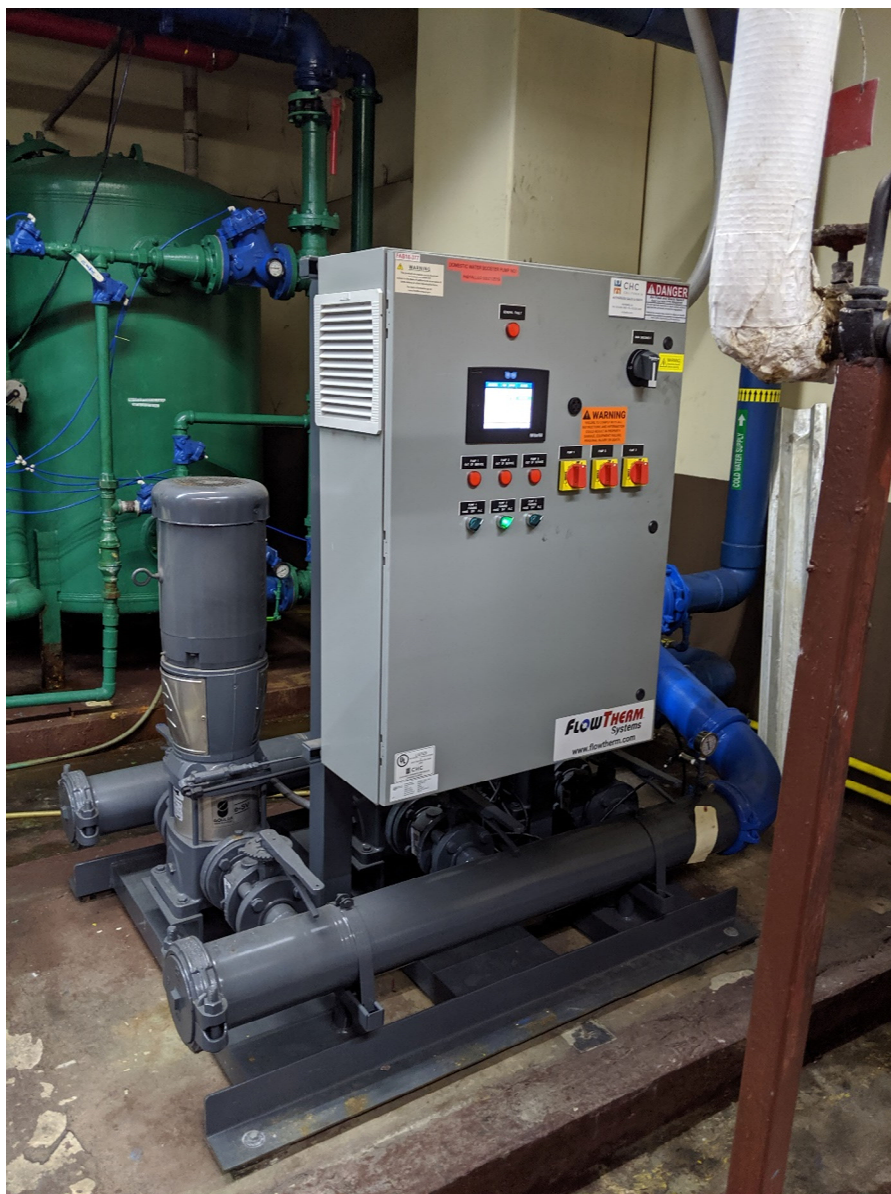
Water Supply – Domestic water is provided by the local water utility provider. GMHA has two 400,000 gallon below grade on-site storage tanks, a 20,000 gallon above grade tank, and a domestic water pumping unit. The domestic water pumping unit is manufactured by FlowTherm, includes triplex Goulds pumps, was replaced recently, and appears to be in good operating condition. All domestic water is conditioned by a duplex salt brine ion exchange softening system. Chlorination was said to be provided by the local water utility provider. There is no additional chlorination or secondary water treatment at the tanks or within the facility. No Legionella outbreaks were reported by the staff.

Domestic water pumping unit

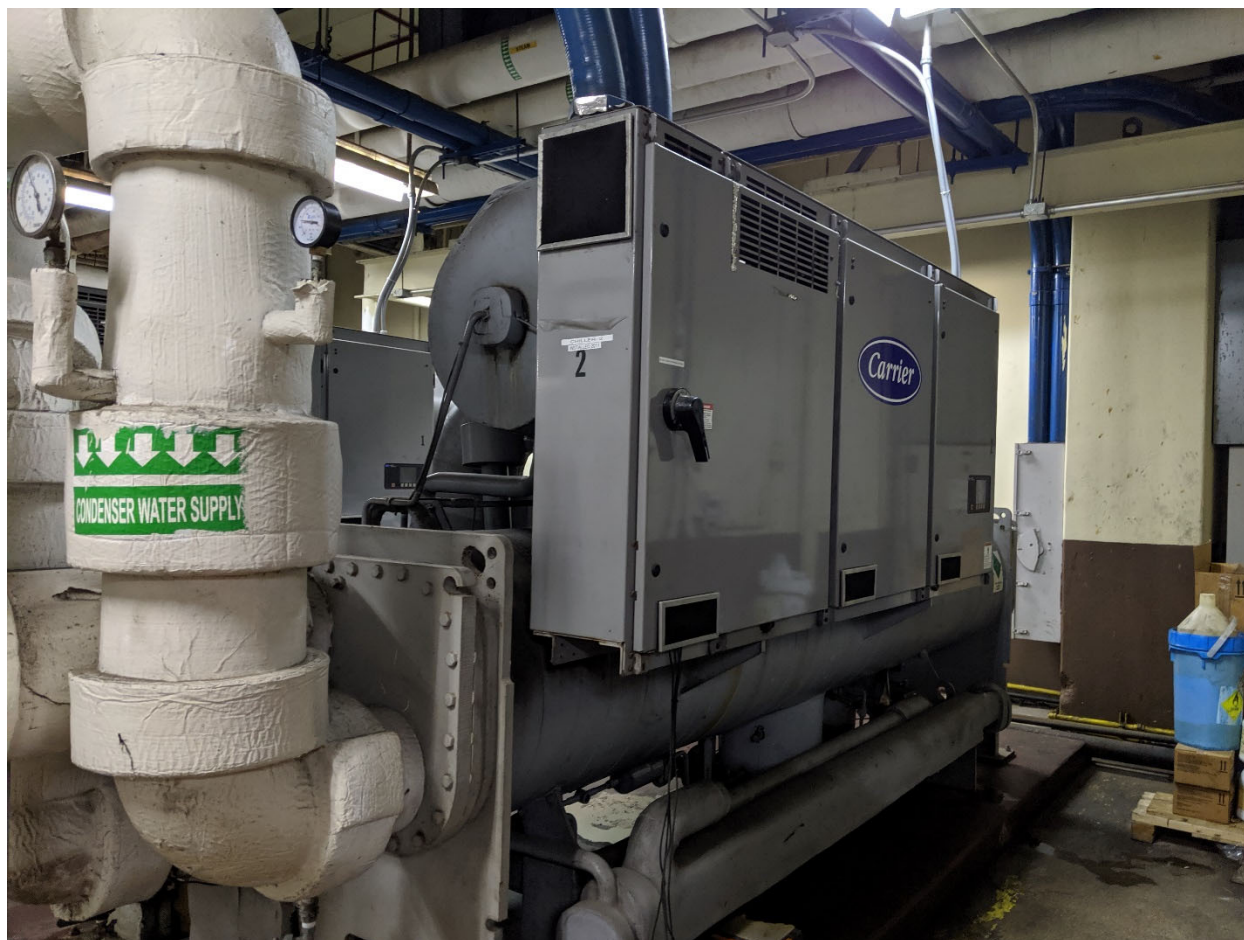
Water cooled chiller

Based on the as-builts the chilled water supply set-point is 42 deg F; however, the chillers are providing a 44 deg F supply temperature. While this difference did not seem to effect the ability of the system to maintain temperature and humidity in the patient care areas at the time of the survey, this difference could contribute to the high humidity reported when the ambient weather approaches design day conditions.

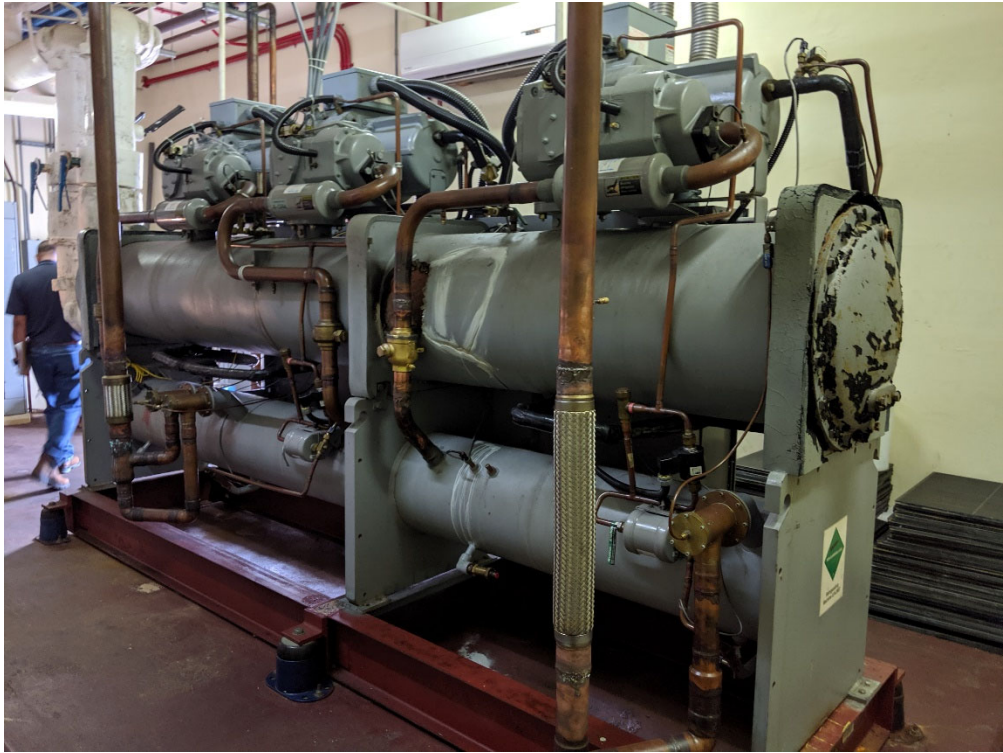
The emergency air-cooled chiller has three compressors and three remote air-cooled condensers with common refrigerant piping. While the emergency chiller is tested regularly, and appears to be operational, the condensers are severely corroded from exposure to the salt spray. The inlet side of the aluminum/copper fin-tube coil is completely corroded to just past the first row of copper tubes. It is only a matter of time before the coils are corroded to the point that high refrigerant head pressures prevent the chiller from operating at all. Based on the level of corrosion observed, the condensers are nearing the end of their usable life.

Emergency chiller

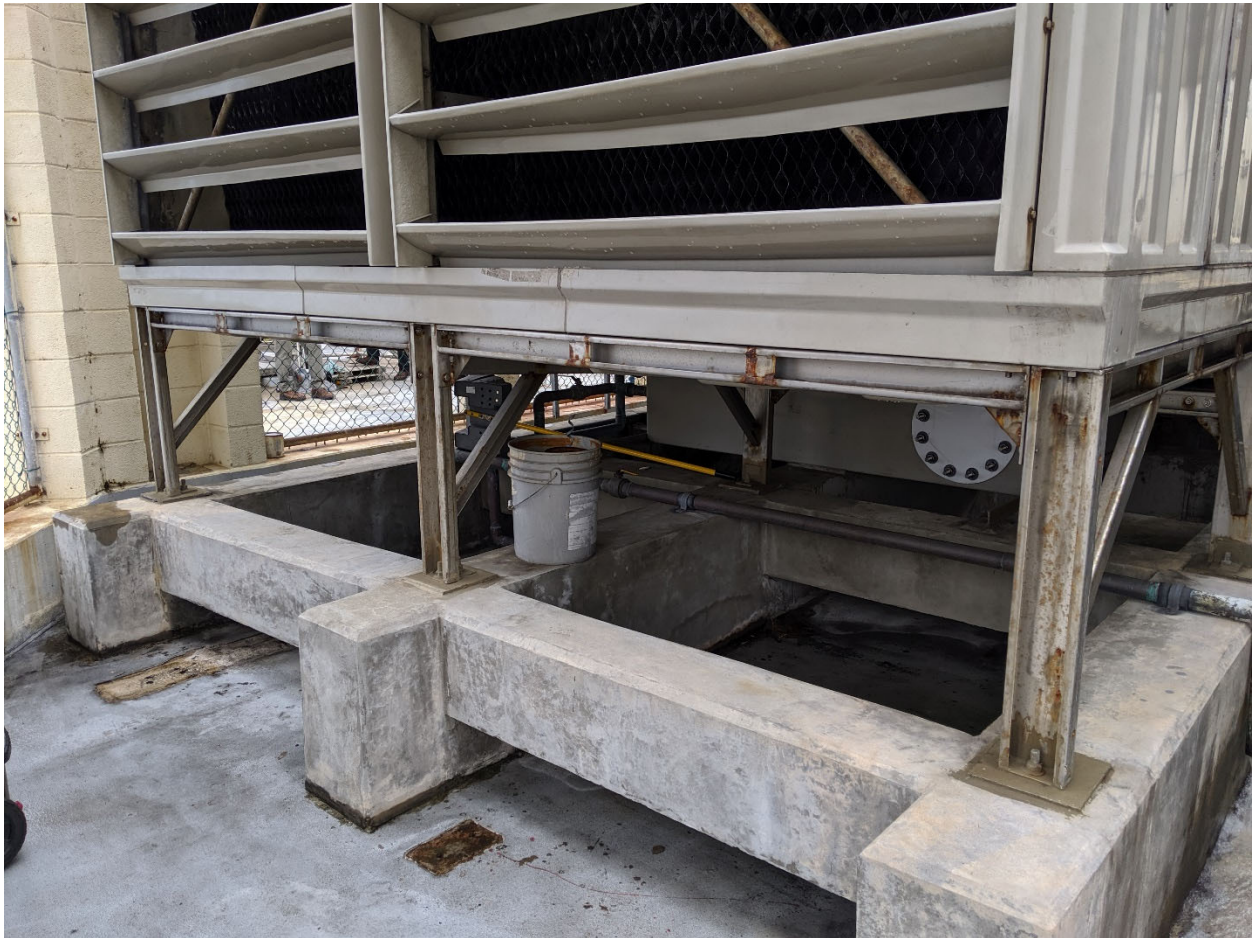
Condenser Water – The condenser water system serving the two primary chillers consists of two fiberglass cooling towers with fabricated stainless steel supports located on the roof of the Central Utility Plant. The condenser water system appears to be in good operating condition. This is likely due to the selection of materials with high resistance to corrosion and careful attention to condenser water treatment. It should be noted that there is some light rusting of the stainless steel in areas where the stainless steel was either cut or welded during the fabrication of the cooling tower support. This is likely due to a reduction of the self-passivating chromium oxide layer caused by the welding or cutting operation. For any new stainless steel fabrications that will be exposed to the local environment, a post-fabrication passivation treatment is recommended.

Cooling towers

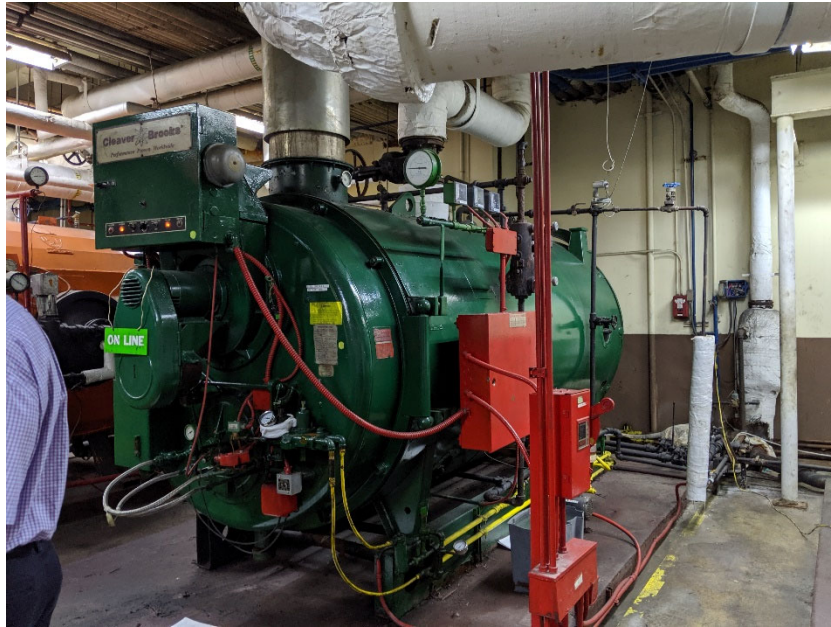
Steam - Steam is provided by two 125 HP (4300 lbs/hr) diesel fuel fired boilers operating at 75 PSI. Steam is utilized for sterilization, and to generate domestic hot water. One boiler is currently out of service for re-tubing. The tubes in the other boiler are planned for replacement once the one currently being worked on is operational. The boilers are in excess of 25 years old, exhibit significant exterior corrosion, and are beyond their useful life. In addition, when the boiler restarts at low load, significant smoke is produced. This continues for several minutes. Repair/renewal of the facility would require replacement of the boiler system. The boiler feedwater/condensate recovery tank is severely corroded, leaking, almost non-operational, and beyond repair. Complete replacement is the only viable remedy.

Steam boiler

Replacement of the boilers should also consider inclusion of a pressurized deaerator for feedwater treatment to reduce corrosion in the steam system.

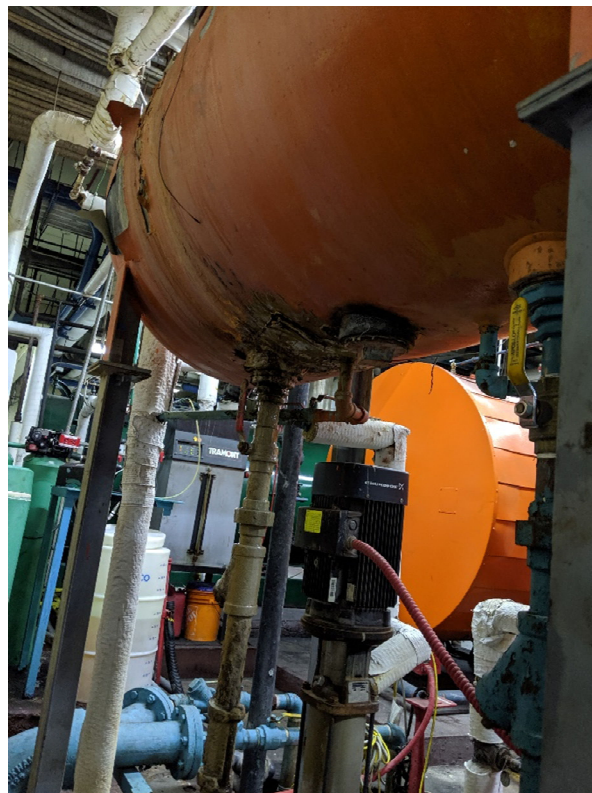
Boiler feedwater/condensate receiver tank

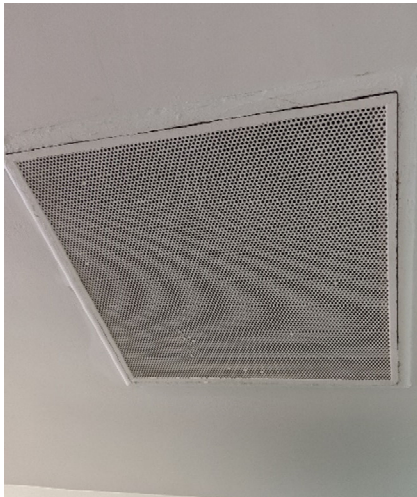
Access panel/grille into patient bedroom soffit space

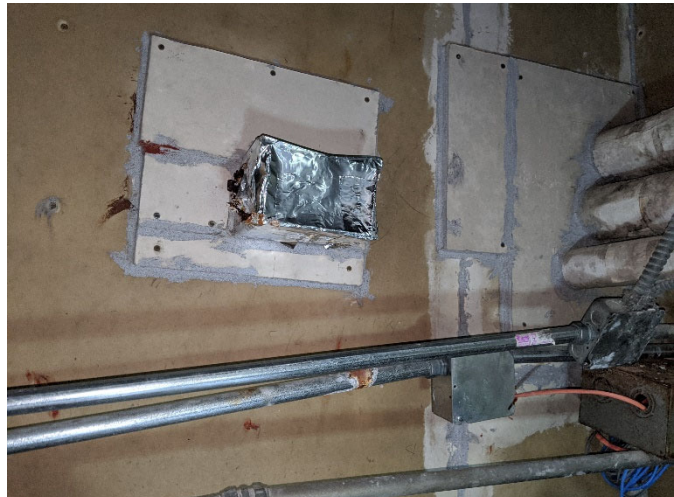
With the exception of the newly renovated areas, a typical patient ward is served by independent recirculating fan coil units (which include only a filter, fan, and cooling coil) for each room, and typically three or four outside air fan coil units which also include only a filter, fan, and cooling coil. The recirculating room fan coil units draw air from the above ceiling plenum space formed by a soffit above and just inside the room entry door, and discharge through the side of the soffit into the patient room. Return air is drawn into the plenum space through a combination access panel/grille in the bottom of the soffit. This is not in compliance with ASHRAE STD 170 which requires fully ducted return for all inpatient areas. The outside air fan coil units are located above the ceiling in the corridors. Outside air is ducted from a louver above the exit doors to the outside air fan coil units. From there it is ducted to each room and discharges through a volume damper into each soffit plenum space. However, since these systems are not operational, or their outside air louver has been blocked off as discussed above, there is no outside air being provided to the spaces at this time.

View through access panel/grille inside patient bedroom soffit/plenum space

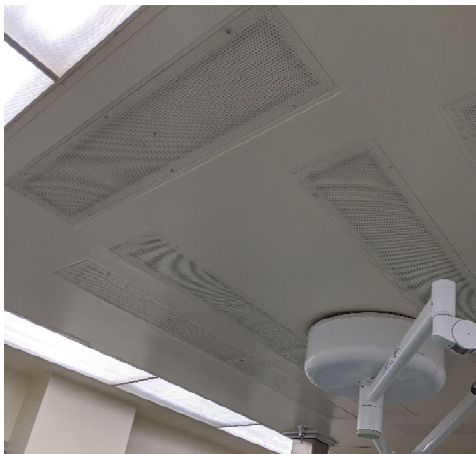
Surgical Department – The surgical department, with the exception of operating room #2, is served by a single 100% outside air constant volume air handling unit. Operating room #2, which is currently not being used, is served by AHU3 that also serves the ICU common areas. While space temperatures within the ORs were reported as within requirements, portable dehumidifiers were being used to keep the space humidity within limits. This is likely due to the lack of reheat in the AHU's serving the ORs. Without reheat it is difficult, if not impossible, to lower the humidity without overcooling the space as described above. In addition, the air supply to the ORs does not comply with current industry requirements (ASHRAE STD 170) since the unidirectional low aspirating diffusers do not cover at least 70% of the ceiling space above the surgical table and extend 12 in. on either side.

OR ceiling showing inadequate coverage

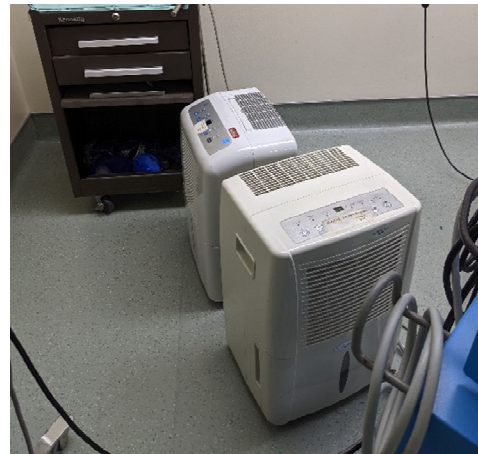
Portable dehumidifiers being used in ORs

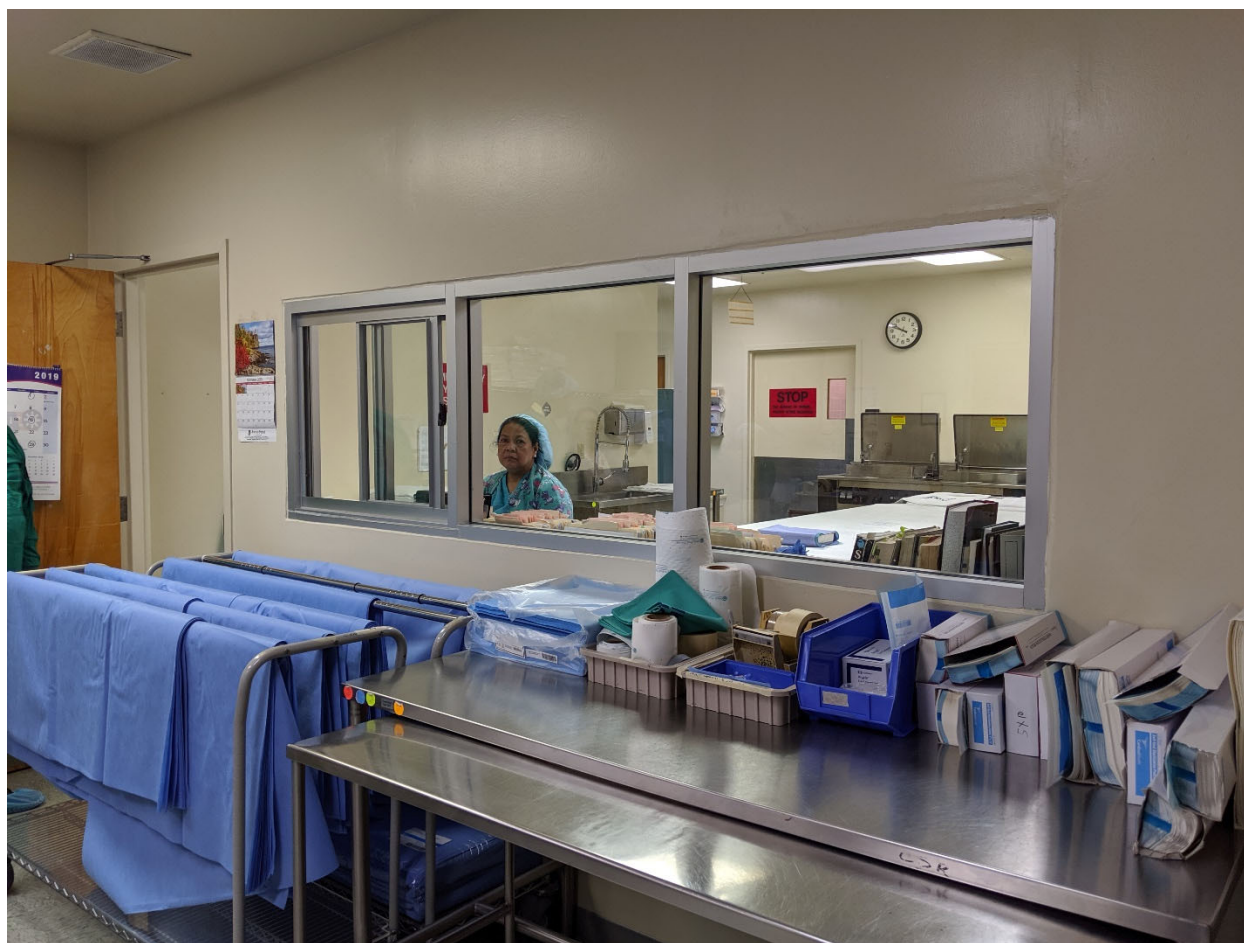
CMS (Central Sterilization) – The central sterilization department is not compliant with current industry guidelines (FGI/ASHRAE STD 170). FGI now requires at least a two room suite with the decontamination area separated from the clean workroom (assembly/prepack) and sterile storage by a building partition. There is currently a wall between the decontamination area and the clean workroom. However, since the pass through window is not large enough to accommodate most of the items/containers processed, the door between the spaces is being propped open and the items carried through the doors. While not specifically required by criteria, typical industry practice is to provide double sided pass through washers between decontamination and the clean work room, similar to the pass through sterilizers between the clean workroom and sterile storage. In addition, a pass through window is typically provided to accommodate those items that would not be processed through the washers. With the door between the decontamination area and the clean workroom being propped open it is impossible to maintain the ASHRAE STD 170 required negative pressure in the decontamination area and the positive pressure in the clean work room.

Sterilization clean workroom with decontamination beyond

New double sided pass through sterilizers have recently been added between the clean work room (assembly/prepack) and sterile storage similar to a three room sterilization suite. This is an industry accepted best practice. However, it does not appear that the HVAC system was upgraded to comply

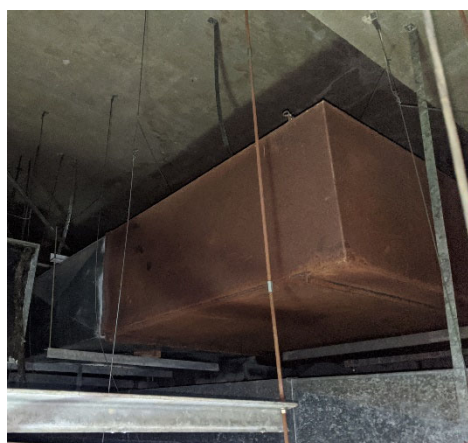
Kitchen – In addition to the inoperative make-up air unit mentioned previously, at least two sections of the kitchen exhaust hood grease duct have been replaced with light gauge galvanized metal as opposed to the NFPA 96 required 16 ga. black steel or 18 ga. stainless steel. While this is not an immediate threat to life or health, in the event of a cooking fire, the exhaust duct may not effectively contain the fire within the exhaust system. At a minimum, the non-compliant kitchen exhaust hood duct sections should be replaced with materials that comply with NFPA 96.

Inappropriate kitchen exhaust duct material

1. The non-compliant light gauge galvanized ductwork needs to be removed from the kitchen exhaust and replaced with 16 ga. welded black steel to comply with NFPA 96.
2. The kitchen make-up air system needs to be repaired and placed back in service.
3. All HVAC systems need to be evaluated and renovations/repairs made to provide ASHRAE STD 170 minimum outside ACH rates.

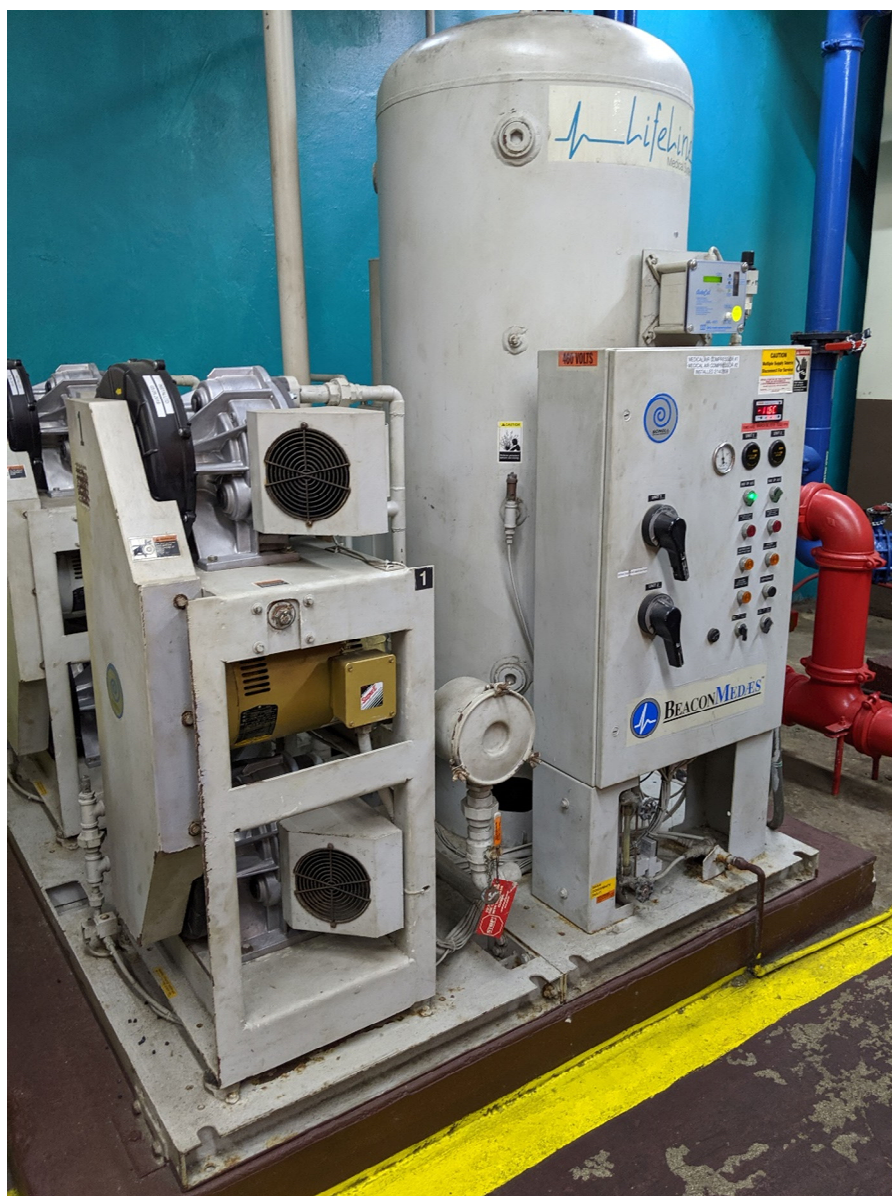
General – Med gas producers appear to be in working order, and no significant issues were reported by the staff. All med gas systems (vacuum pumps, medical air compressors, oxygen manifold, and nitrous oxide manifold) are located either in the open medical gas building or in the unconditioned CUP. This subjects the medical gas equipment to the corrosive ambient environment. In addition, the medical vacuum pumps, and medical air compressors are located within the CUP in the same room with both fuel burning and refrigeration equipment, and adjacent to the above ground water storage tank. While this location is not in direct conflict with NFPA 99, it places the medical gas producers where catastrophic failure of the other equipment could result in loss of these lifesaving systems.

Medical air compressors with 20,000 gal water tank beyond
