**US Army Corps
of Engineers®**

**Facilities Condition Assessment
Guam Memorial Hospital
Tamuning, Guam**

08 April 2020

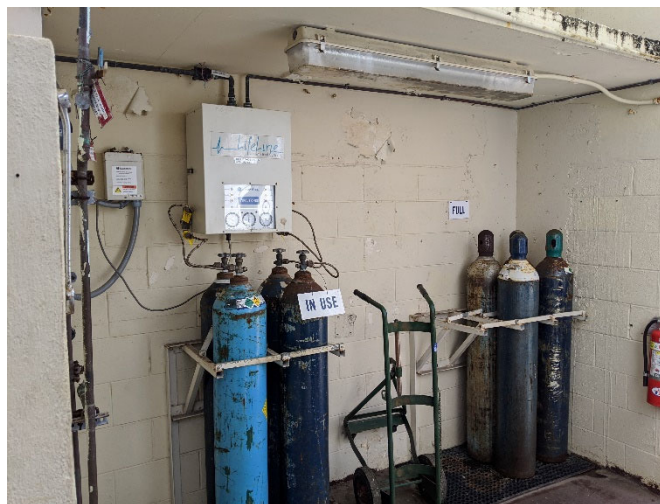
Nitrous Oxide – Nitrous oxide is provided by a primary/reserve cylinder manifold system located in the medical gas compound. This manifold system is in good working condition.

Nitrous oxide system

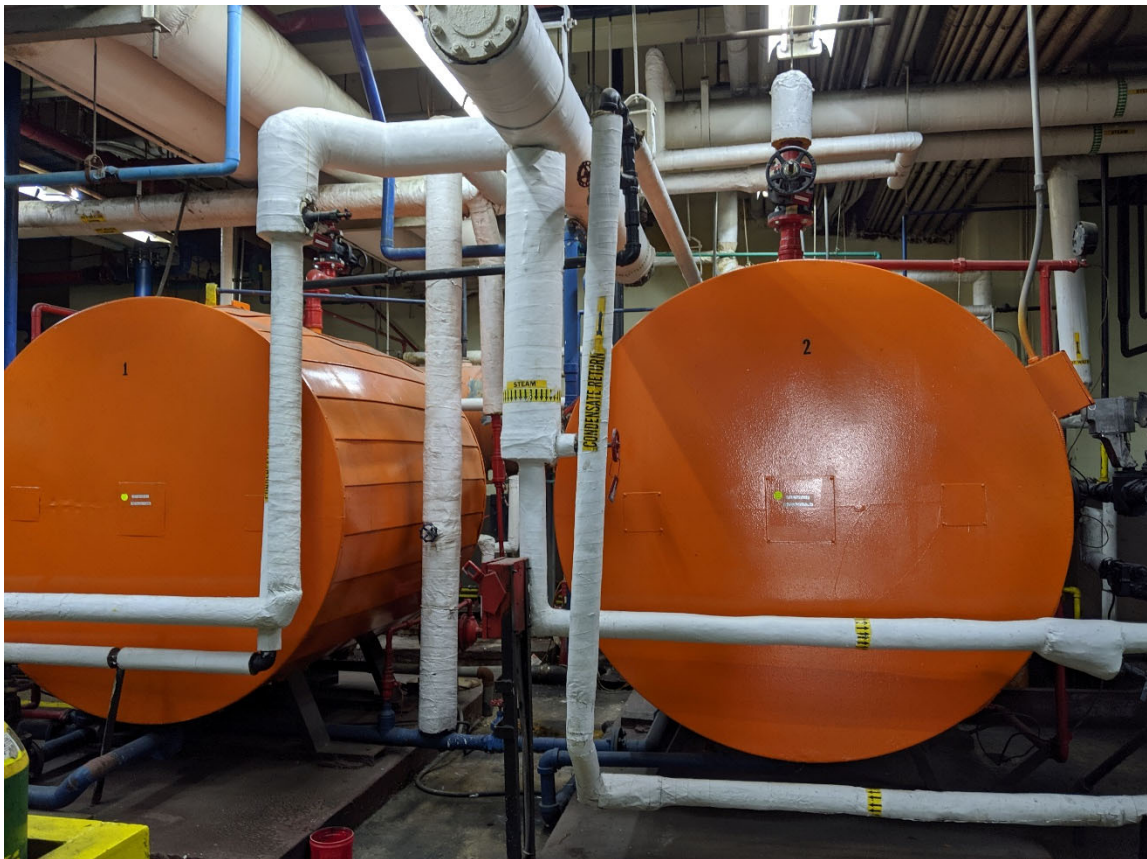
Domestic hot water is generated by steam to water heat exchangers at the CUP and distributed to the hospital. It was indicated that the generation temp and supply temp is 140 deg F. While the actual water temperature delivered to the faucets was not checked, a few hand washing locations were operated, and hot water was available within a reasonable time (around 30 seconds).

Domestic hot water heat exchangers
