Submerged Aquatic Vegetation Assessment

**Gulf State Park
Shelby Lake
87° 39' 28.867" West / 30° 15' 23.501" North
Gulf Shores, Alabama
Volkert Contract No. 334001.12**

**Alabama Department of Conservation and Natural Resources
64 North Union Street
Suite 479
Montgomery, Alabama 36130**

**VOLKERT, INC.
316 South McKenzie Street
Foley, Alabama 36535
(251) 968-7551**

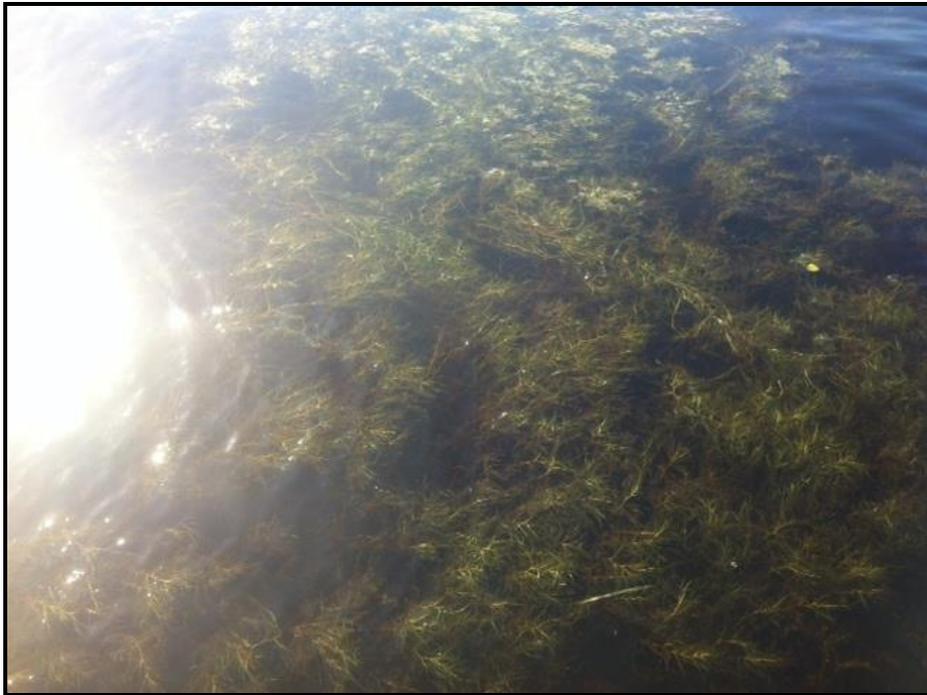
Photo 2: *Ruppia maritima* within survey area 1.

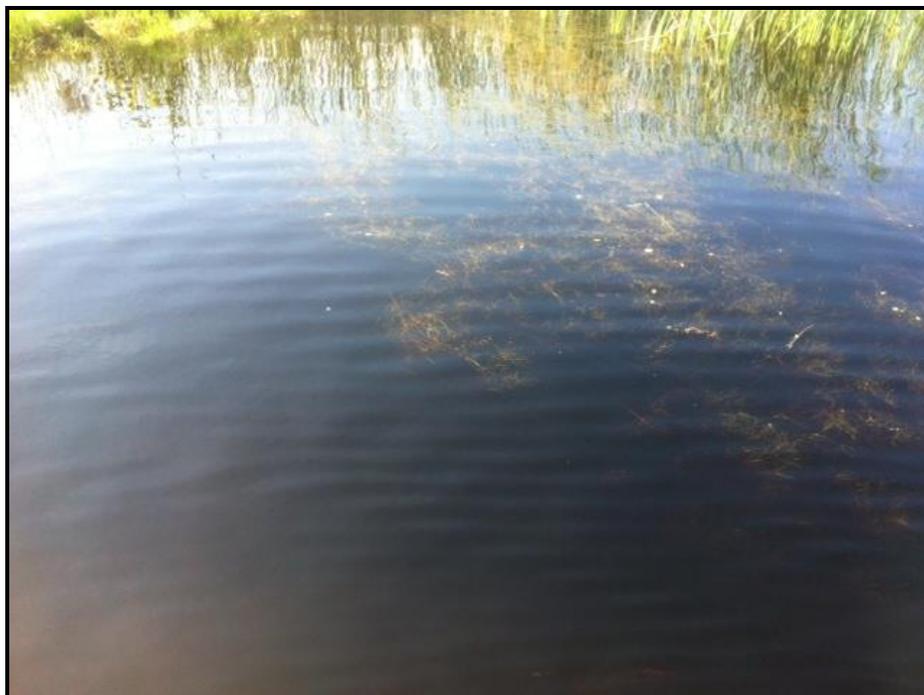
Photo 4: *Ruppia maritima* within survey area 2.

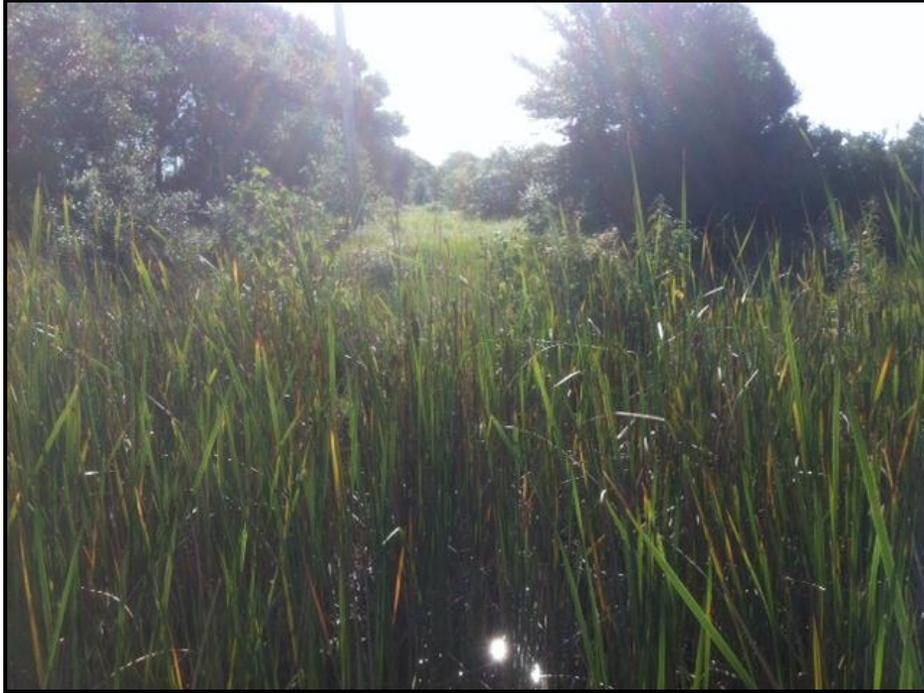
Photo 5: View looking east from within survey area 3. There was no SAV identified at this site.

Using transect lines and with ample sunlight and fair visibility during the survey clumps of SAV were easily identified within portions of the survey areas. A rake was used to help locate SAV in areas of low visibility or where water depths were too great. Where SAV was identified within the survey areas it was growing in a mosaic of patches. Within these identified areas SAV accounts for approximately 40% of the water bottom within mapped polygons (**Figures 2A, 2B**). Due to the dispersal of individual patches itemized mapping was not possible. Of the plant species identified, *Vallisneria americana* and *Ruppia maritime* were identified at sites 1 and 5. Only *Ruppia maritime* was identified at sites 2 and 4. There were no SAV identified at site 3. (**Table 1**).

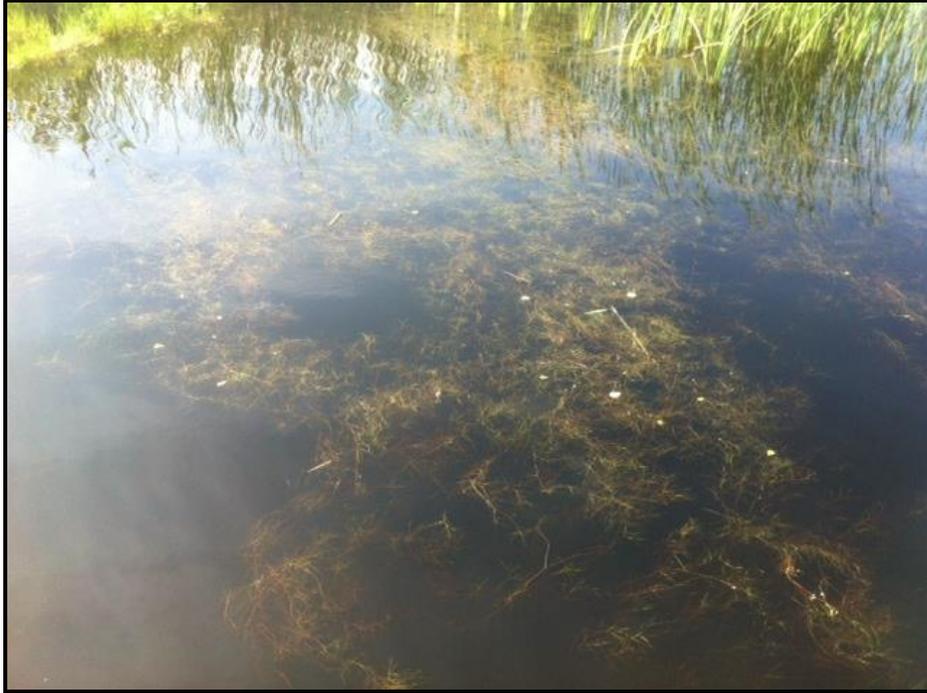
Photo 7: *Ruppia maritima* within survey area 4.

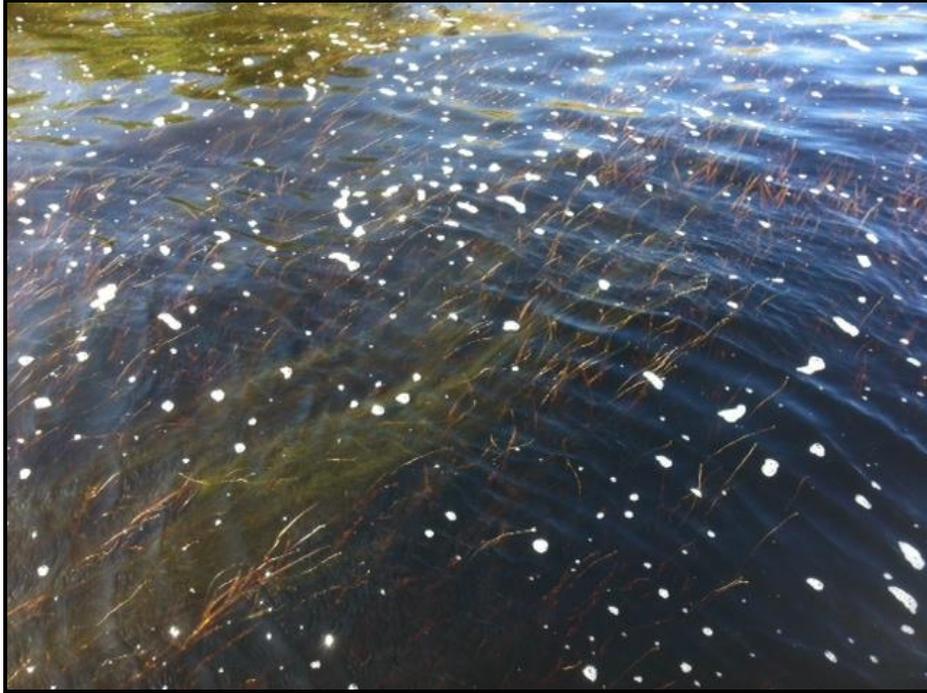
Photo 9: *Vallisneria americana* within survey area 5.

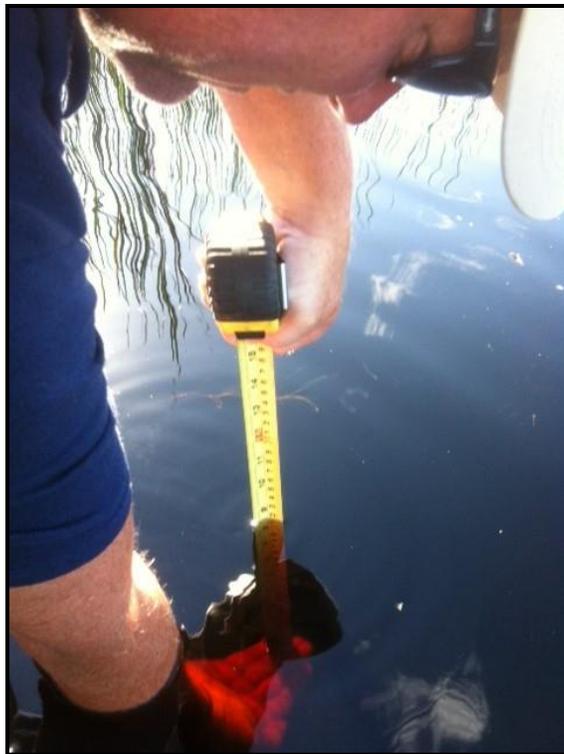
Photo 10: Water visibility was approximately 12 inches at the time of the survey.
