Interagency Aviation Lessons Learned

No. IALL 08-04

Subject: Incident With Potential (IWP): Near Wire-Strike during Fire Suppression Operations

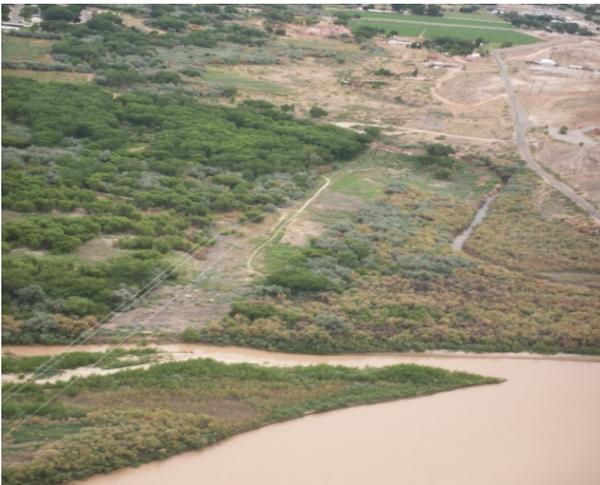
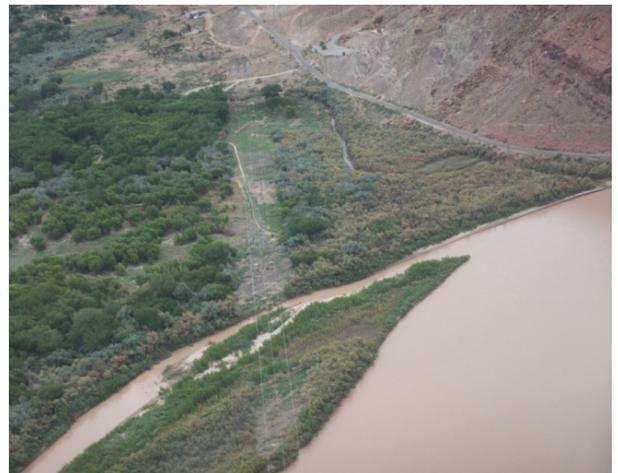
Discussion: A near wire-strike occurred during fire suppression operations. The helicopter involved in the IWP was in search of an adequate dip site to support a Wildland Urban Interface (WUI) fire. During the high-level recon, the pilot and helicopter manager identified two ponds that could potentially be used. Upon closer inspection, one pond was too shallow and the other was small and located in a camp park with numerous civilians in the area. A river, which was a viable alternative, was located a little further away. The pilot, concerned with the strength of the current, continued to fly downriver in order to find a wider spot where the current wasn't as strong. Both the pilot and the helicopter manager were "heads down" looking at the river when a crewmember sitting in the backseat called over the intercom system "POWERLINES." The pilot instantly responded by initiating a climbing left turn. The pilot estimated that he missed the power lines by approximately 150 feet. The photographs below, taken above those powerlines, shows how difficult it can be to see wire hazards.

The power lines did not have any high visibility markers, but were indicated on the local aerial hazard map posted at the helibase. This flight had been diverted while enroute to a different incident.

1. Pre-mission briefings should include known local aerial hazards. Aircrew should carry smaller aerial hazard maps in order to maintain situational awareness of known hazards and to identify other existing hazards not listed on maps. Previous hazard map editions should be updated to indicate any newly identified hazards.

2. Division of duties. In this IWP, the pilot and the helicopter manager were both “heads down” looking at the river. One should have been maintaining a visual scan outside the aircraft, looking for potential hazards and other traffic, while the other was looking for an adequate dip site.

4. Hazard communication. During the flight, one set of power lines was identified and communicated to all. It was assumed that the other set of power lines (the one involved in the IWP) was observed by all aircrew, and therefore not specifically identified or communicated to all.

5. Everyone aboard an aircraft should maintain a lookout for aerial hazards and traffic and speak up if something is seen. The aircrew in the backseat of this helicopter prevented a potentially fatal accident from occurring.

1. Know where your local wire hazards are. Check local hazard maps and survey the area for wires before conducting low level operations.
2. Slow down! Lower speeds significantly increase your ability to detect and avoid wires.
3. In general, cross power lines at towers or poles, taking care to avoid any static lines that may be above the transmission line. However, when conducting operations in the vicinity of steep canyons or valleys that contain transmission lines, make sure that the lines that cross these areas are not configured with floating static lines prior to crossing at towers or poles.
4. Power lines and supporting towers are considered structures by the FAA and aircraft must maintain clearance in accordance with FAR 91.119.
5. Report wire hazards via the SAFECOM system.
